METROPOLITAN EDISON COMPANY
THREE MILE ISLAND NUCLEAR STATION
UNIT NO. 1

REACTOR BUILDING RING GIRDER
SURVEILLANCE REPORT

November, 1973

THREE MILE ISLAND NUCLEAR STATION

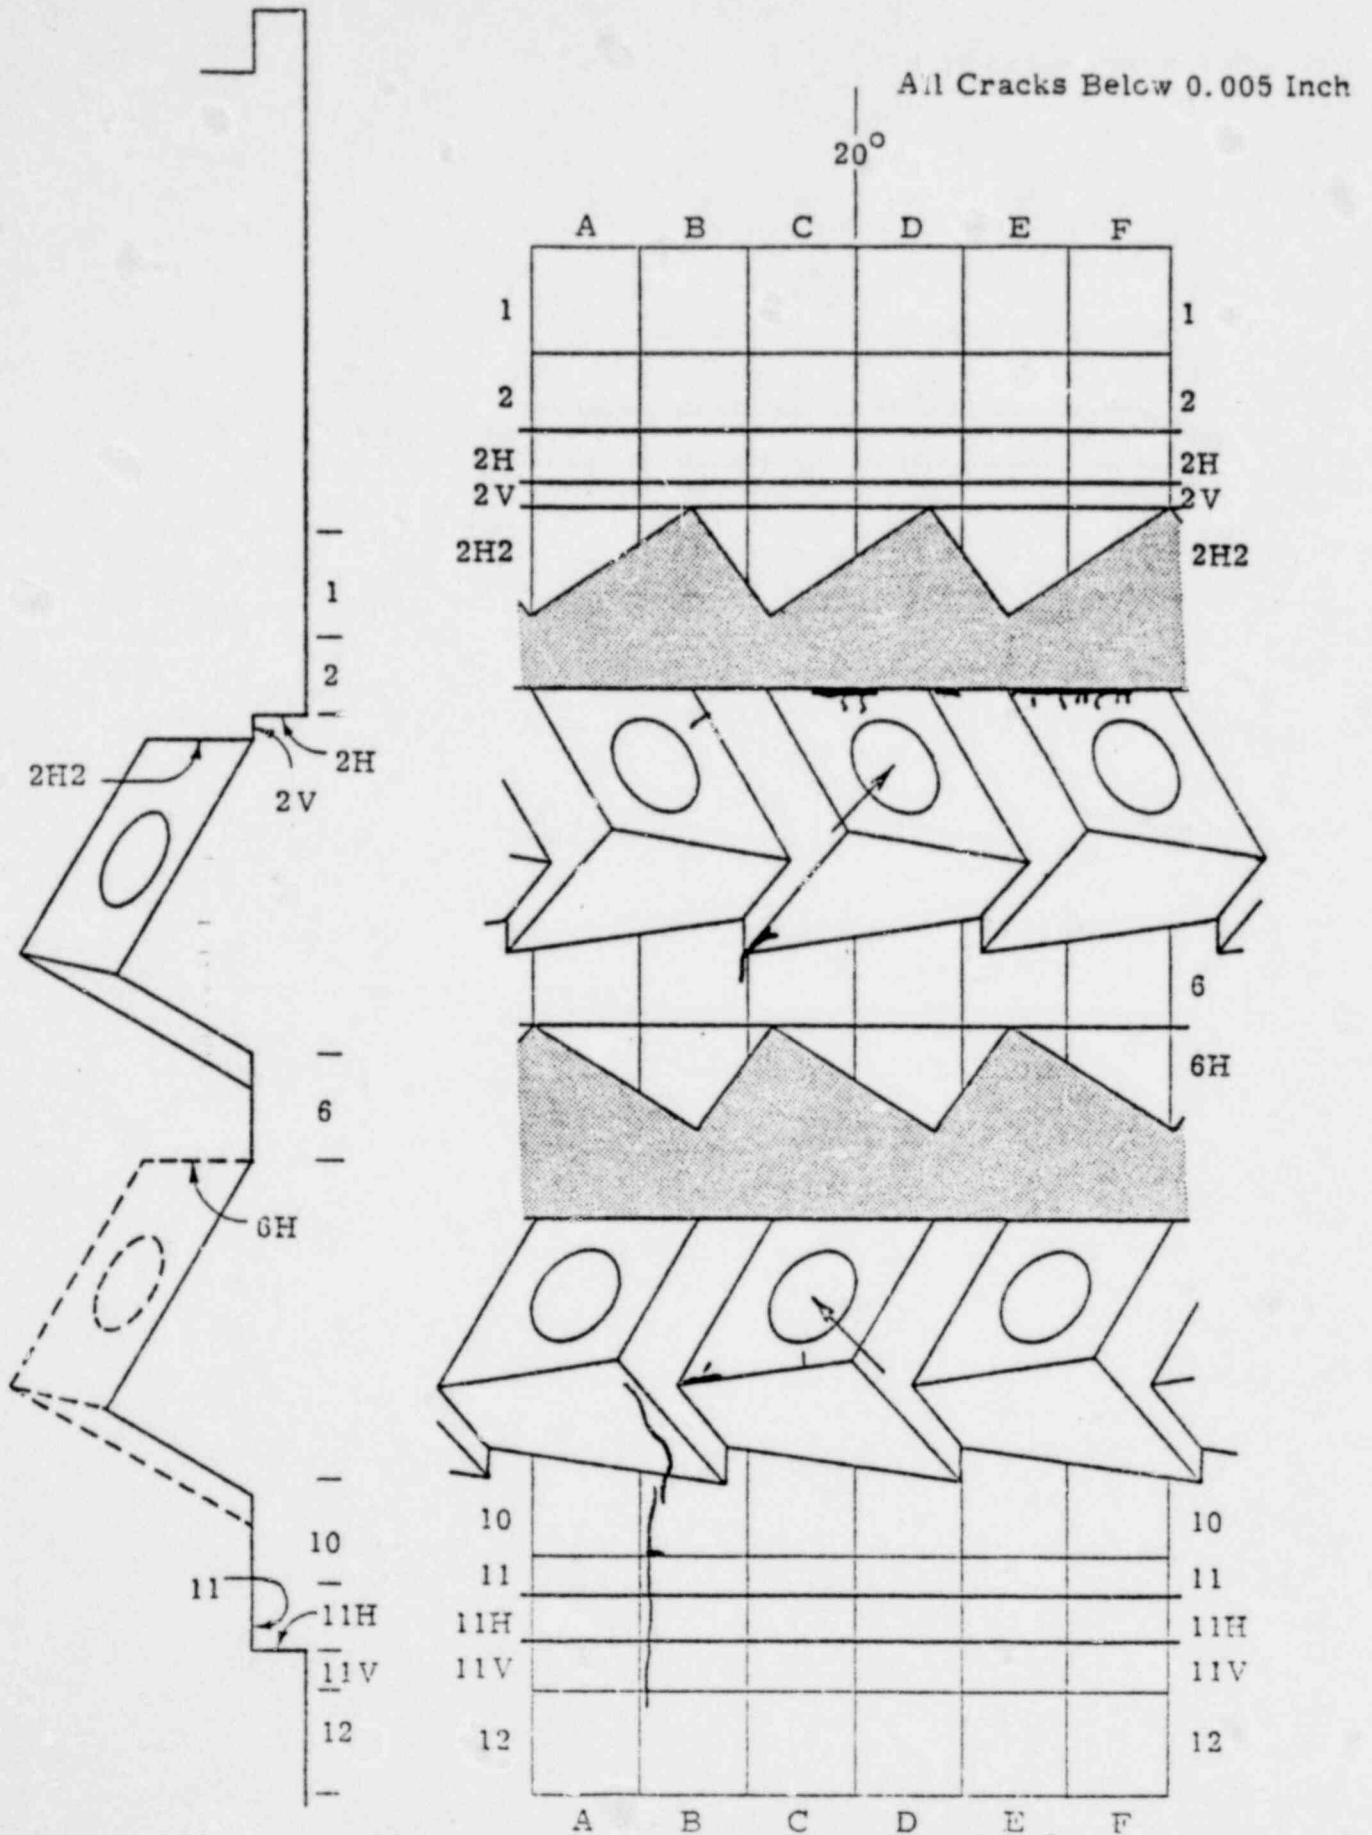
FIGURE 7.

CRACK PATTERN AT AZIMUTH 20°
 PRIOR TO PRESTRESS, 5-14-73.

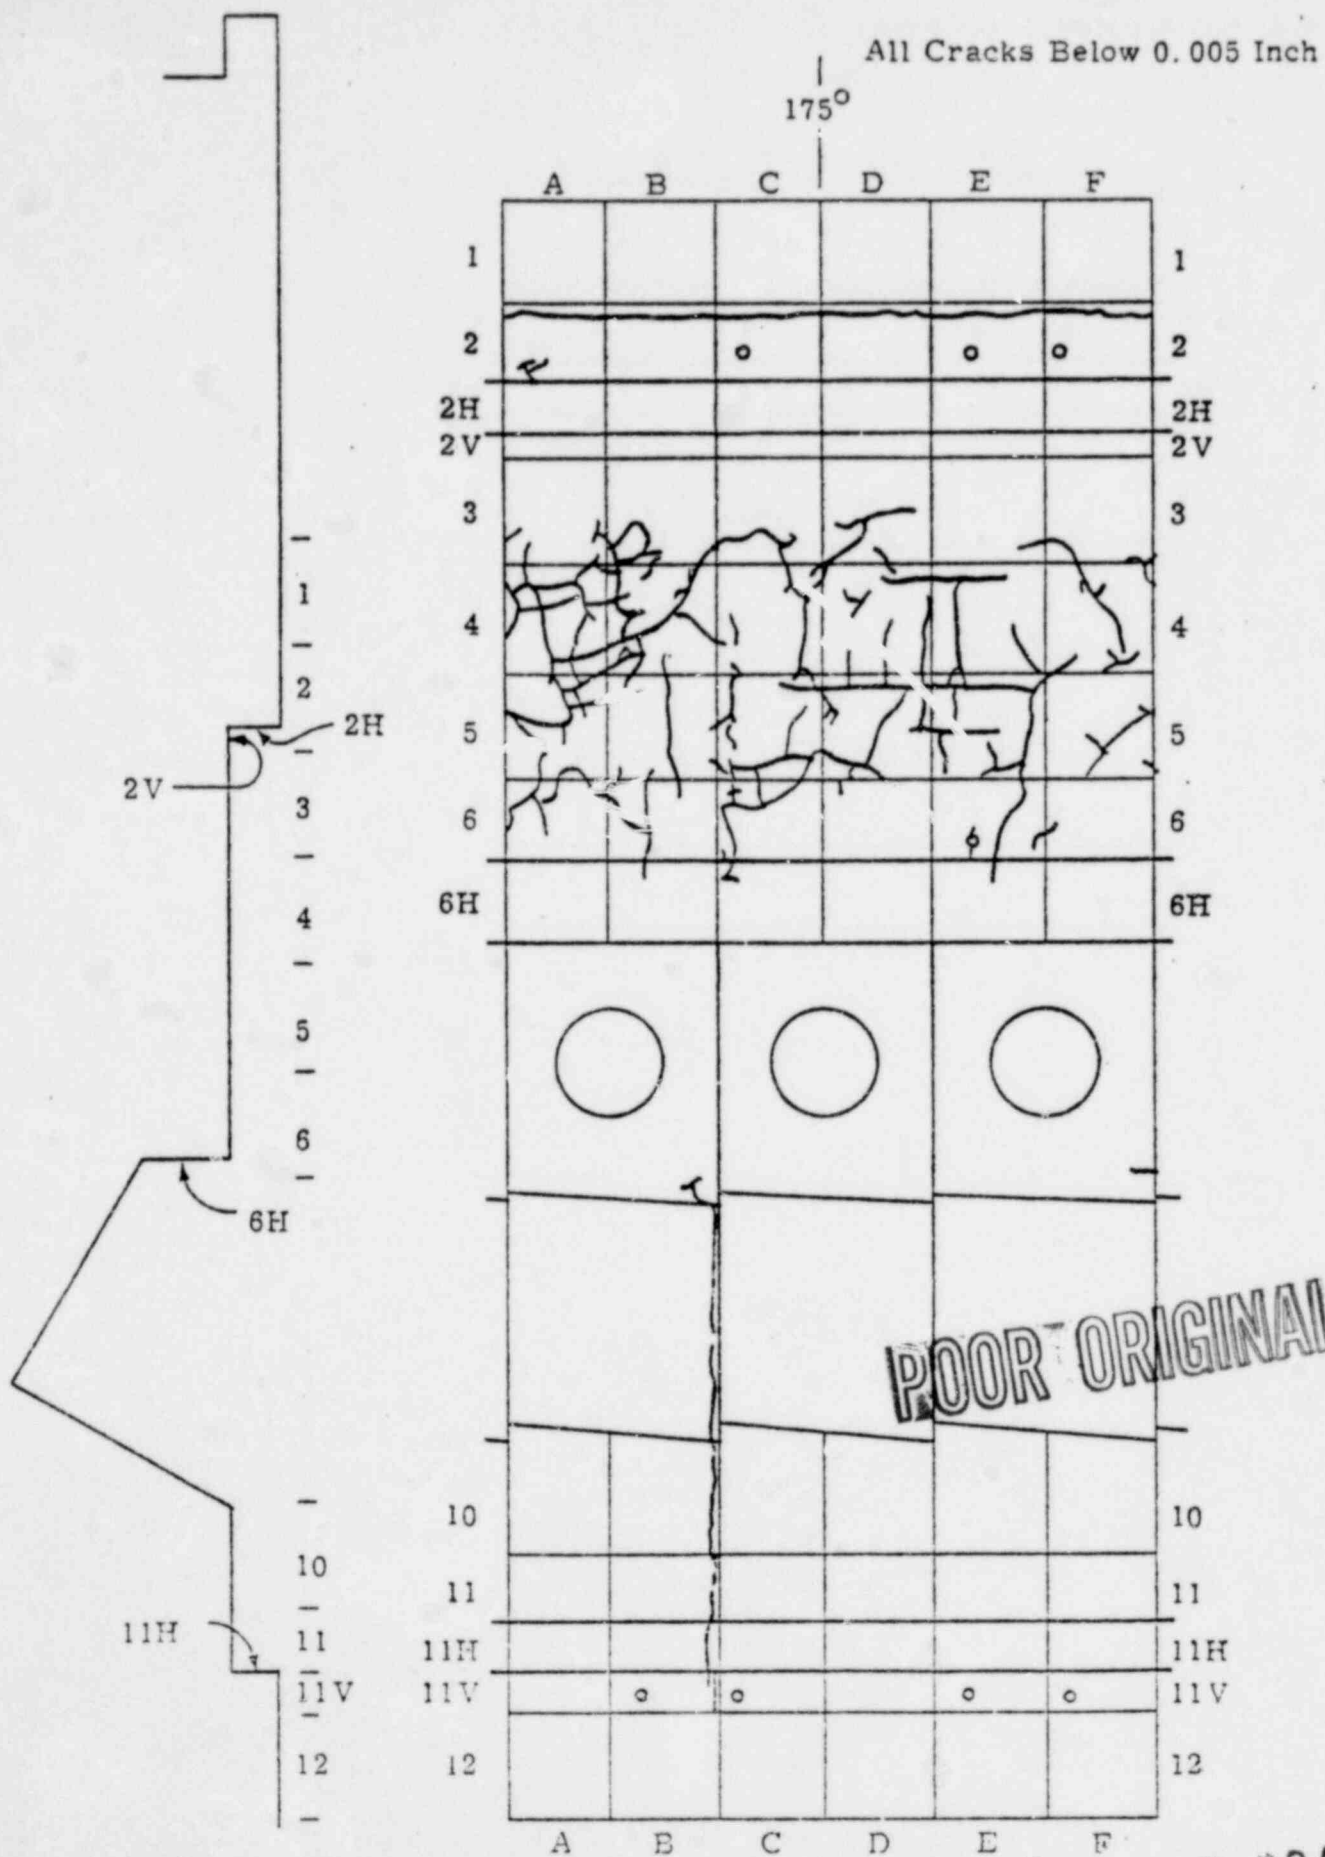
FIGURE 3.

CRACK PATTERN AT AZIMUTH 175°
PRIOR TO PRESTRESS, 5-14-73.

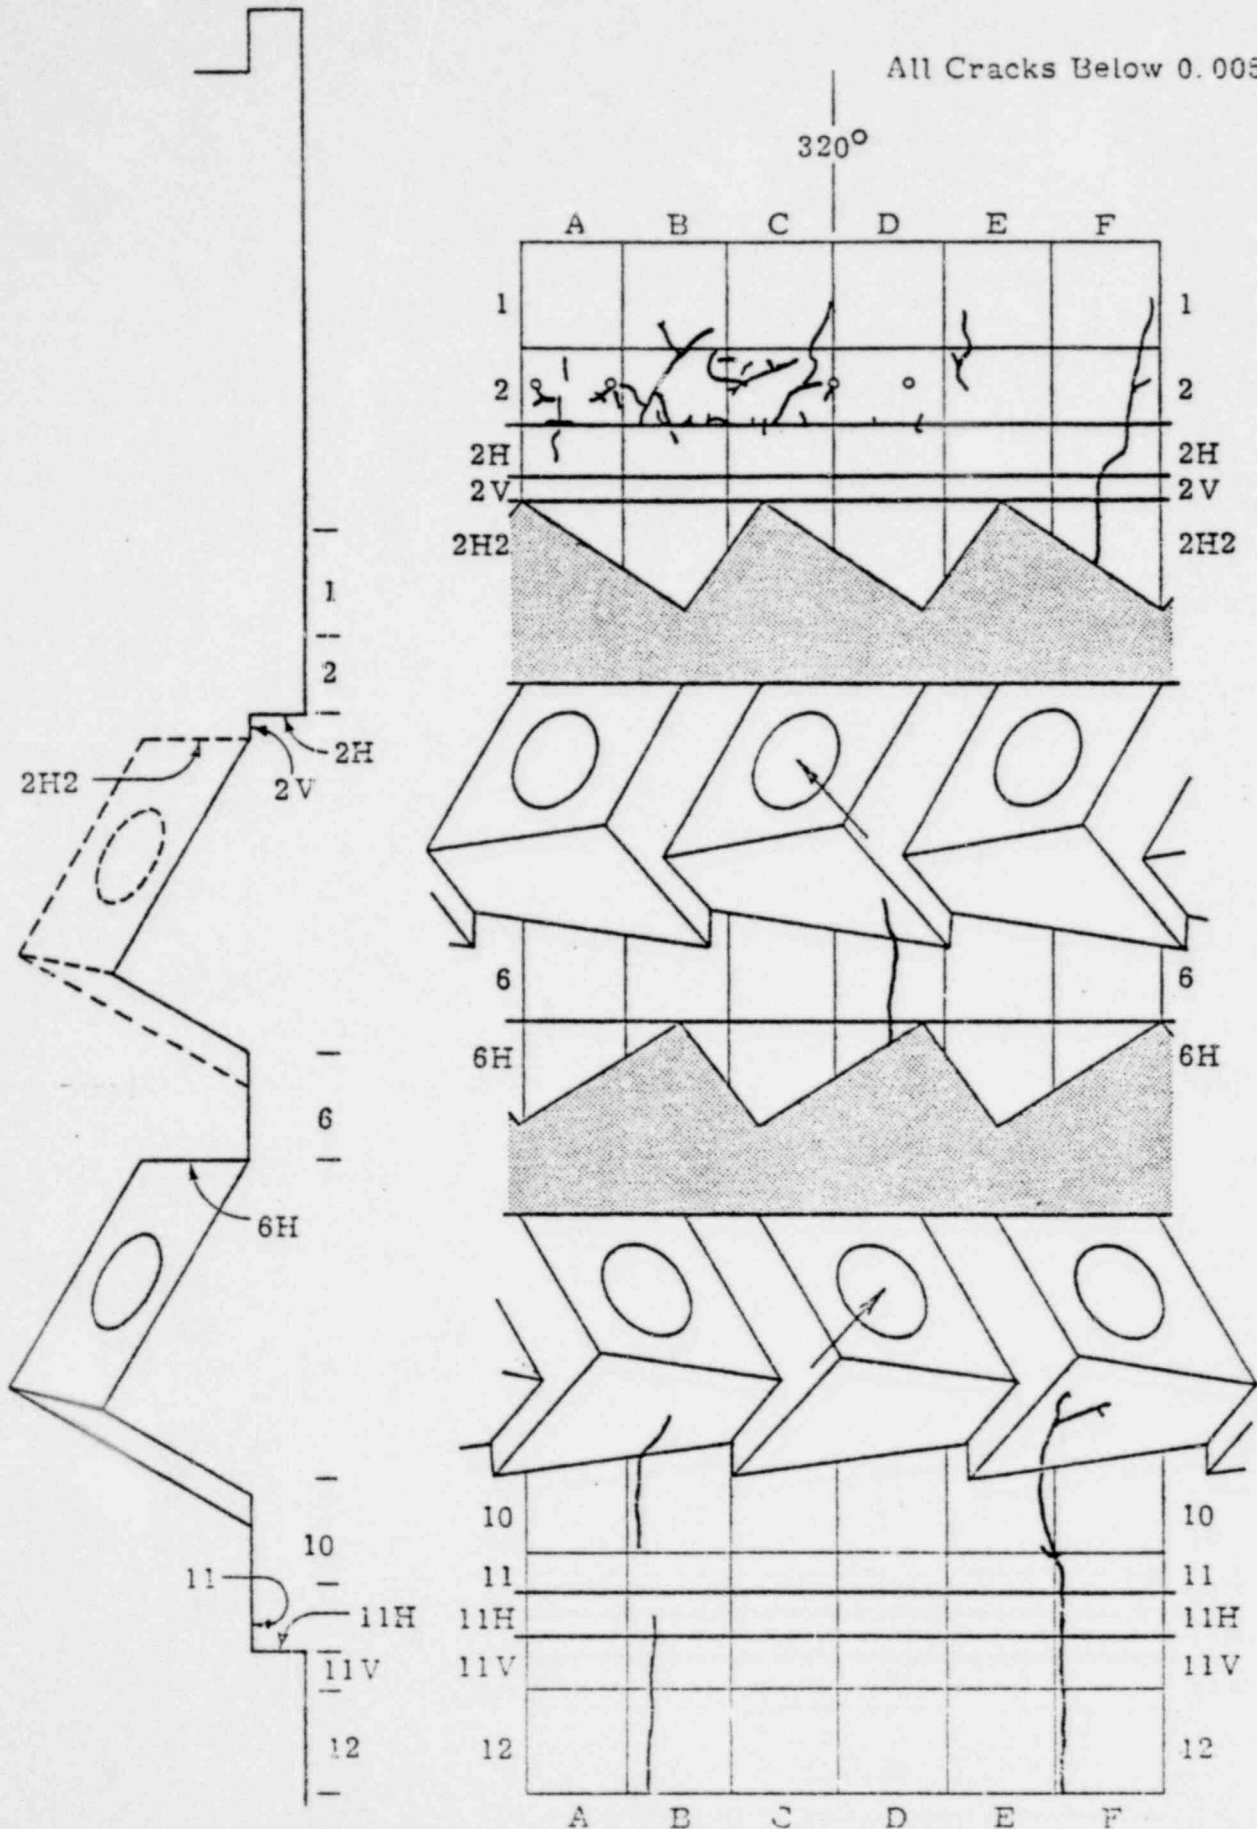
FIGURE 9.

All Cracks Below 0.005 Inch

CRACK PATTERN AT AZIMUTH 320°
PRIOR TO PRESTRESS, 5-14-73.

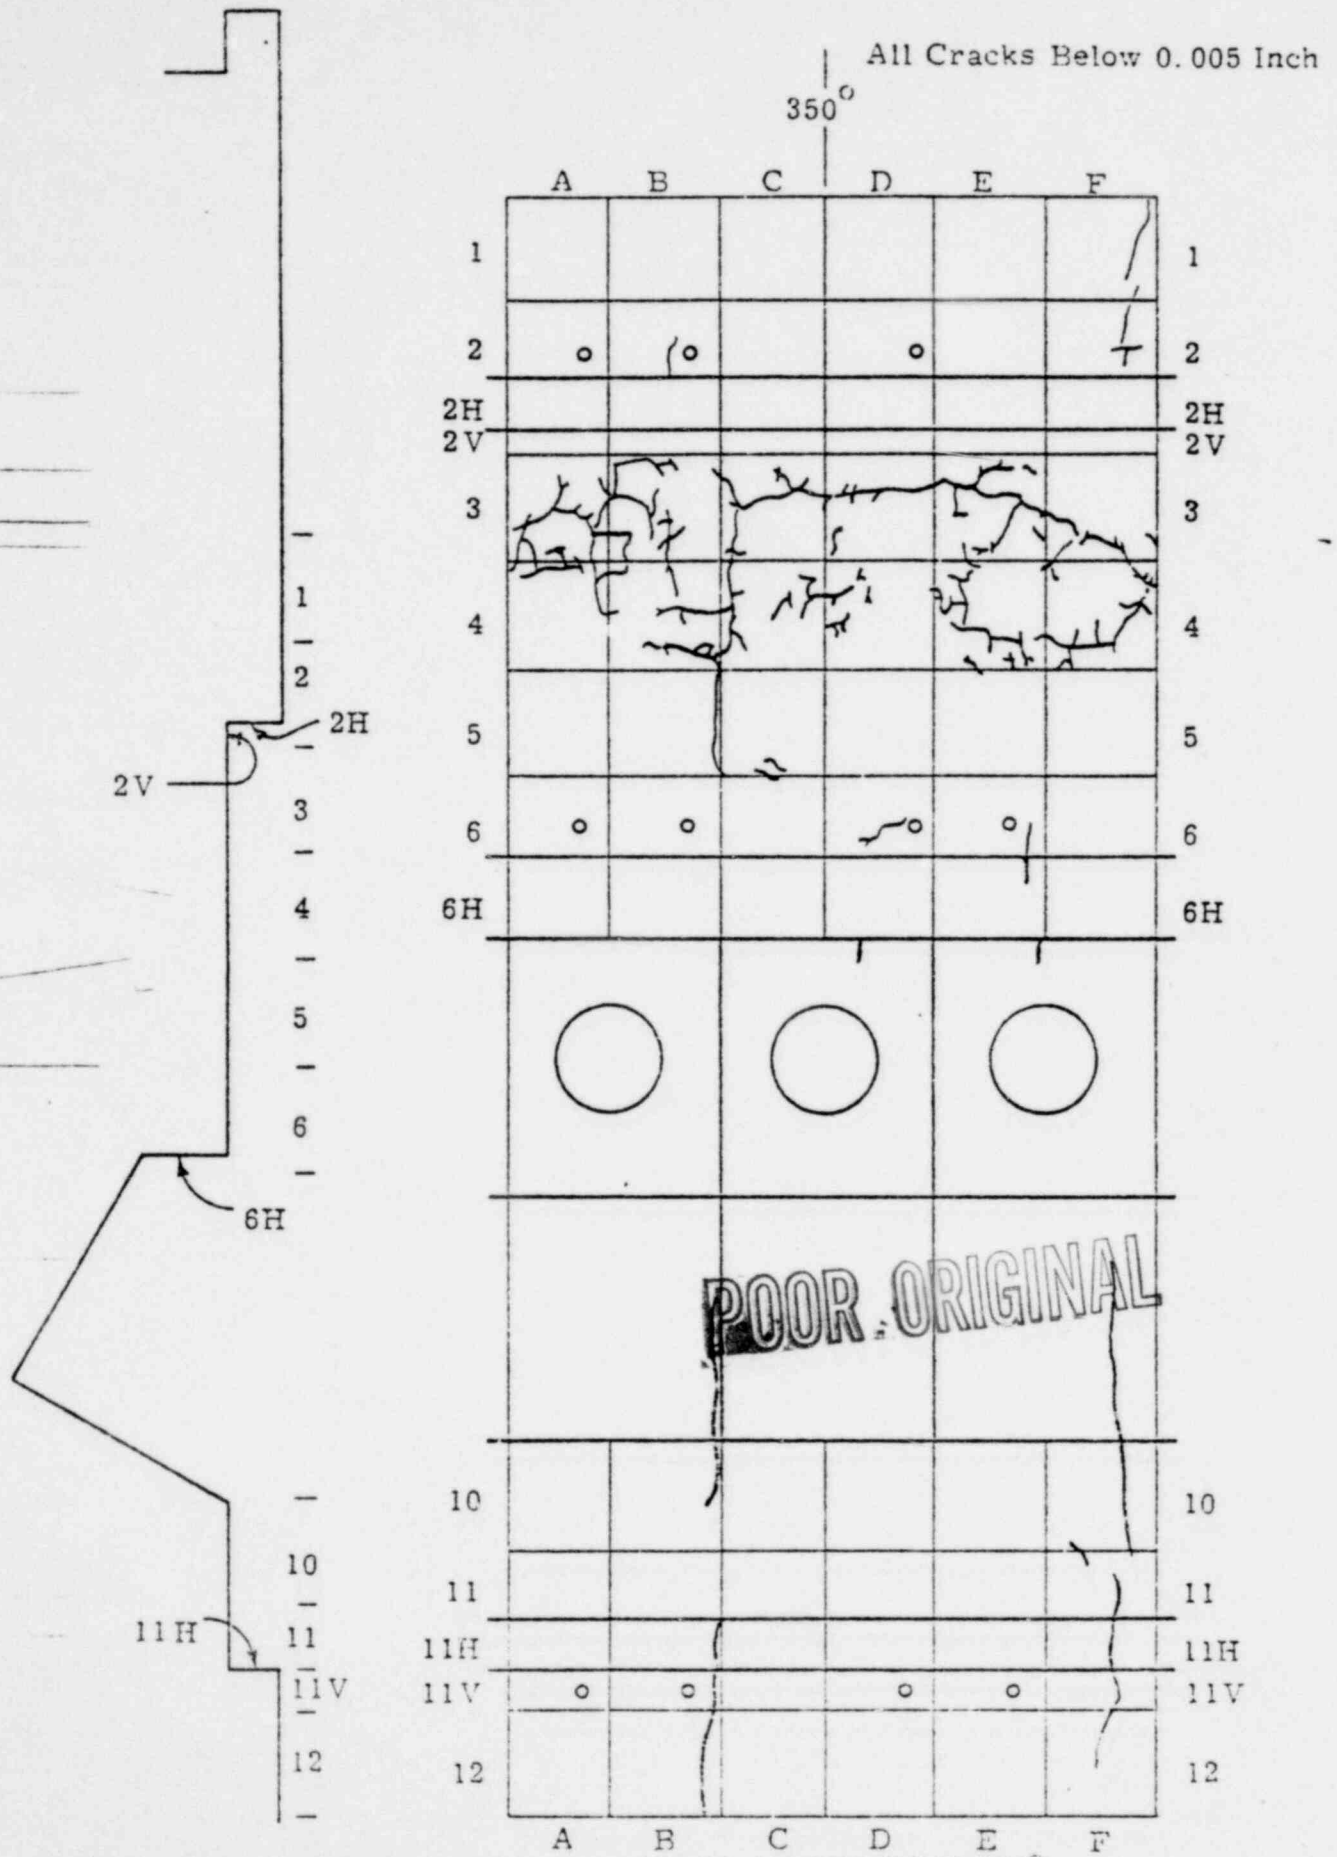
FIGURE 10.

CRACK PATTERN AT AZIMUTH 350°
 PRIOR TO PRESTRESS, 5-14-73.

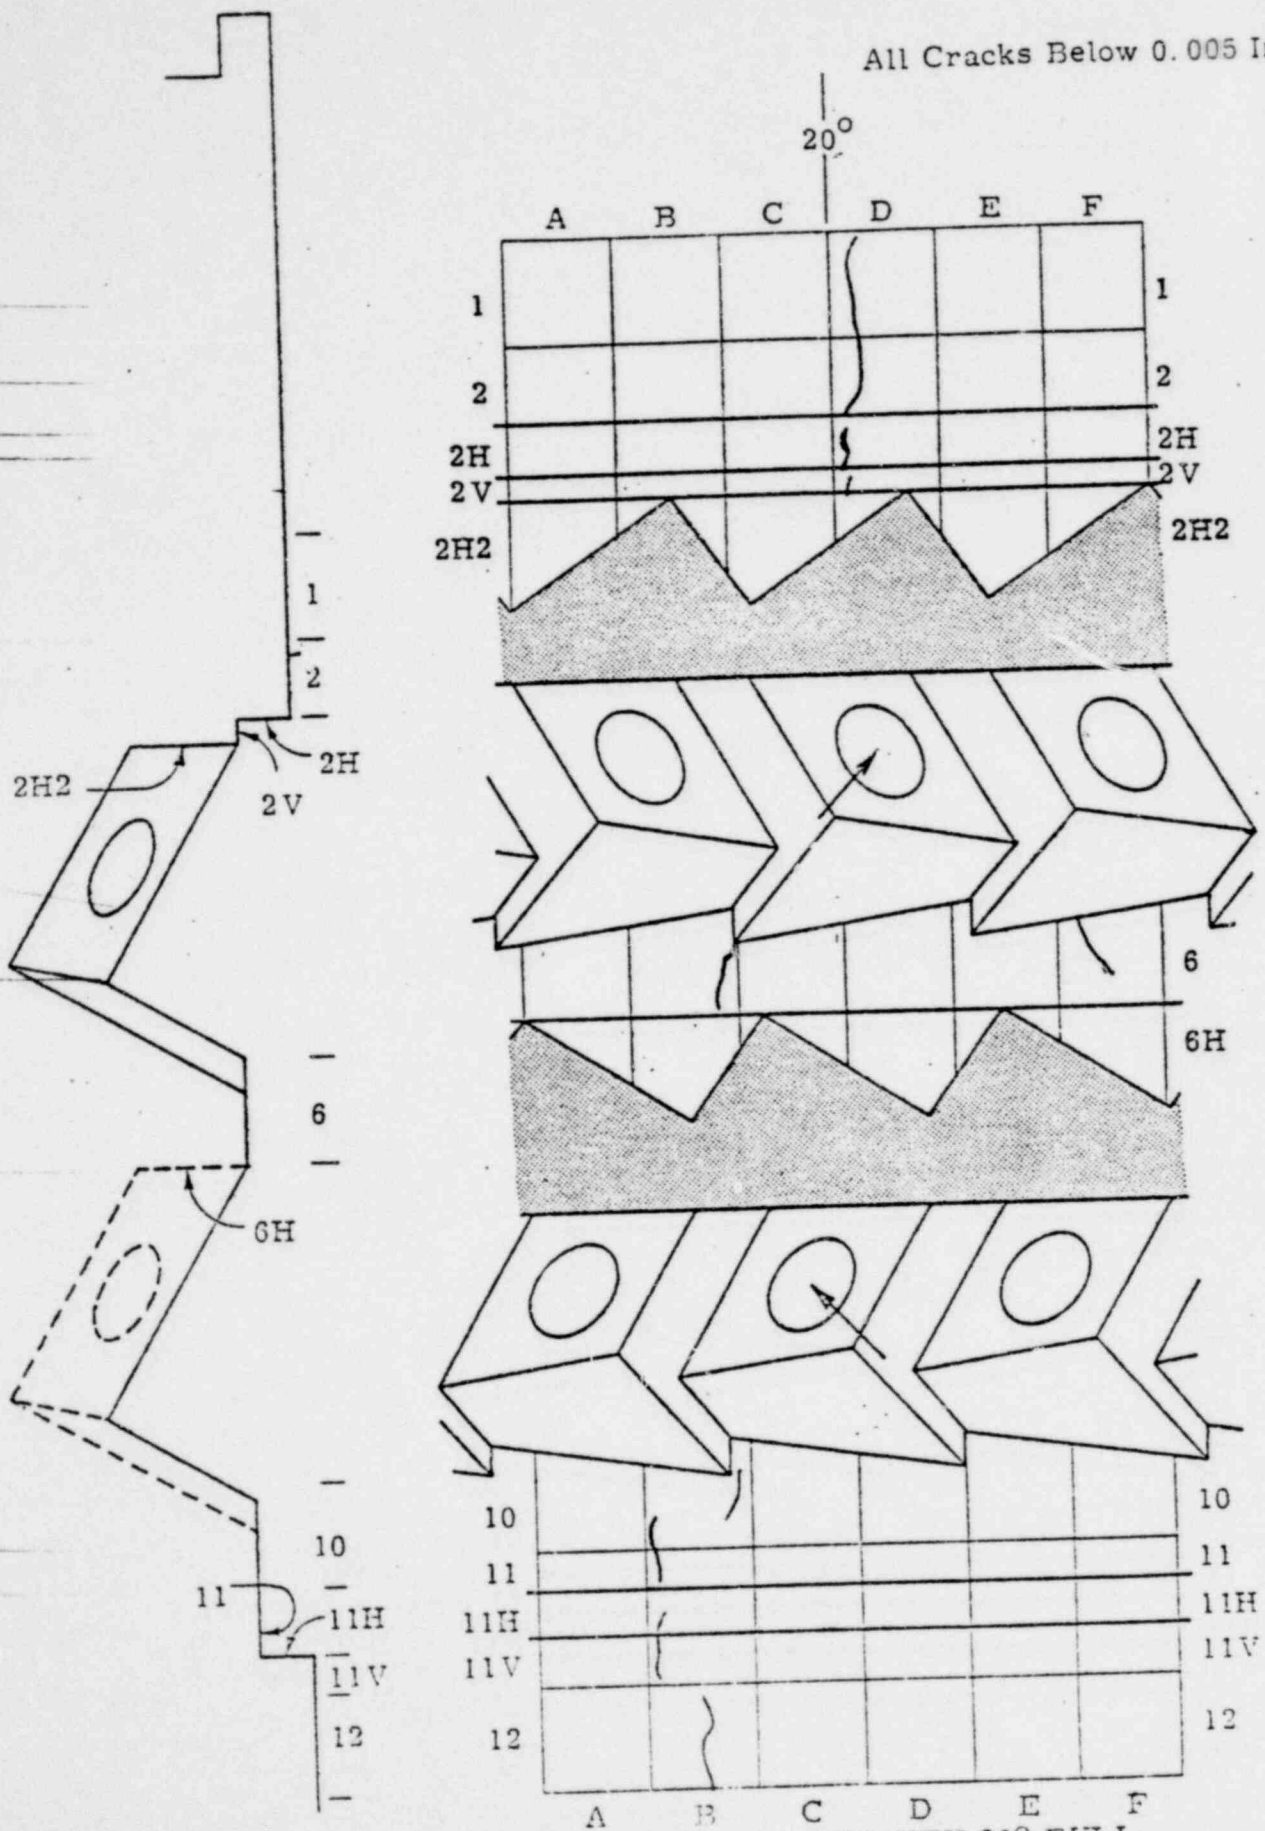
FIGURE 11.

CRACK PATTERN AT AZIMUTH 20° FULL
VERTICAL PRESTRESS, 6-6-73.

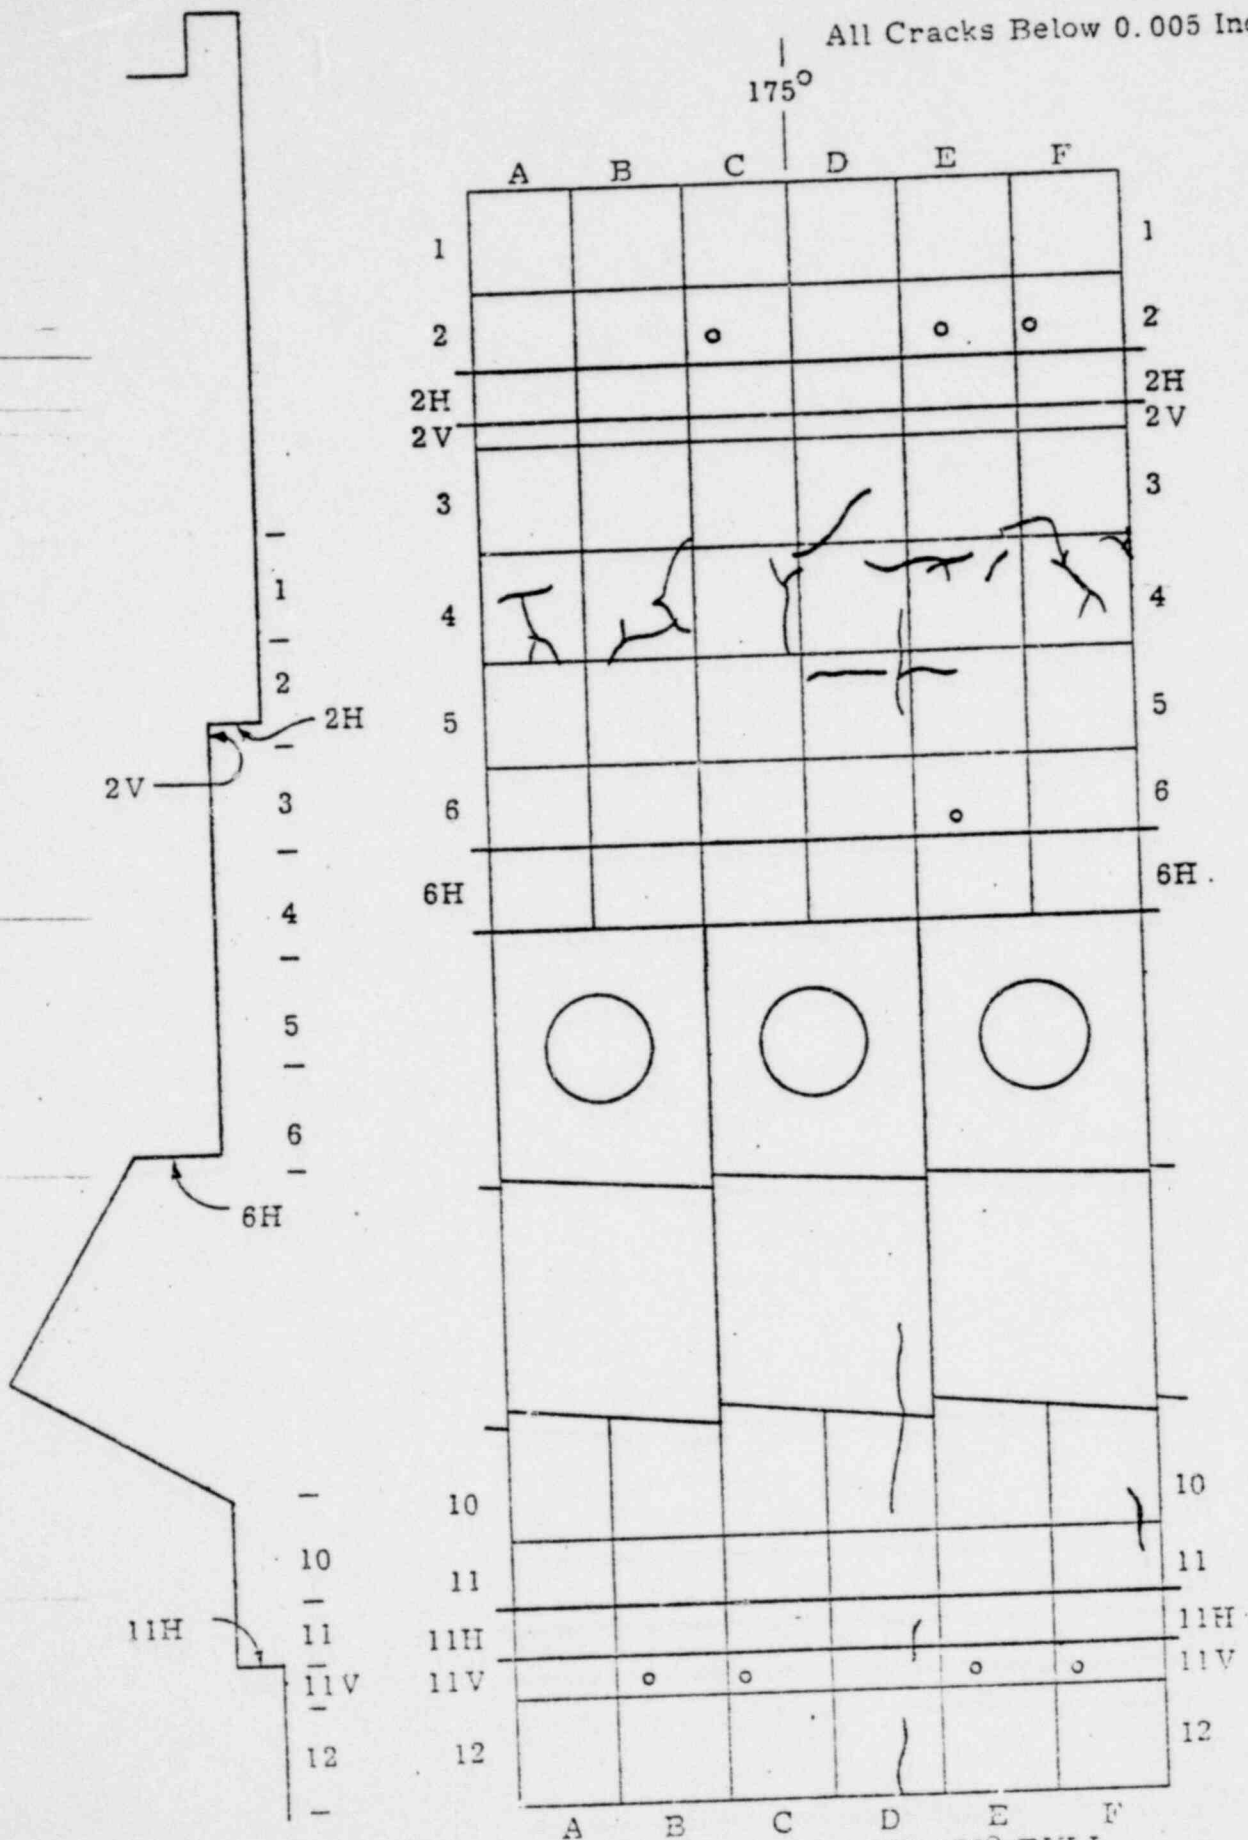
FIGURE 12

All Cracks Below 0.005 Inch

CRACK PATTERN AT AZIMUTH 175° FULL VERTICAL PRESTRESS, 6-6-73.

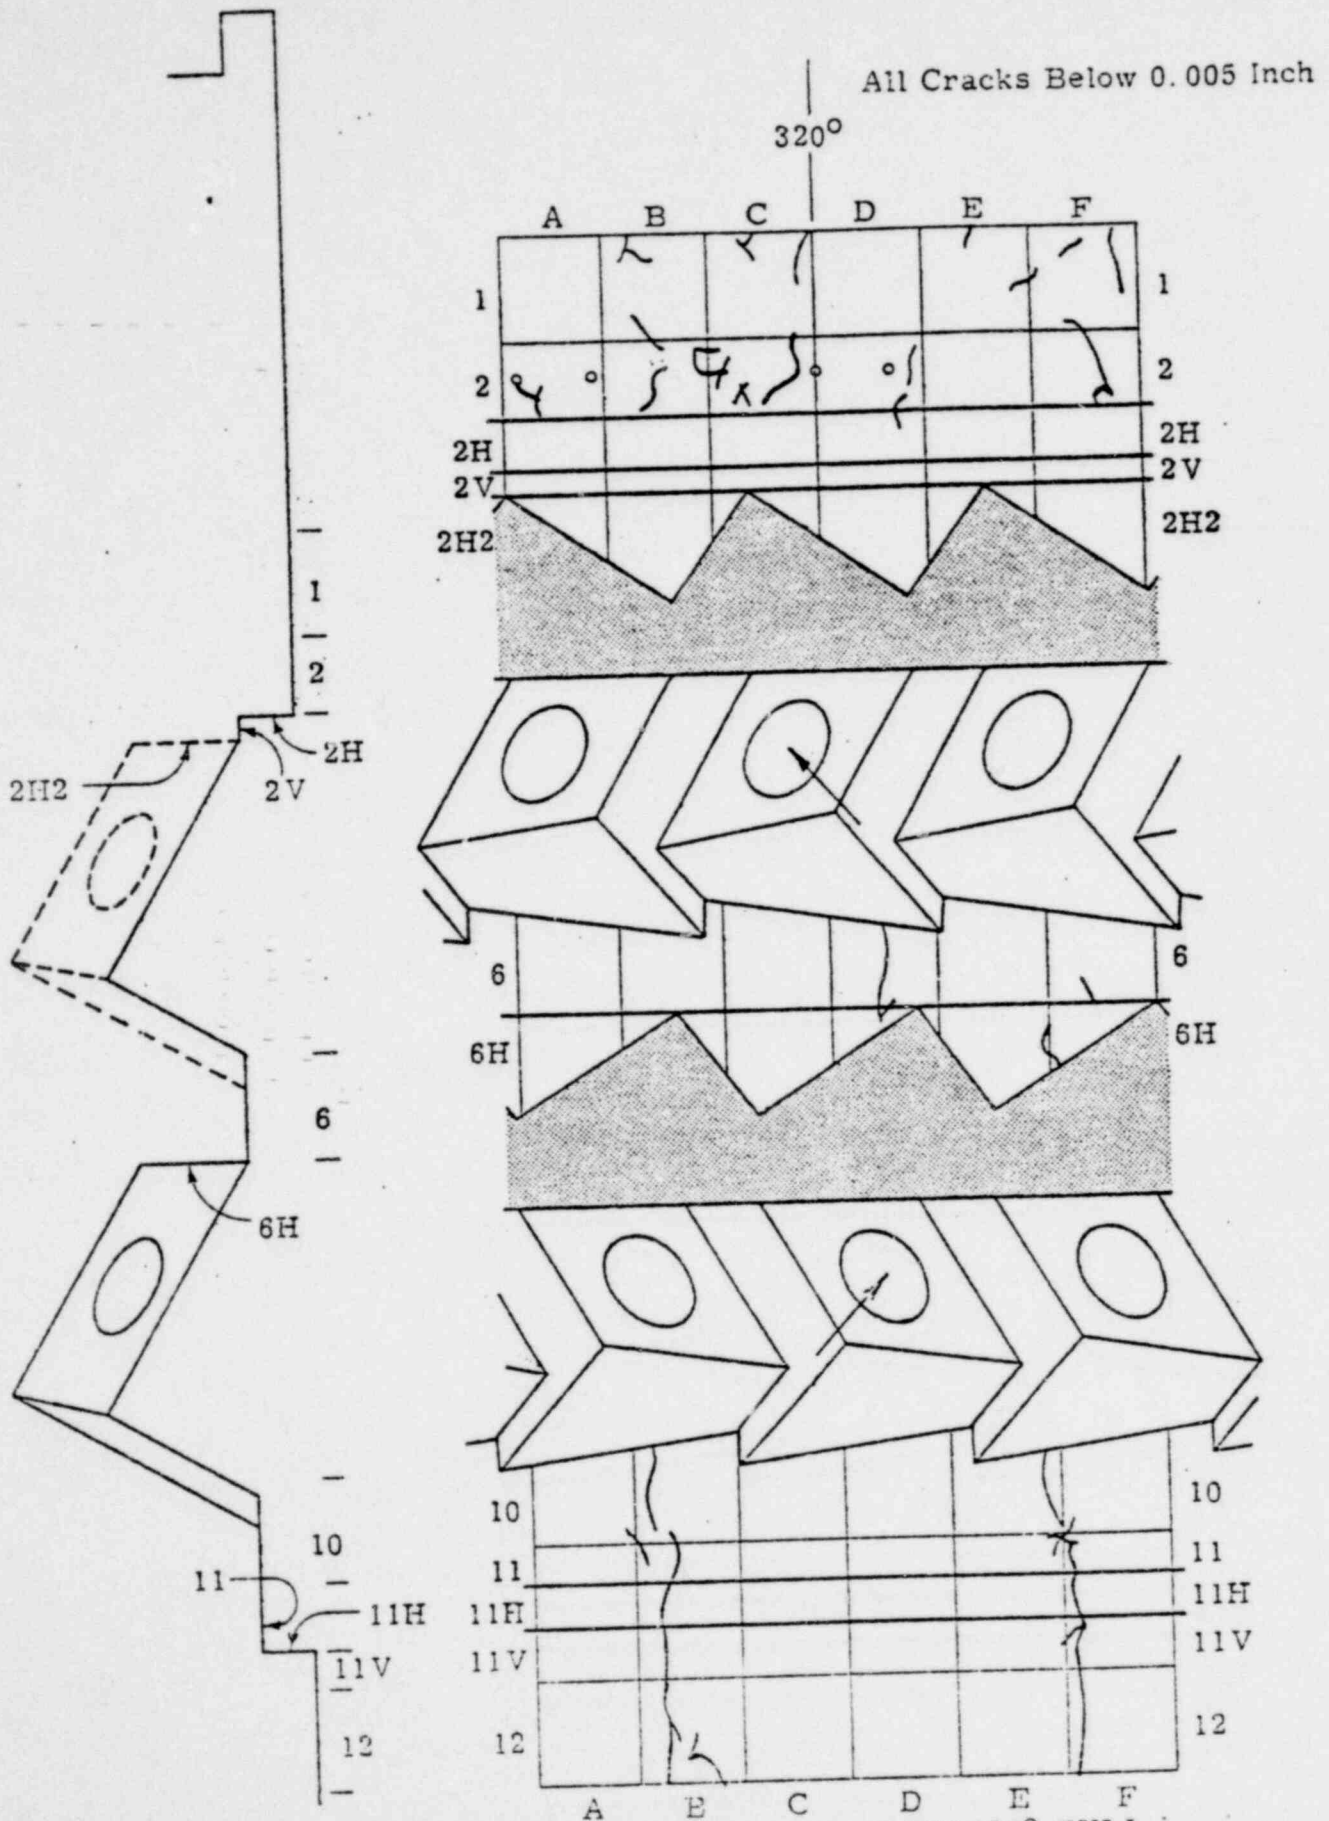
FIGURE 13.

CRACK PATTERN AT AZIMUTH 320° FULL :
VERTICAL PRESTRESS, 6-6-73.

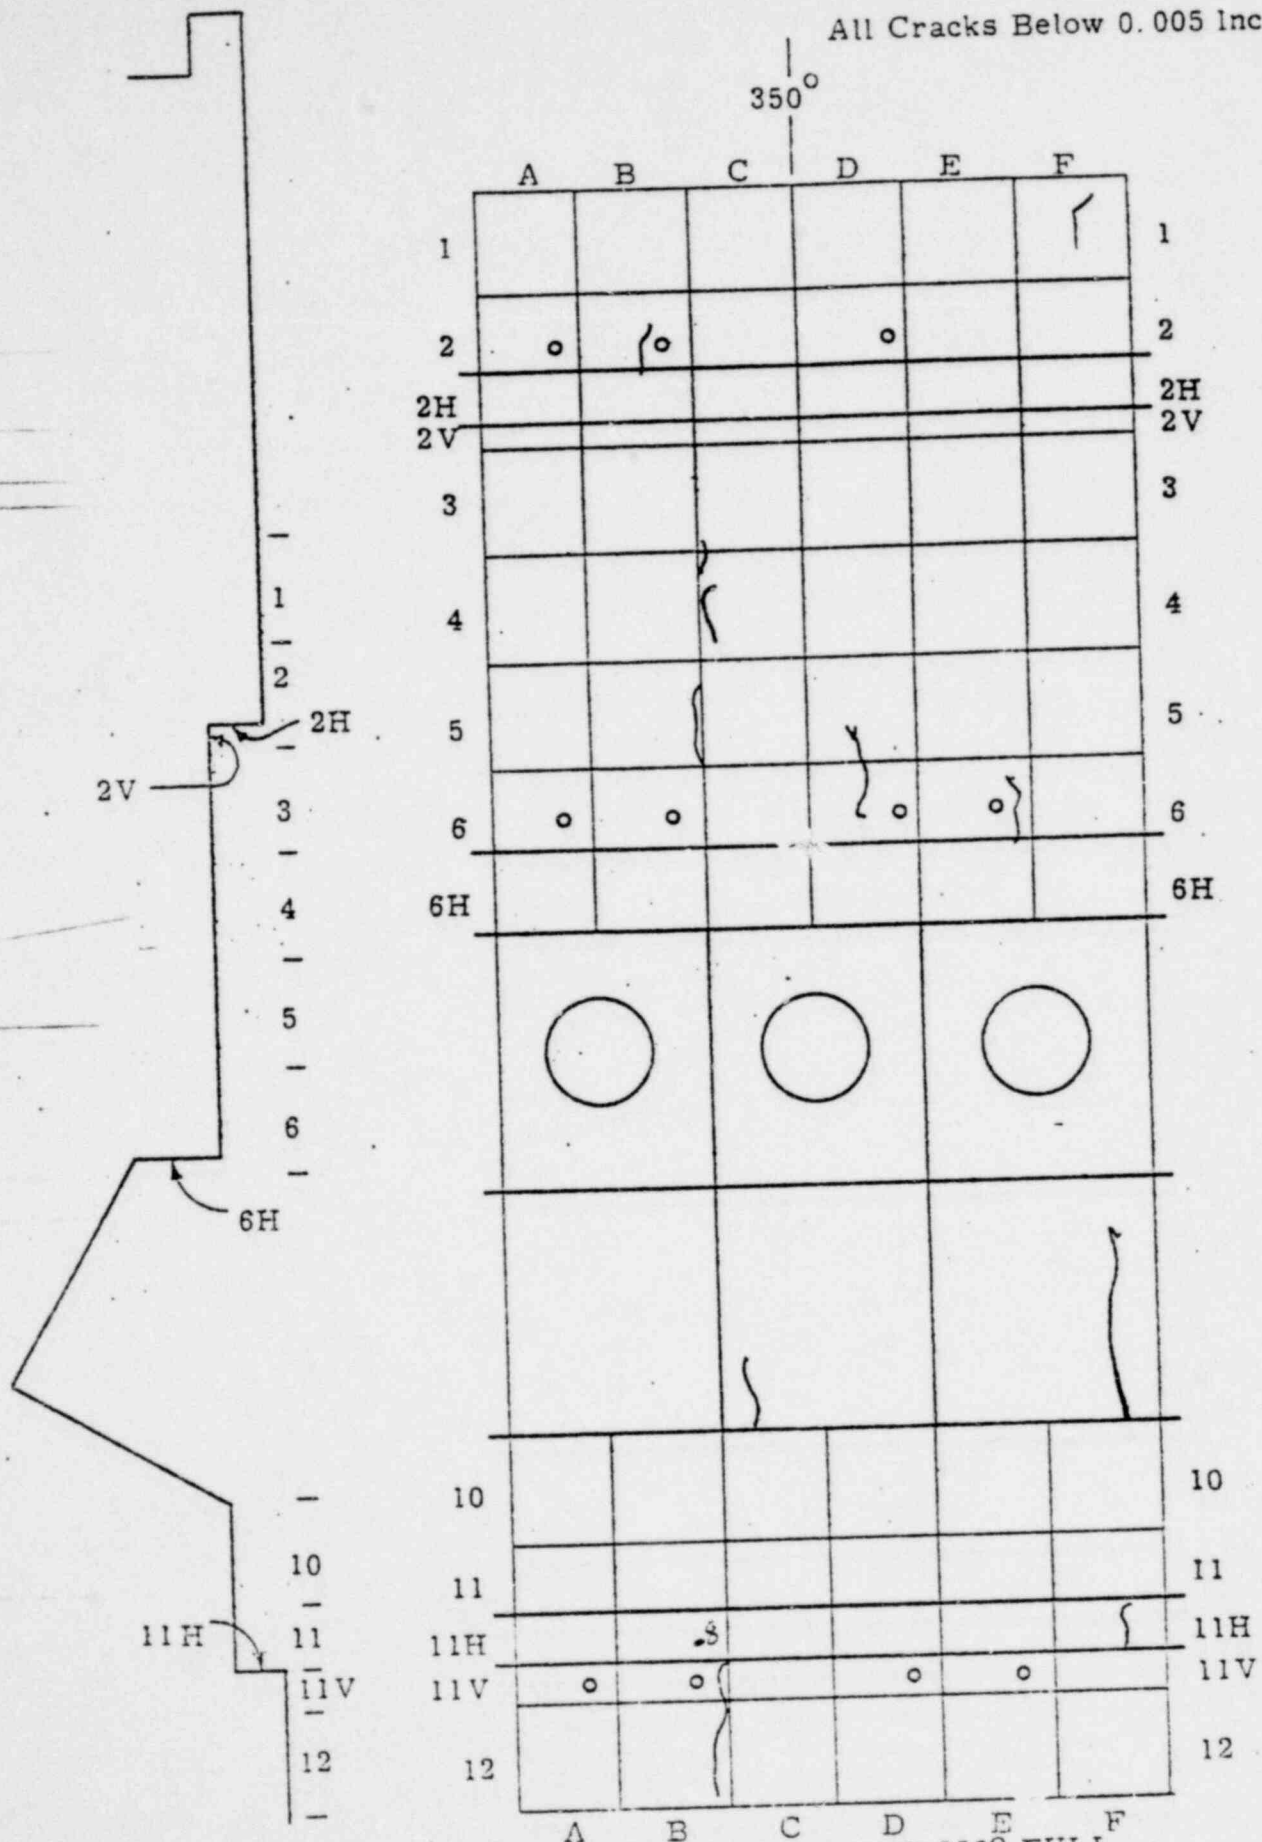
FIGURE 14.

All Cracks Below 0.005 inch

CRACK PATTERN AT AZIMUTH 350° FULL VERTICAL PRESTRESS, 6-6-73.

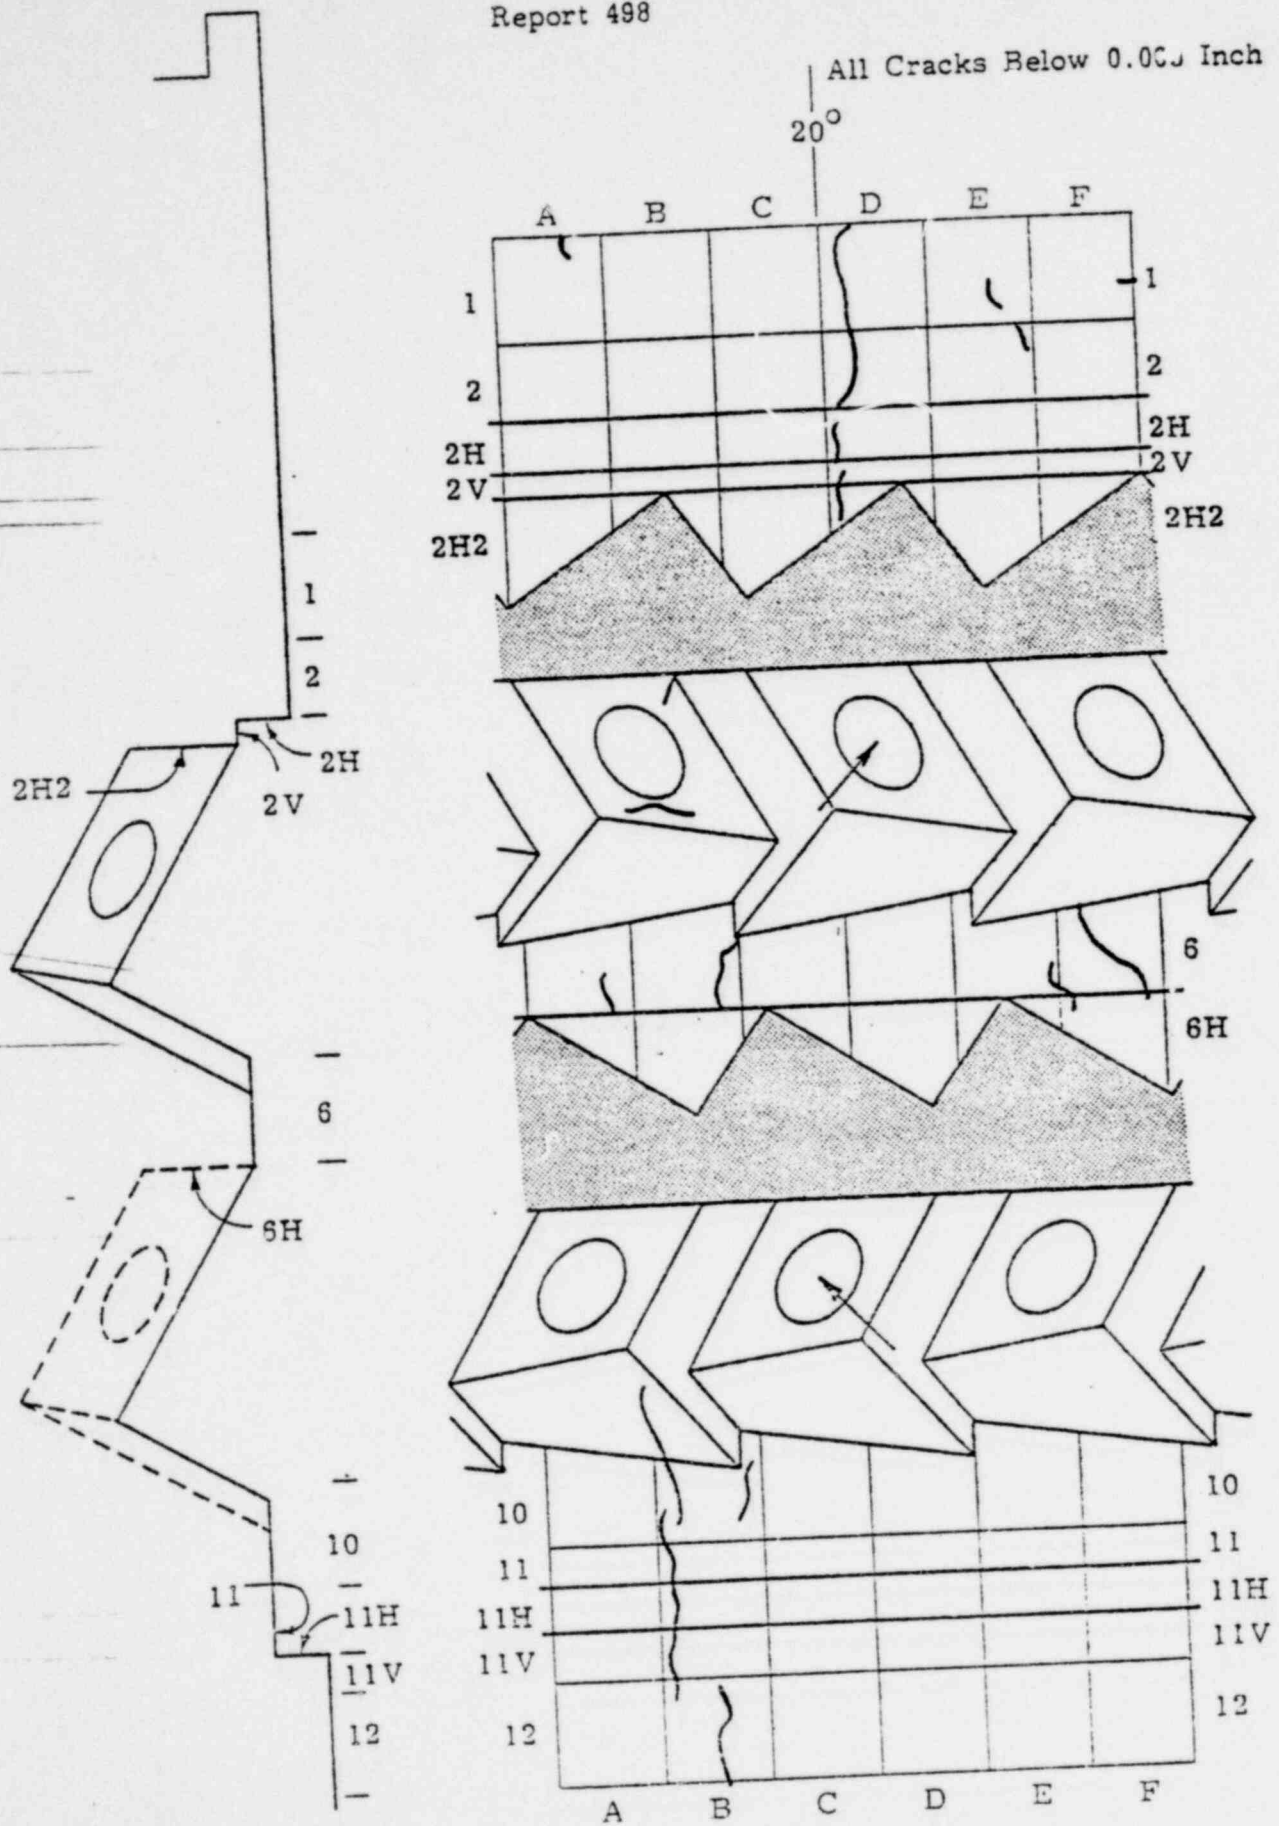
FIGURE 15.

All Cracks Below 0.005 Inch

CRACK PATTERN AT AZIMUTH 20° FULL VERTICAL AND DOME PRESTRESS, JULY 5, 1973.
