METROPOLITAN EDISON COMPANY
THREE MILE ISLAND NUCLEAR STATION
UNIT NO. 1

REACTOR BUILDING RING GIRDER
SURVEILLANCE REPORT

November, 1973

THREE MILE ISLAND NUCLEAR STATION

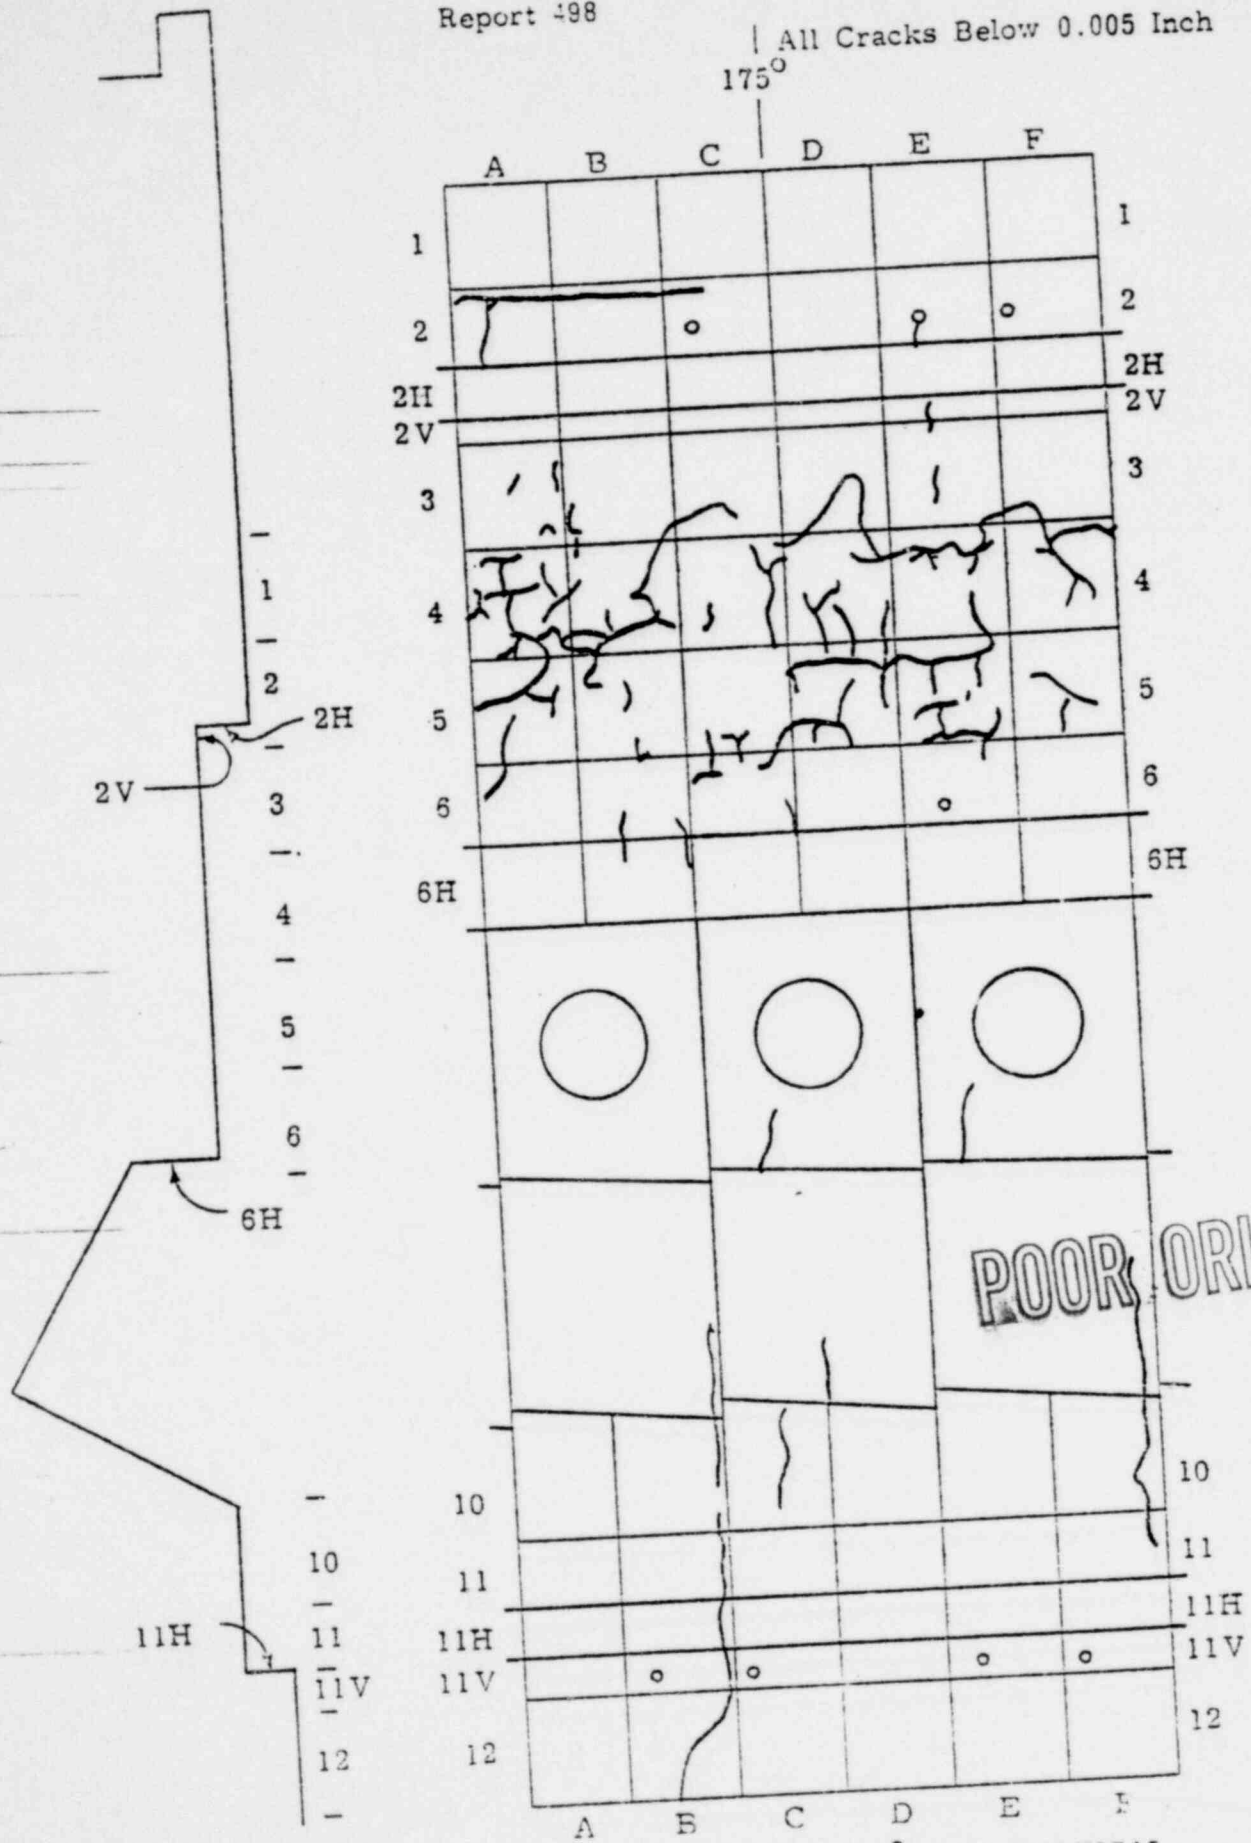
FIGURE 16.

CRACK PATTERN AT AZIMUTH 175° FULL VERTICAL AND DOME PRESTRESS, JULY 5, 1973.

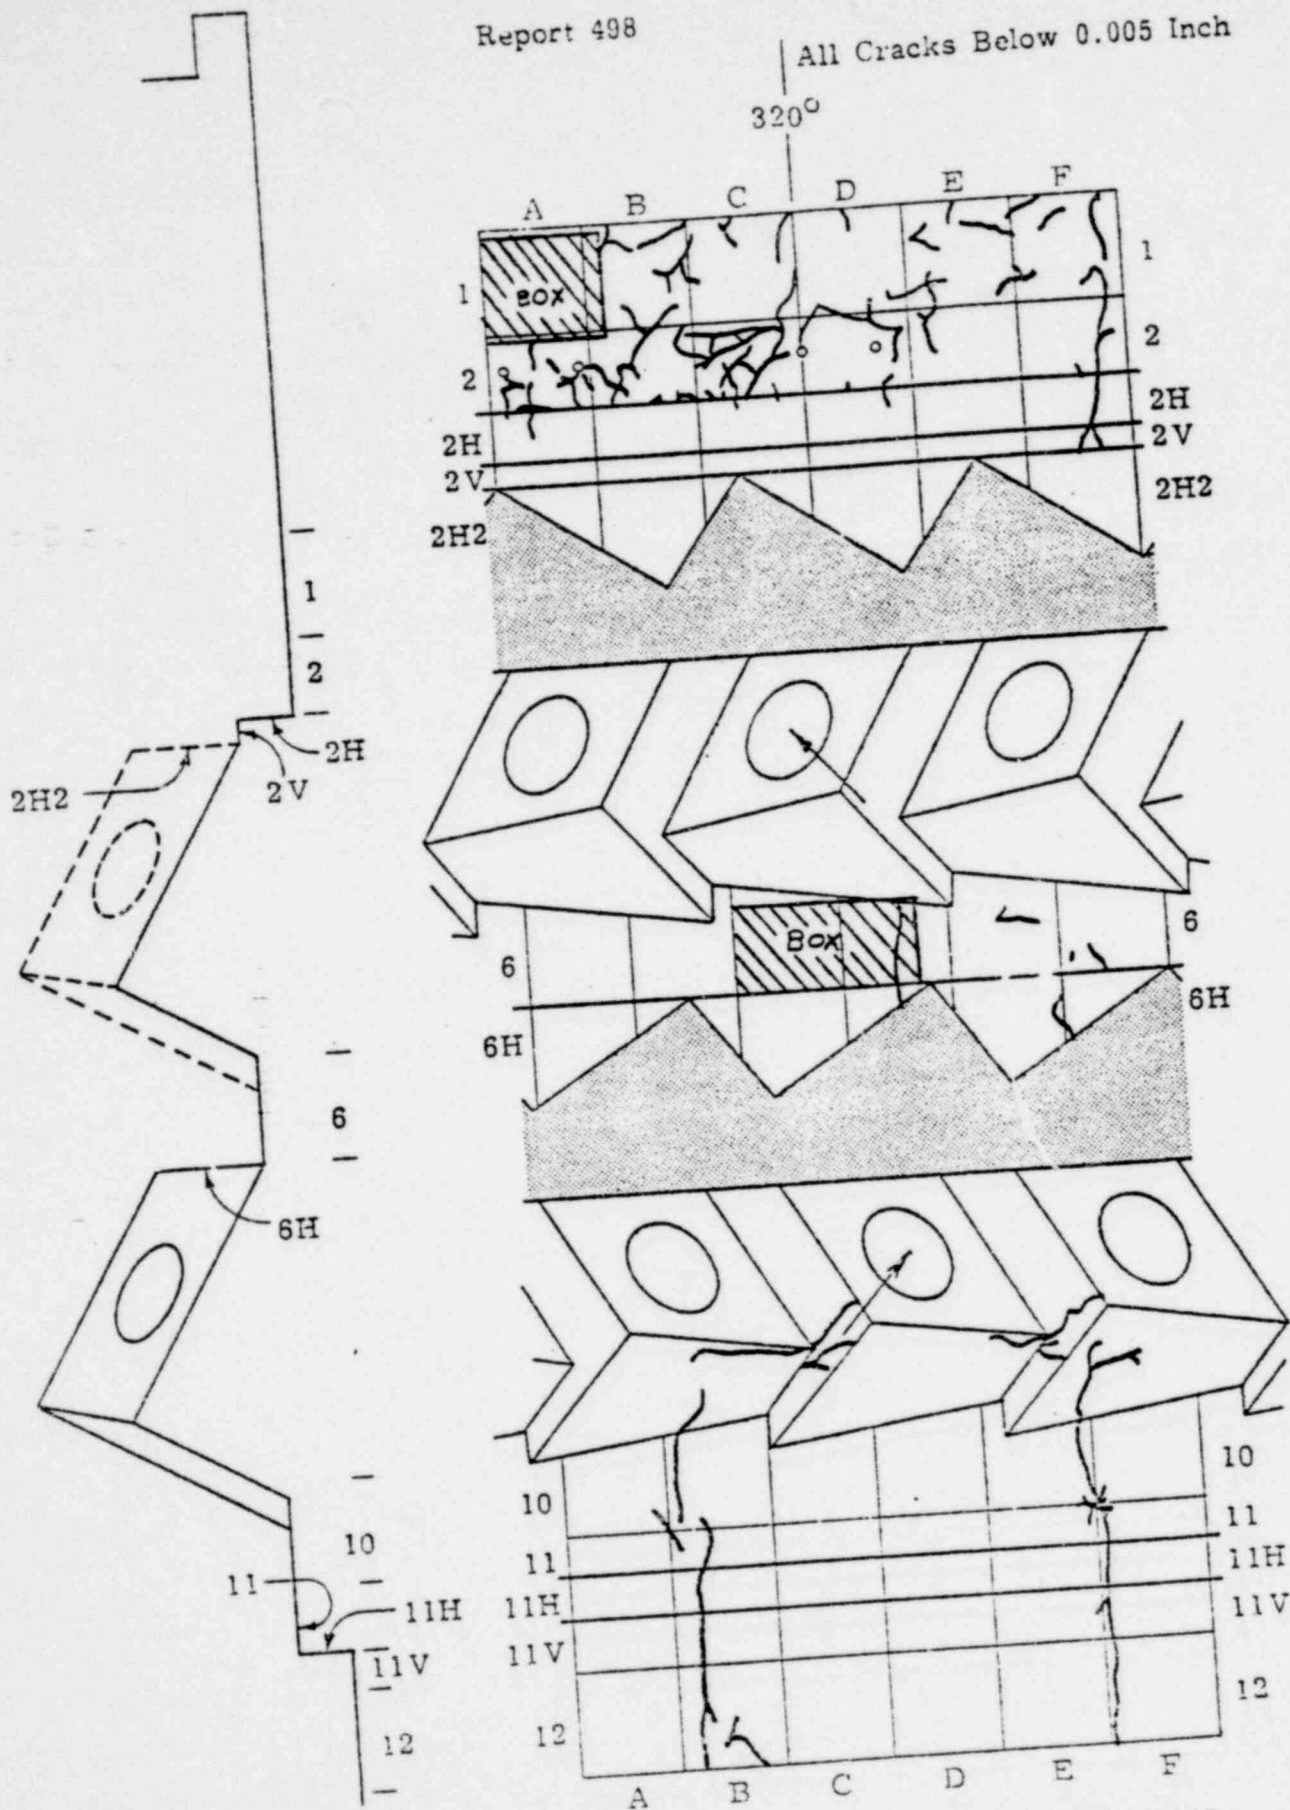
All Cracks Below 0.005 Inch

FIGURE 17. CRACK PATTERN AT AZIMUTH 320° FULL VERTICAL AND DOME PRESTRESS, JULY 5, 1973.

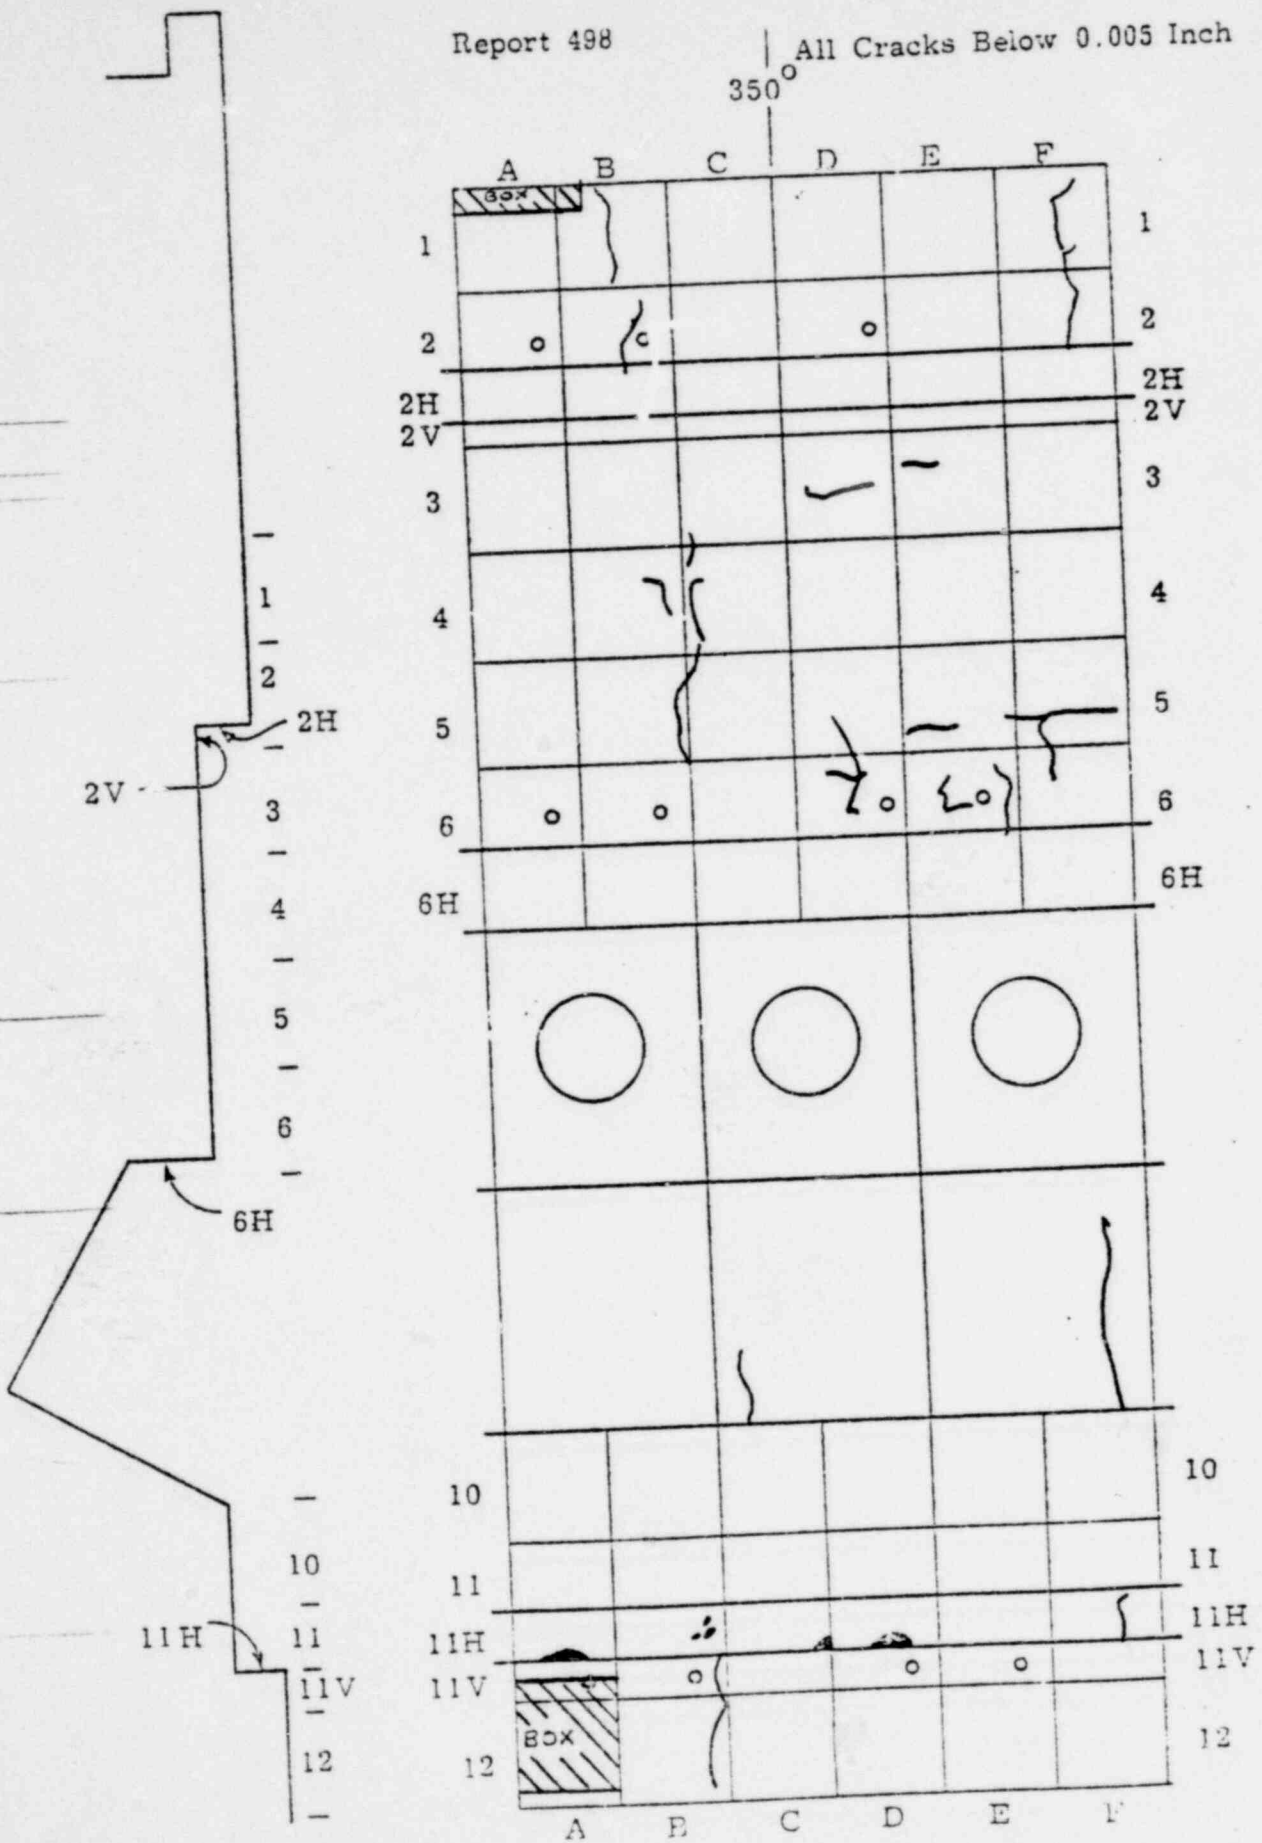
FIGURE 18. CRACK PATTERN AT AZIMUTH 350° FULL VERTICAL AND DOME PRESTRESS, JULY 5, 1973.

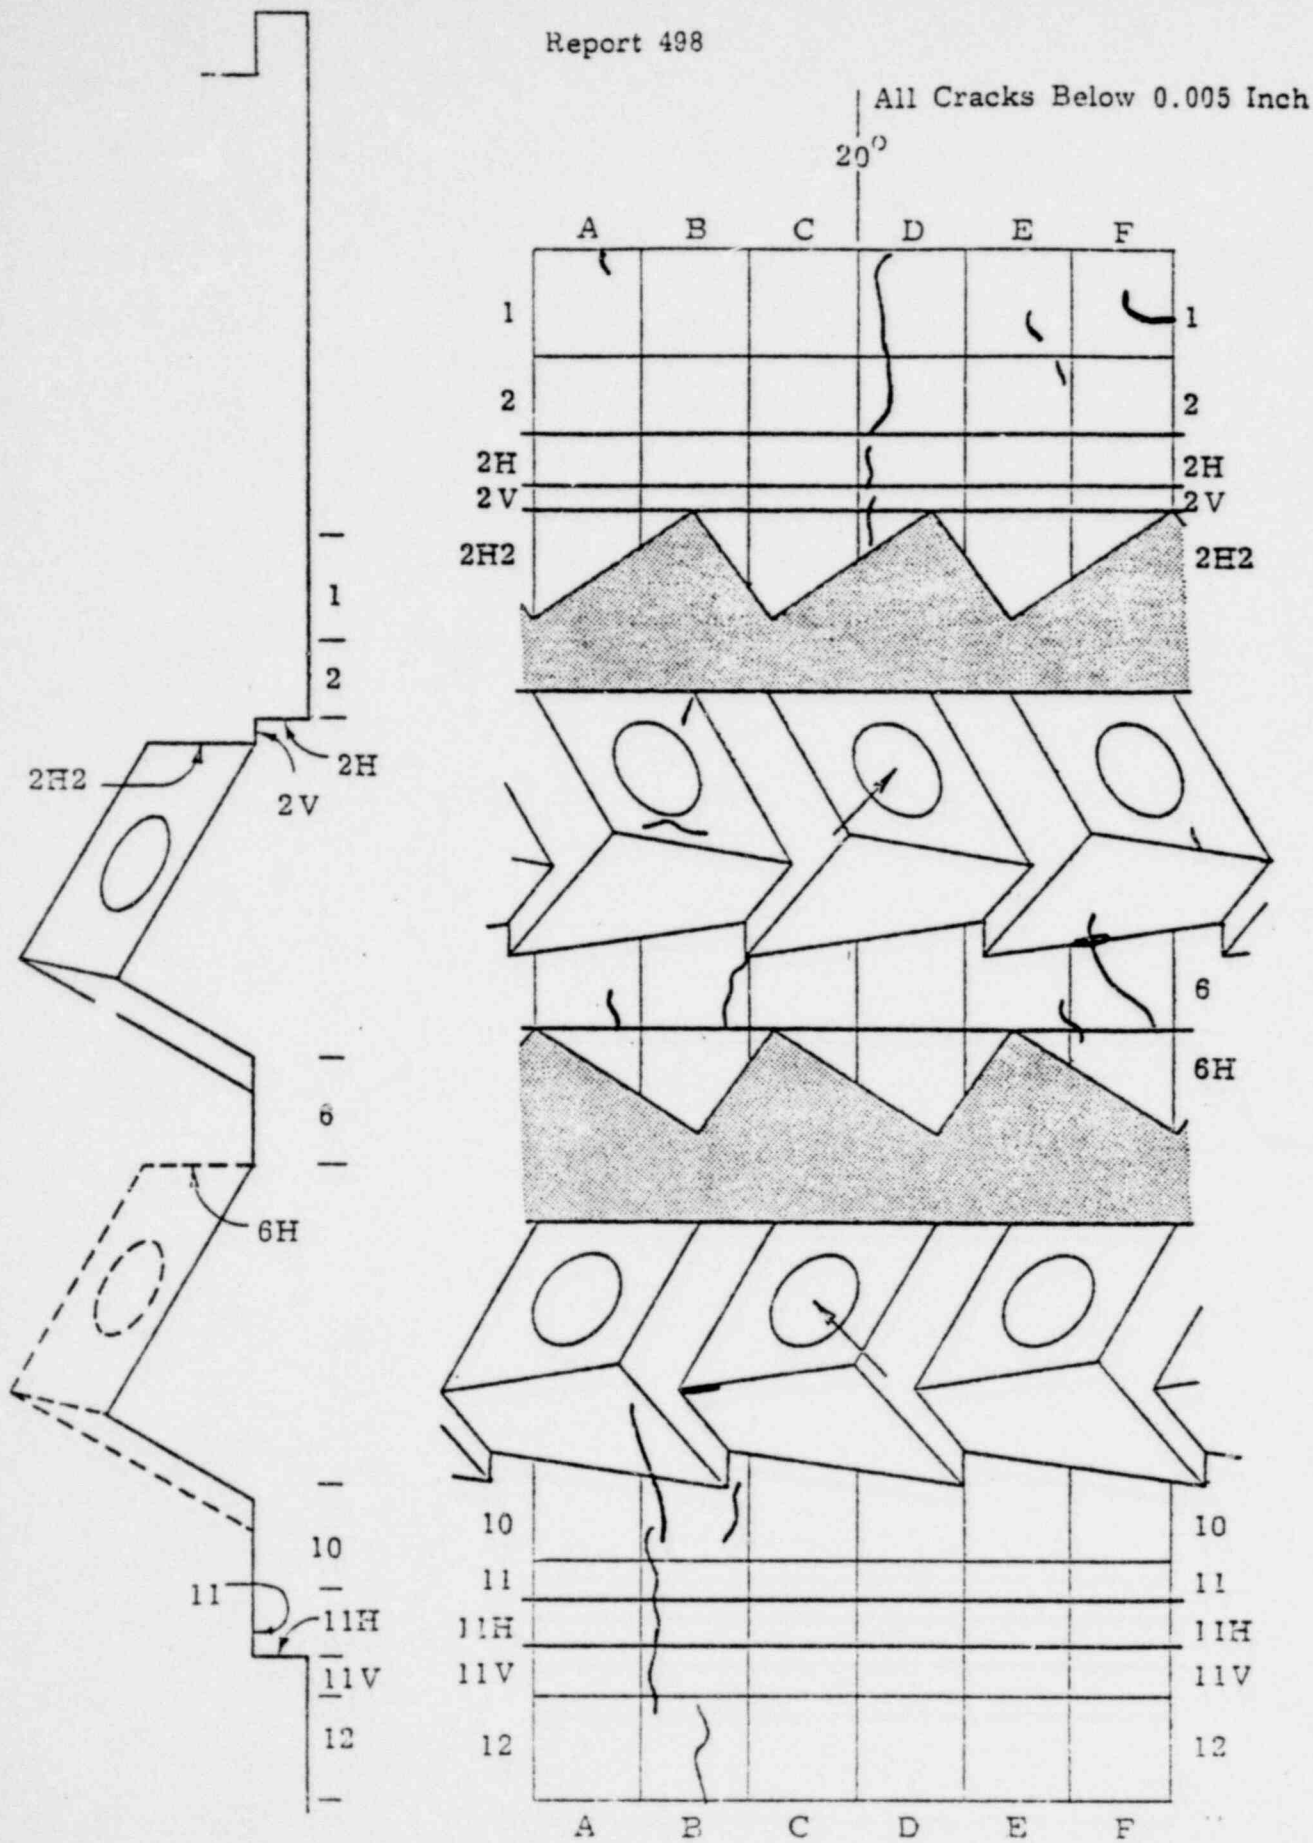
All Cracks Below 0.005 Inch

FIGURE 19. CRACK PATTERN AT AZMUTH 20° AFTER FULL PRESTRESS, SEPTEMBER 18, 1973.

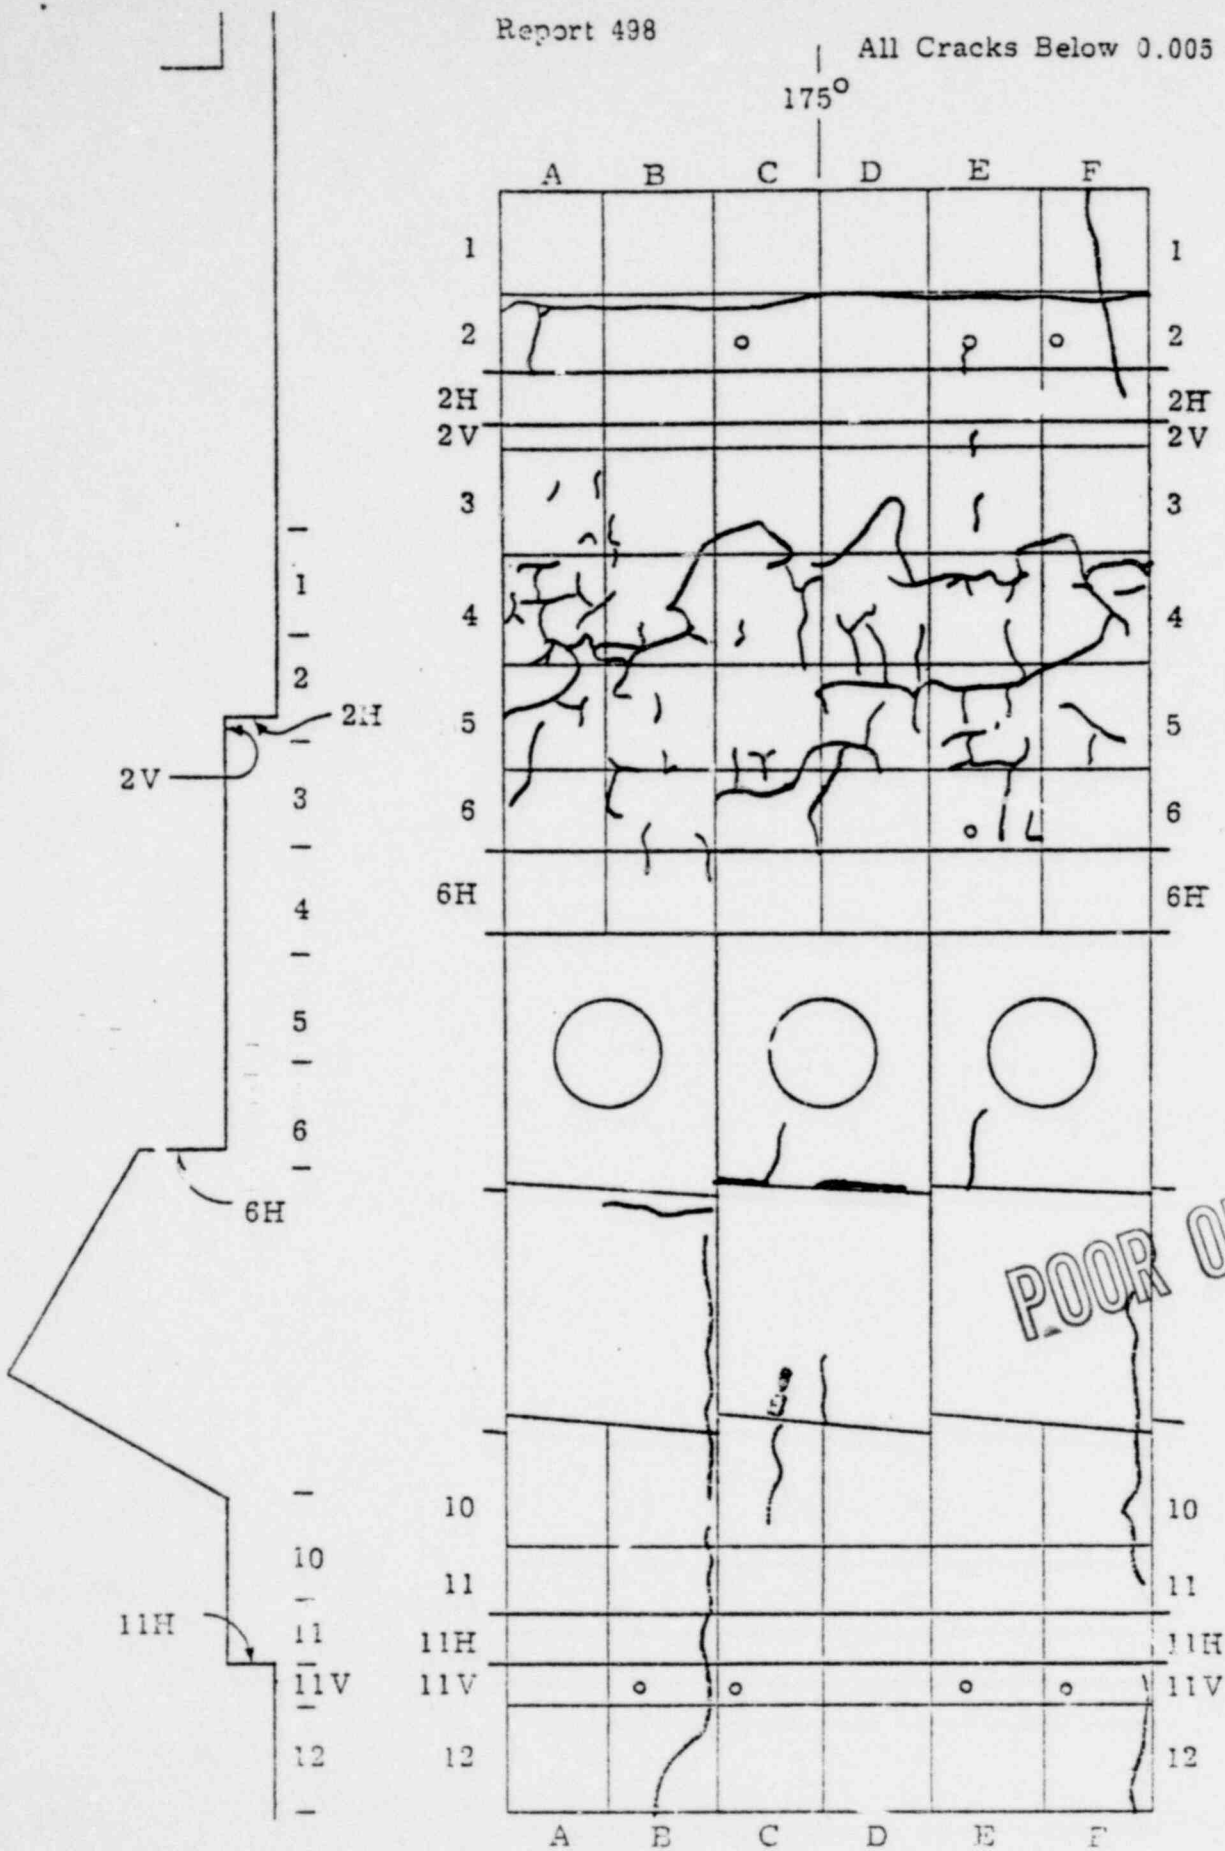
FIGURE 20. CRACK PATTERN AT AZIMUTH 175° AFTER FULL PRESTRESS, SEPTEMBER 18, 1973.

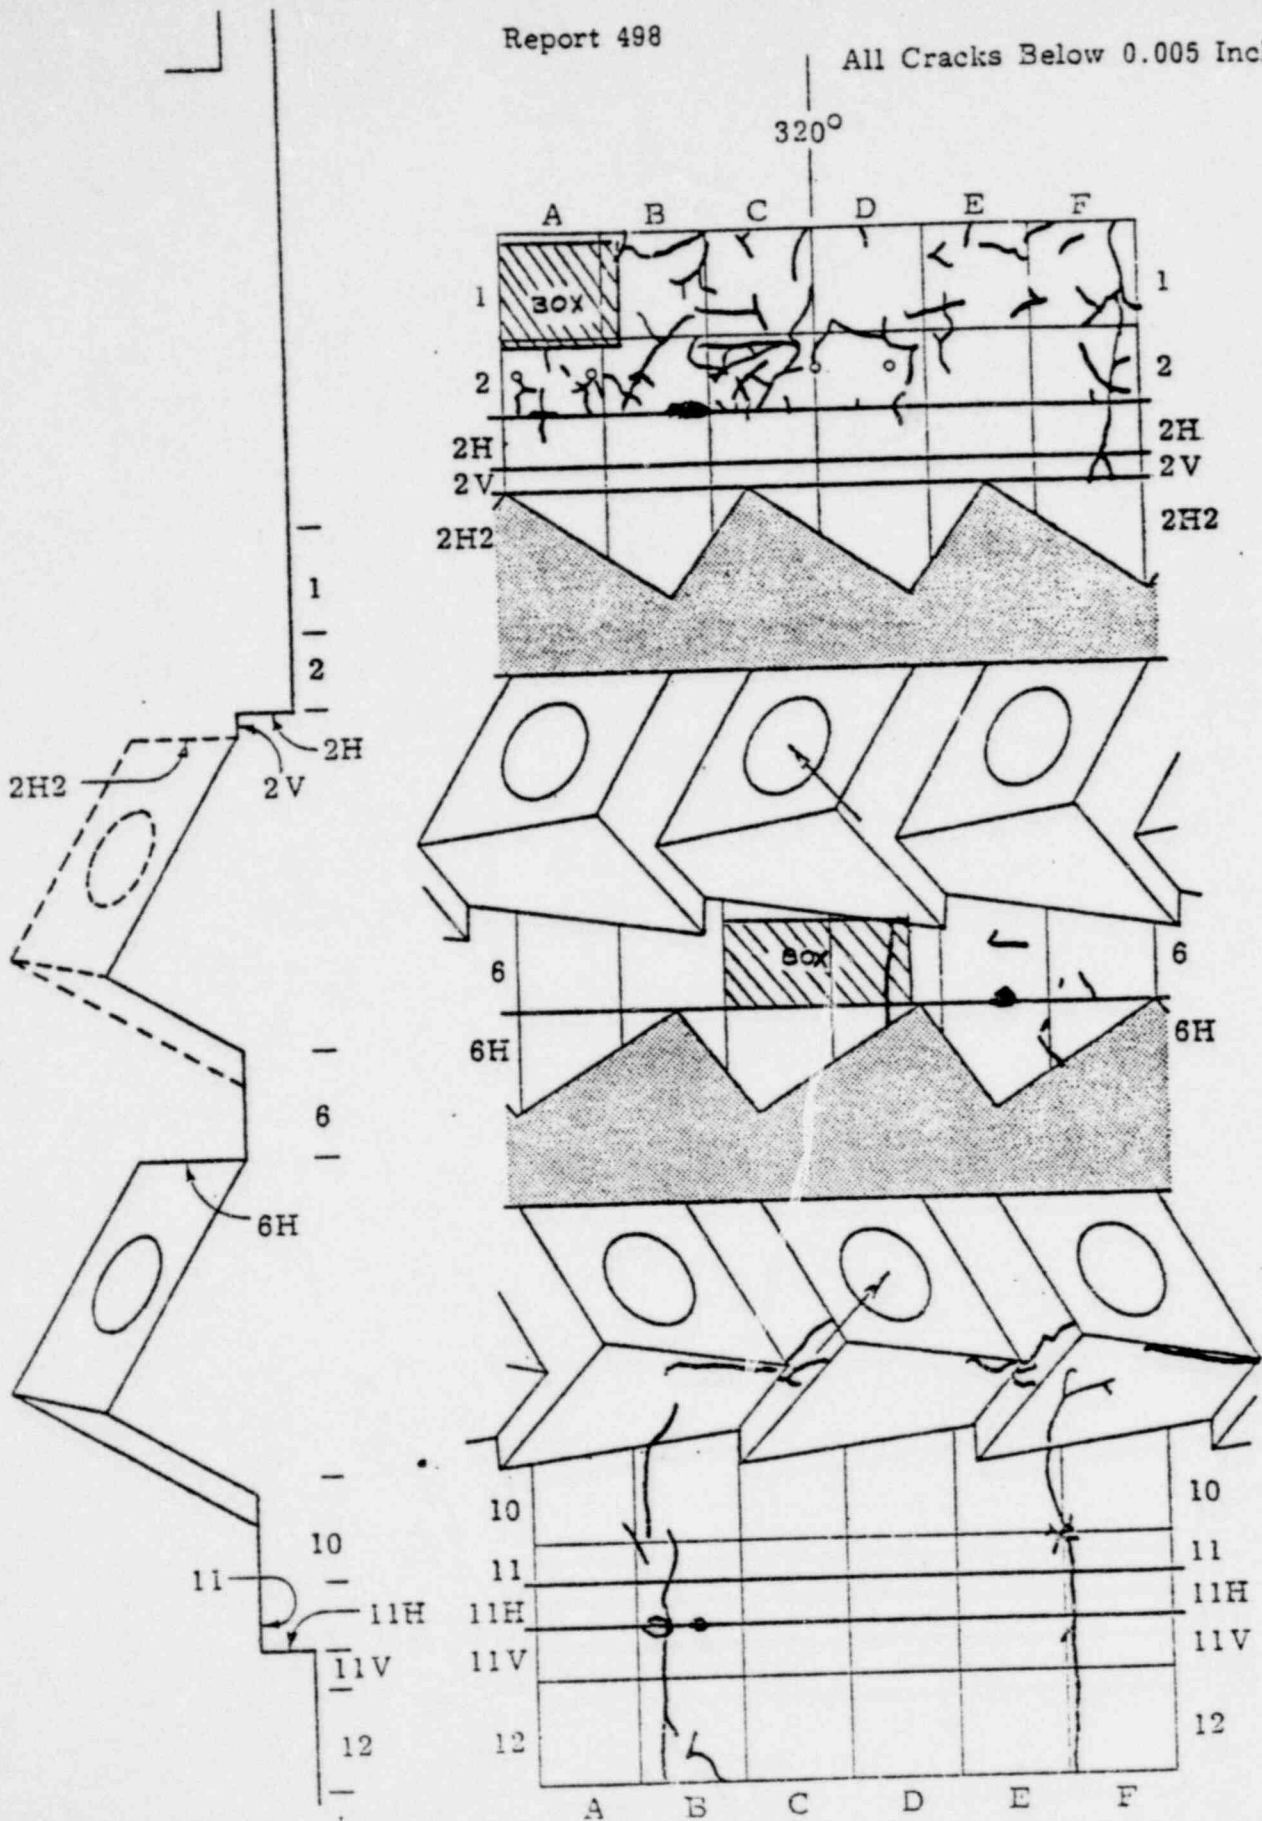
FIGURE 21. CRACK PATTERN AT AZIMUTH 320° AFTER FULL PRESTRESS, SEPTEMBER 18, 1973.

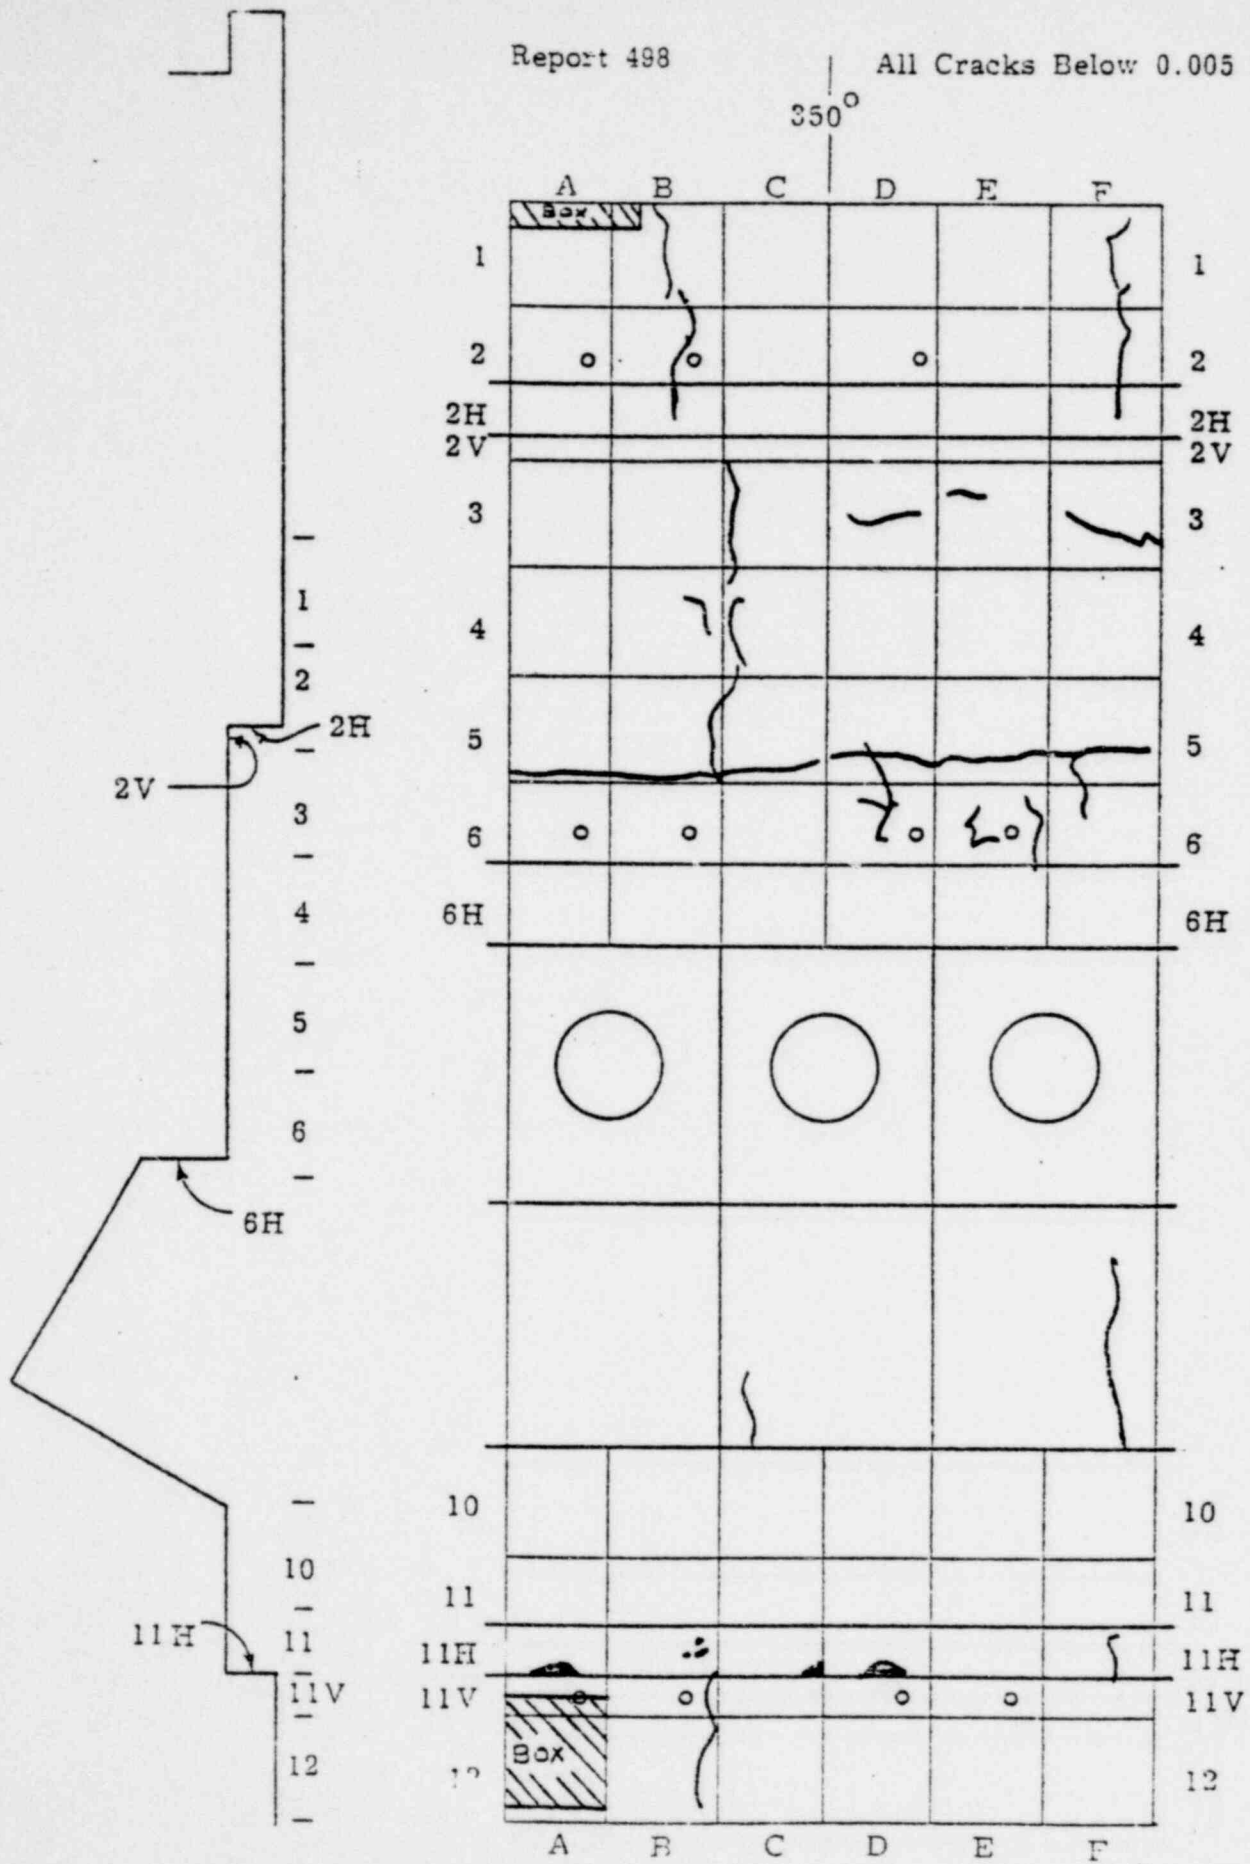
FIGURE 22. CRACK PATTERN AT AZIMUTH 350° AFTER FULL PRESTRESS, SEPTEMBER 19, 1973.
