October 31, 1979  
Fort St. Vrain  
Unit No. 1  
P-79252

REPORTABLE OCCURRENCE 79-42  
ISSUE 0  
Page 1 of 4

FORT ST. VRAIN NUCLEAR GENERATING STATION  
PUBLIC SERVICE COMPANY OF COLORADO  
16805 WELD COUNTY ROAD 19 1/2  
PLATTEVILLE, COLORADO 80651

REPORT NO. 50-267/79-42/03-L-0

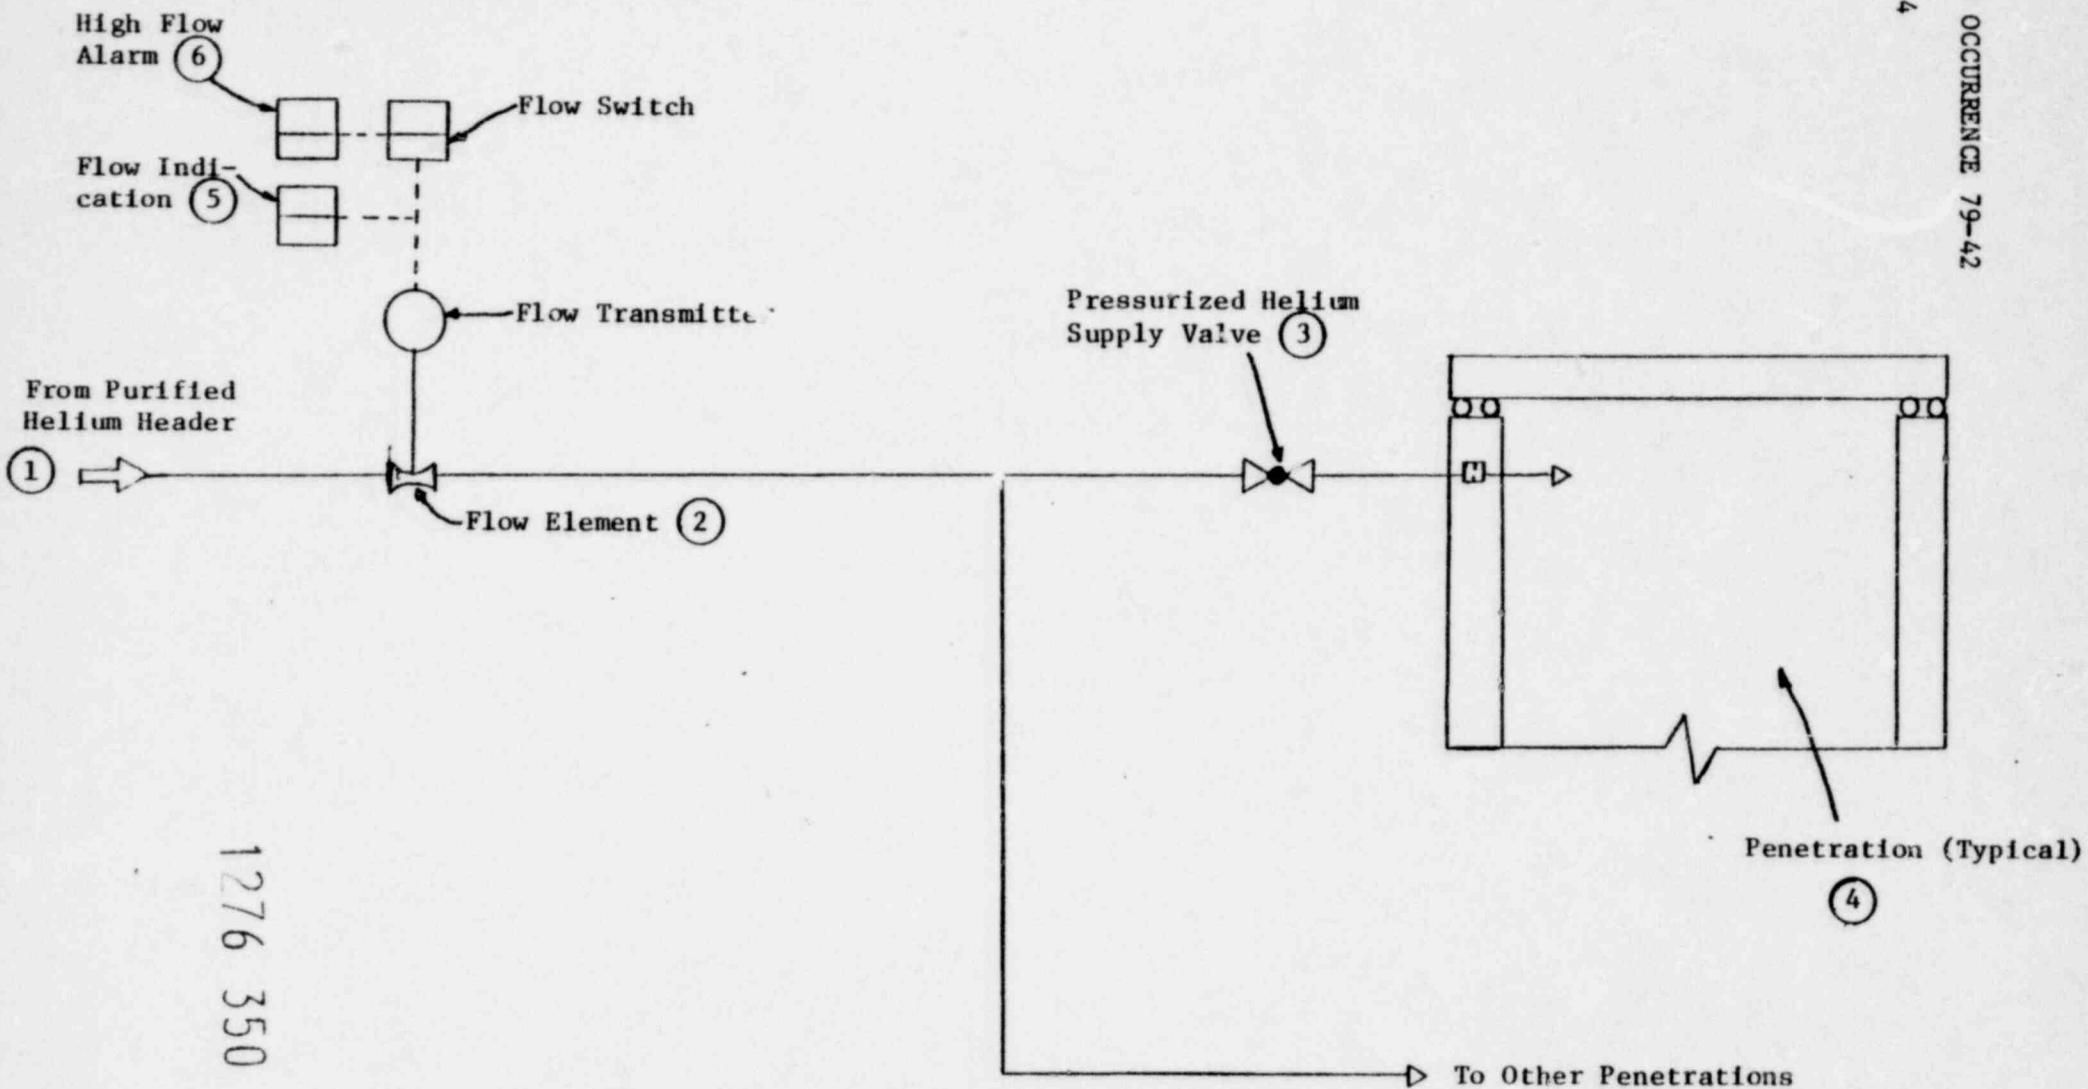
FIGURE 1

At approximately 1200 hours on October 2, 1979, with reactor power at approximately 24%, it was observed that three penetration interspace pressurization valves (one to each of the high temperature filter adsorbers and one to the top access penetration) were closed. This condition was first brought to the attention of plant personnel as the result of a Nuclear Regulatory Commission audit. Per approved plant operating procedures, these valves are called out to be in the open position to provide helium supply. Although a supply of purified helium via these valves is not specifically addressed in the Technical Specifications, the basis of LCO 4.2.9, PCRV Closure Leakage, states that the gas supply to the penetrations is monitored for flow so that an increase in closure leakage can be sensed and alarmed.

Refer to Figure 1 for typical flow path. Under normal operating conditions, gas is supplied to the penetrations via the purified helium header, (1), through a flow element, (2), and a pressurized helium supply valve, (3), to the penetration, (4). With the helium supply valve open as required, any increase in helium flow due to primary/secondary seal leakage would be sensed by the flow element, (2), thereby providing flow indication, (5), and a high flow alarm, (6). However, with the supply valve closed, flow indication and alarm capability associated with these three penetrations was not available. Other penetrations were not affected.

Upon notification that these valves had been found closed, they were reopened by operations personnel.

All personnel have been notified that valve positions are not to be altered without the express knowledge and permission of the Shift Supervisor. Personnel were also advised that any abnormal conditions observed are to be reported to the Shift Supervisor immediately.
