TENNESSEE VALLEY AUTHORITY

August 14, 1979

PHIPPS BEND NUCLEAR PLANT
Transverse Fault In Unit 2 Turbine Building
Extension Of Fault Number 6

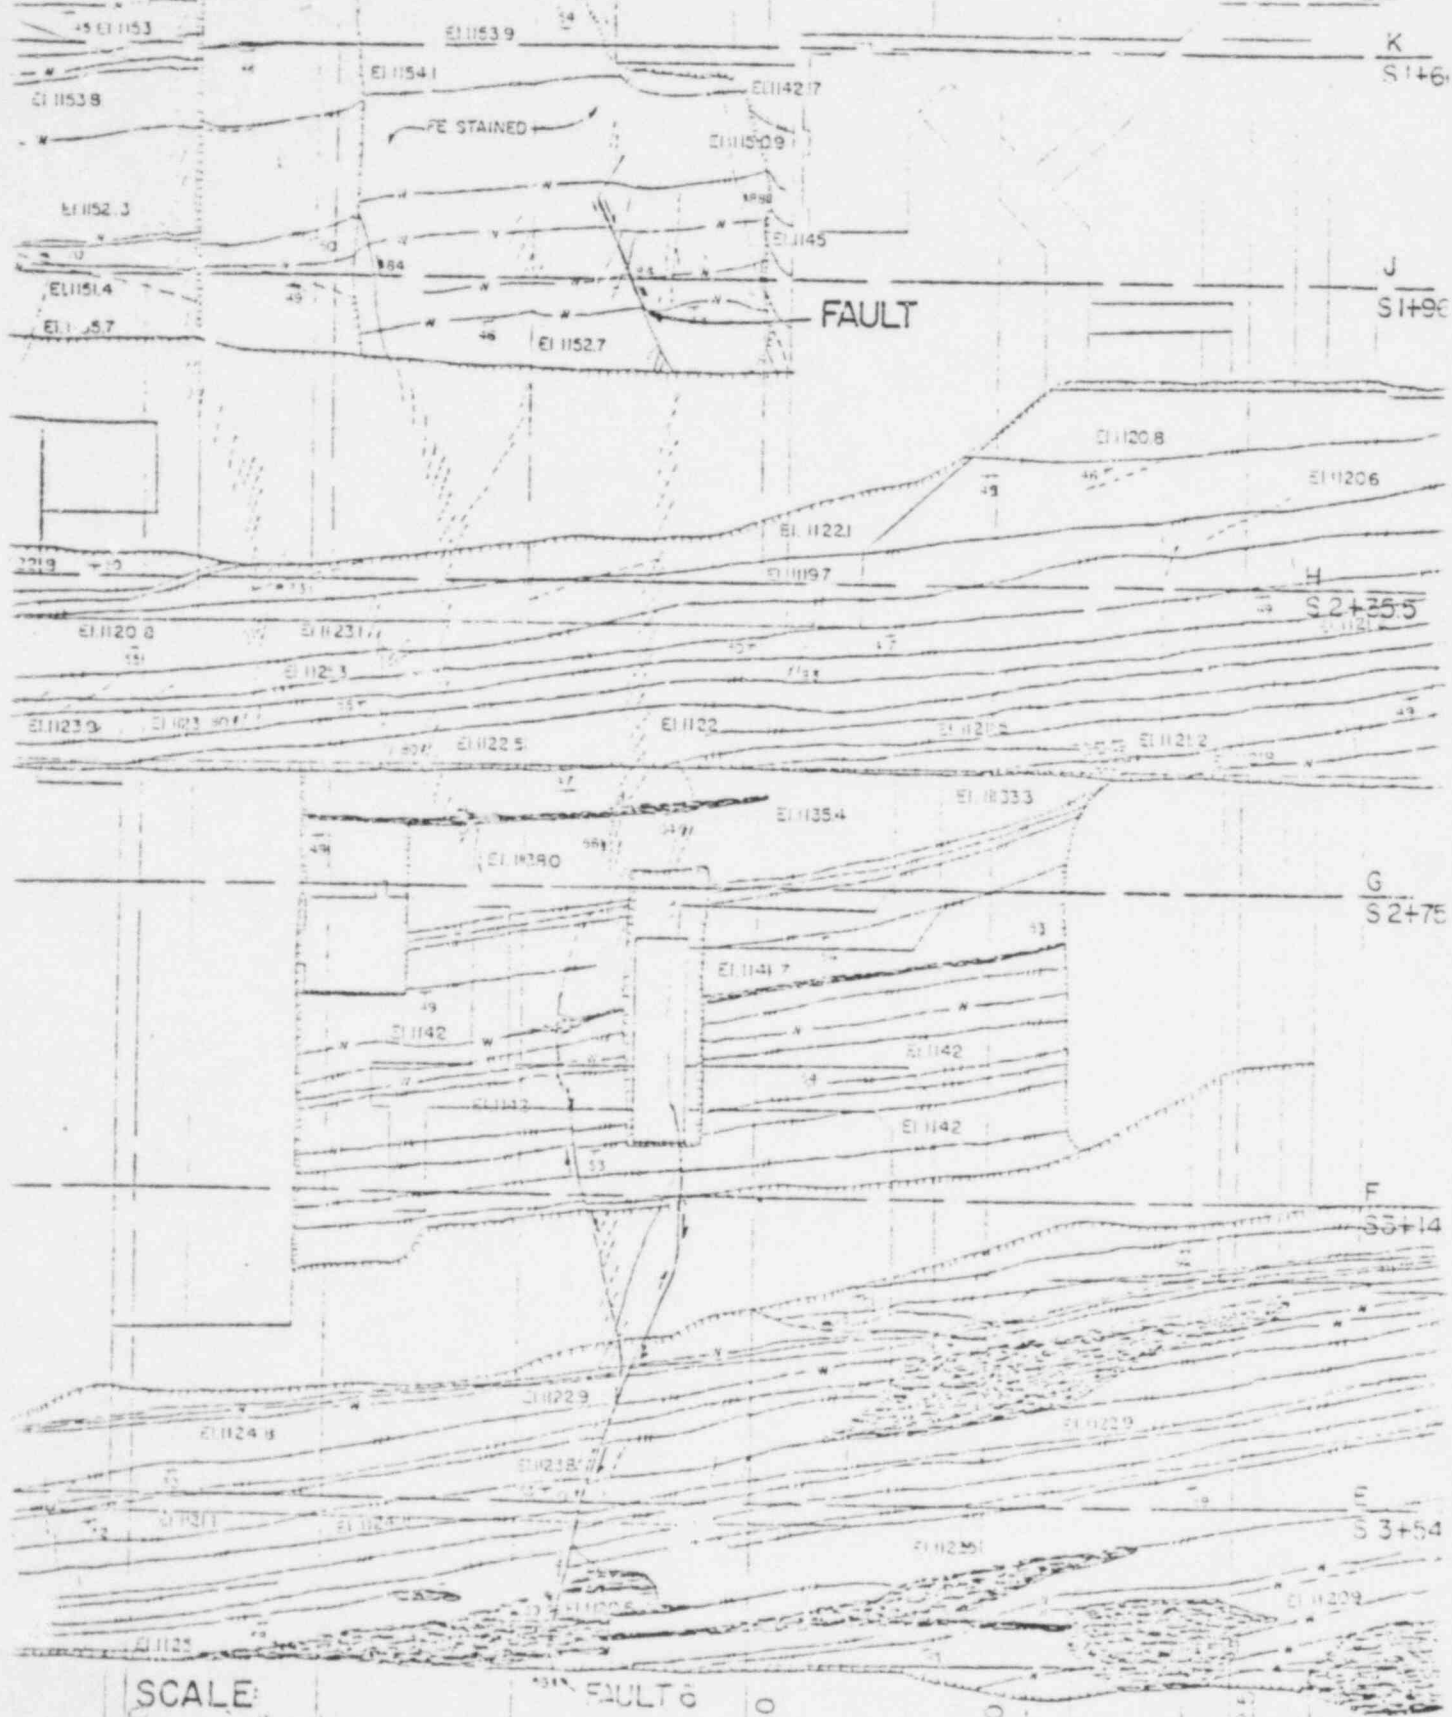
FAULT 10

Top of rock cleaning in Unit 2 turbine building has exposed a transverse fault, located between T-3 and T-4 lines at J-line, in the northeast portion of the building (see attached map and photographs).

The fault is defined by a weathered zone, approximately 4 inches wide, which strikes N 54° W for a distance of 15 feet and dips 84° to the northeast. Bedding is offset an average of 4 inches at its intersection with the fault zone. The fault transitionally terminates into a near vertical joint which can be traced to the south to fault number 6 and to the north approximately 30 feet where the top of rock has not been cleaned.

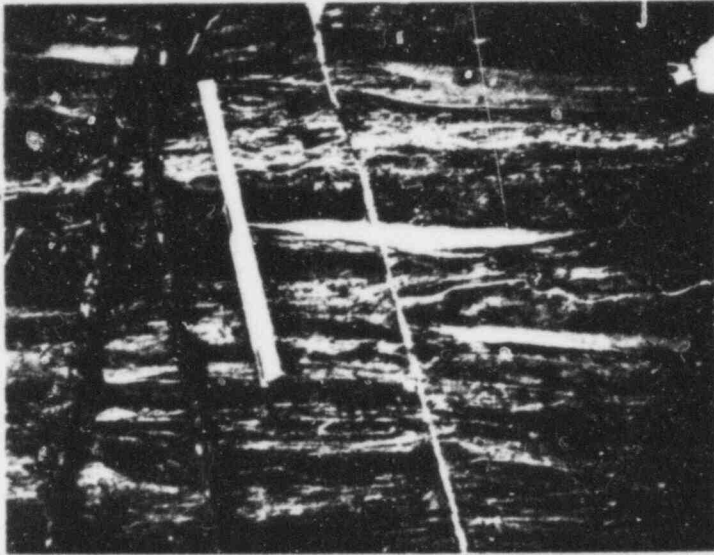
FAULT AT E3+25+JLine

VIEW NORTH

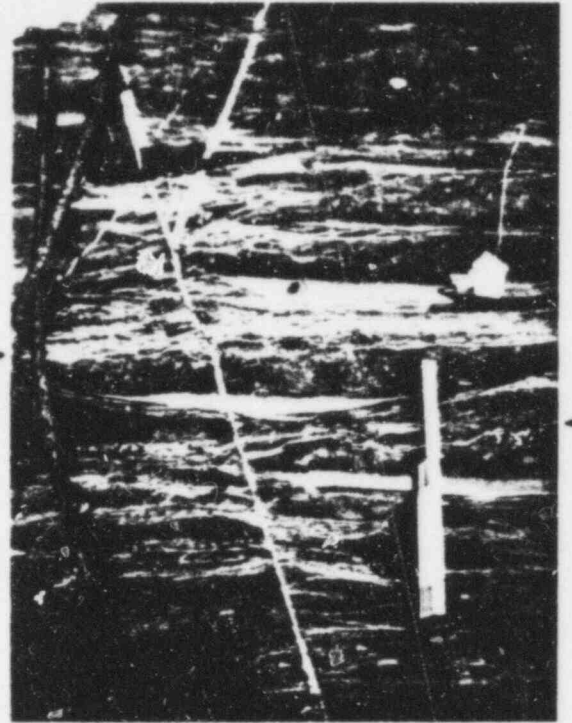
FAULT AT E3+25+JLine

VIEW NORTH

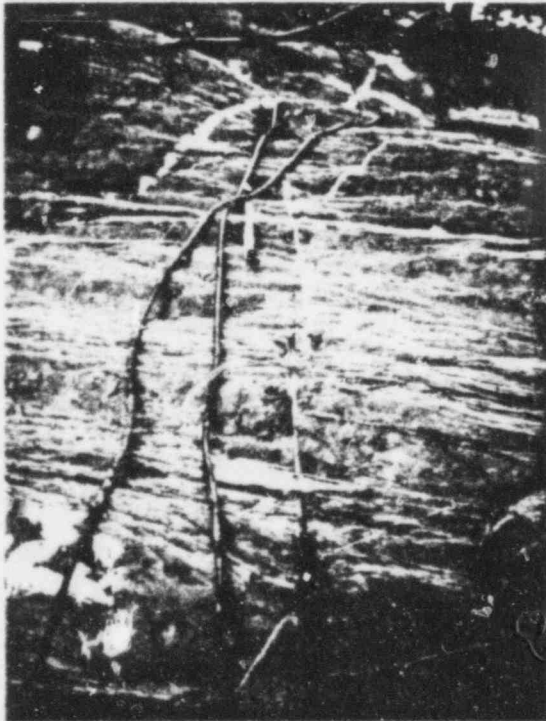
FAULT AT 3+25+ JLINE

VIEW NORTH

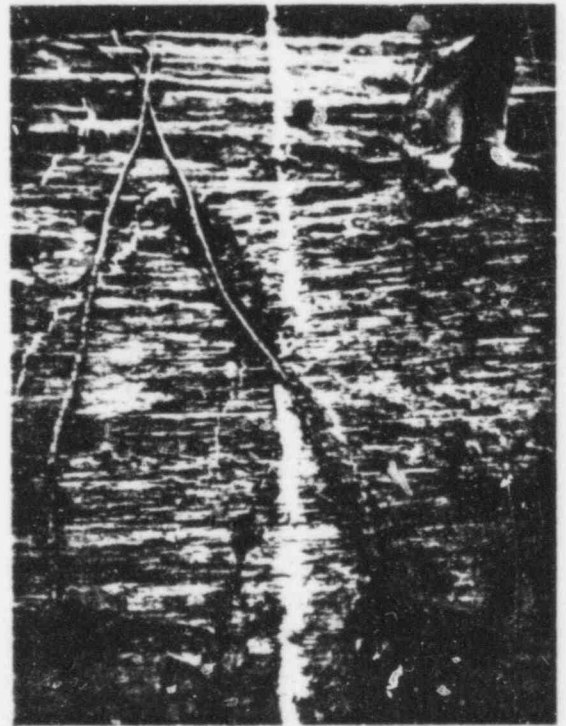
FAULT AT E3+25+JLINE

VIEW NORTH
