Tennessee Valley Authority  
Division of Engineering Design  
Civil Engineering and Design Branch  
Geologic Services

PHIPPS BEND NUCLEAR PLANT  
GEOLOGIC FOUNDATION REPORT  
DESCRIPTIONS OF FAULTS 1-10

August 1979

# STRUCTURAL GEOLOGY OF REACTOR BUILDING EXCAVATION PHIPPS BEND, TENNESSEE

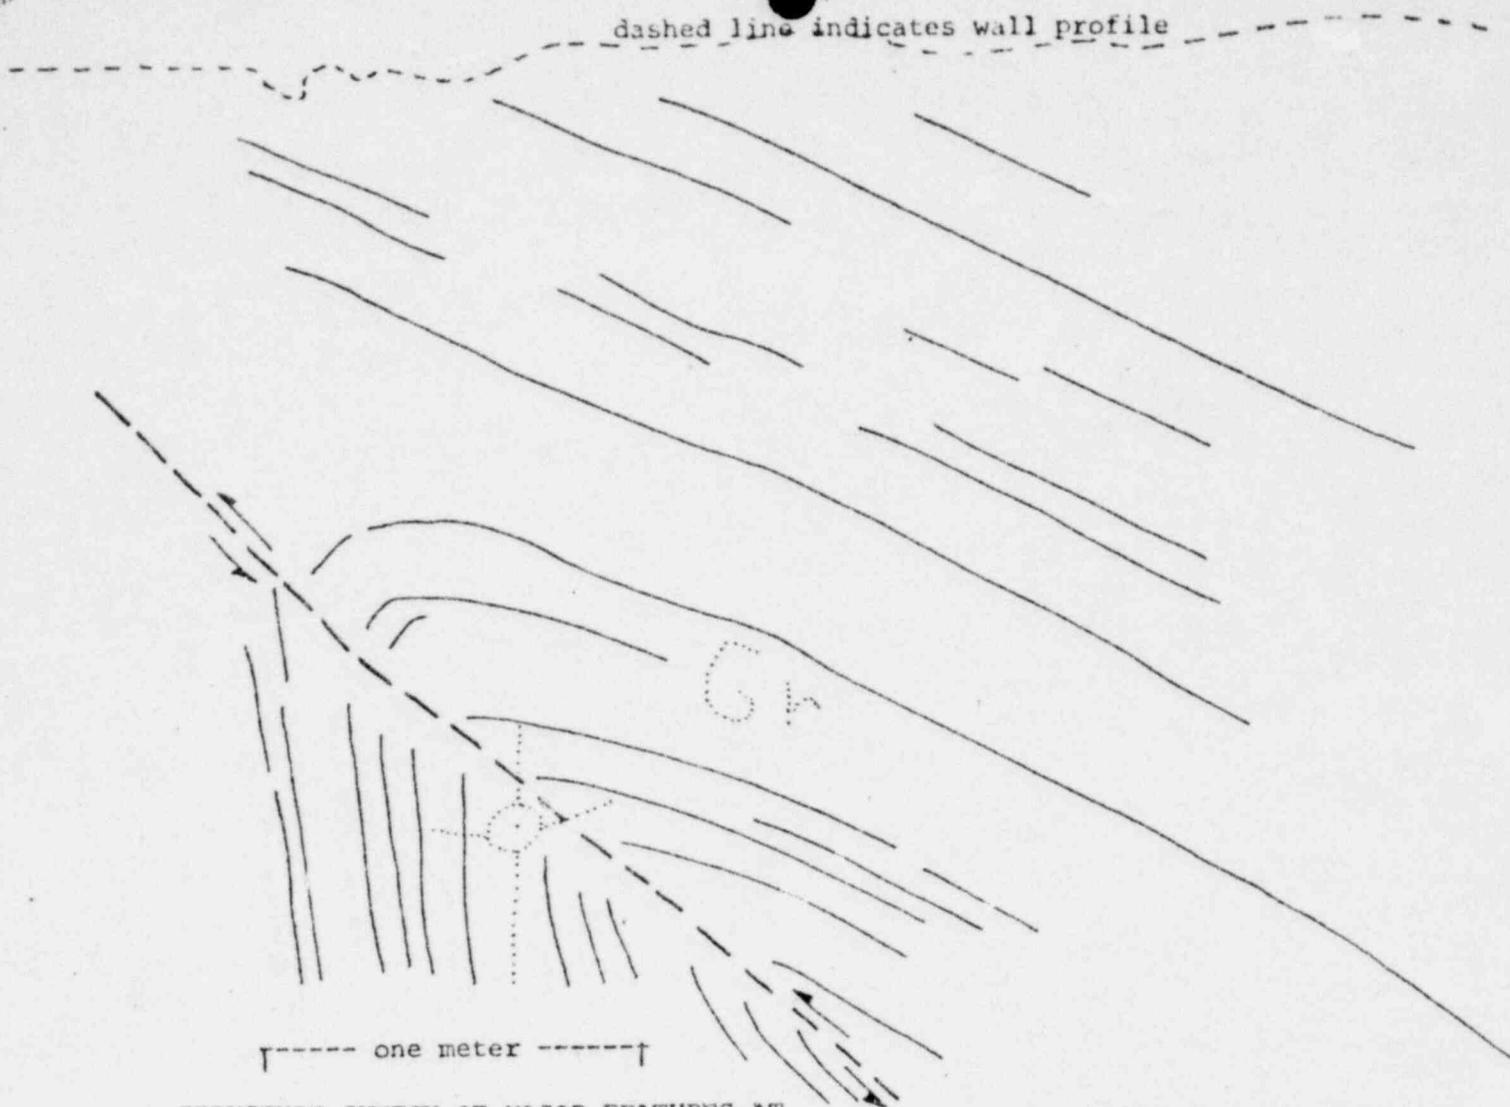
STRUCTURE SKETCH OF MAJOR FEATURES AT  
SITE 1. View toward northeast. Arrows indicate relative motion of fault.  
Dotted lines indicate painted markings of rocks. Most of beds shown are  
marked by slickensided calcite-filled layers.

The fault at this site (see structure sketch) is concordant with the orientation of the axial plane of the asymmetrical anticline which it cuts. Although the displacement is difficult to determine, beds on the north limb of the fold do not appear to have been moved more than a few centimeters. The fault is an example of axial plane "cleavage" developed on a mesoscopic scale. Thus, its origin is by shear stress which was produced during Paleozoic tectonism when overlying beds within the sequence were sliding upward toward the crest of the fold in a manner such as that illustrated in Figure 2. This relation of fault orientation to fold axial plane orientation is similar to that described by Swingle (1973) in calcareous siltstones of Knox County, Tennessee.

Note the migration of the bedding plane fault across overlying bed by ramping.

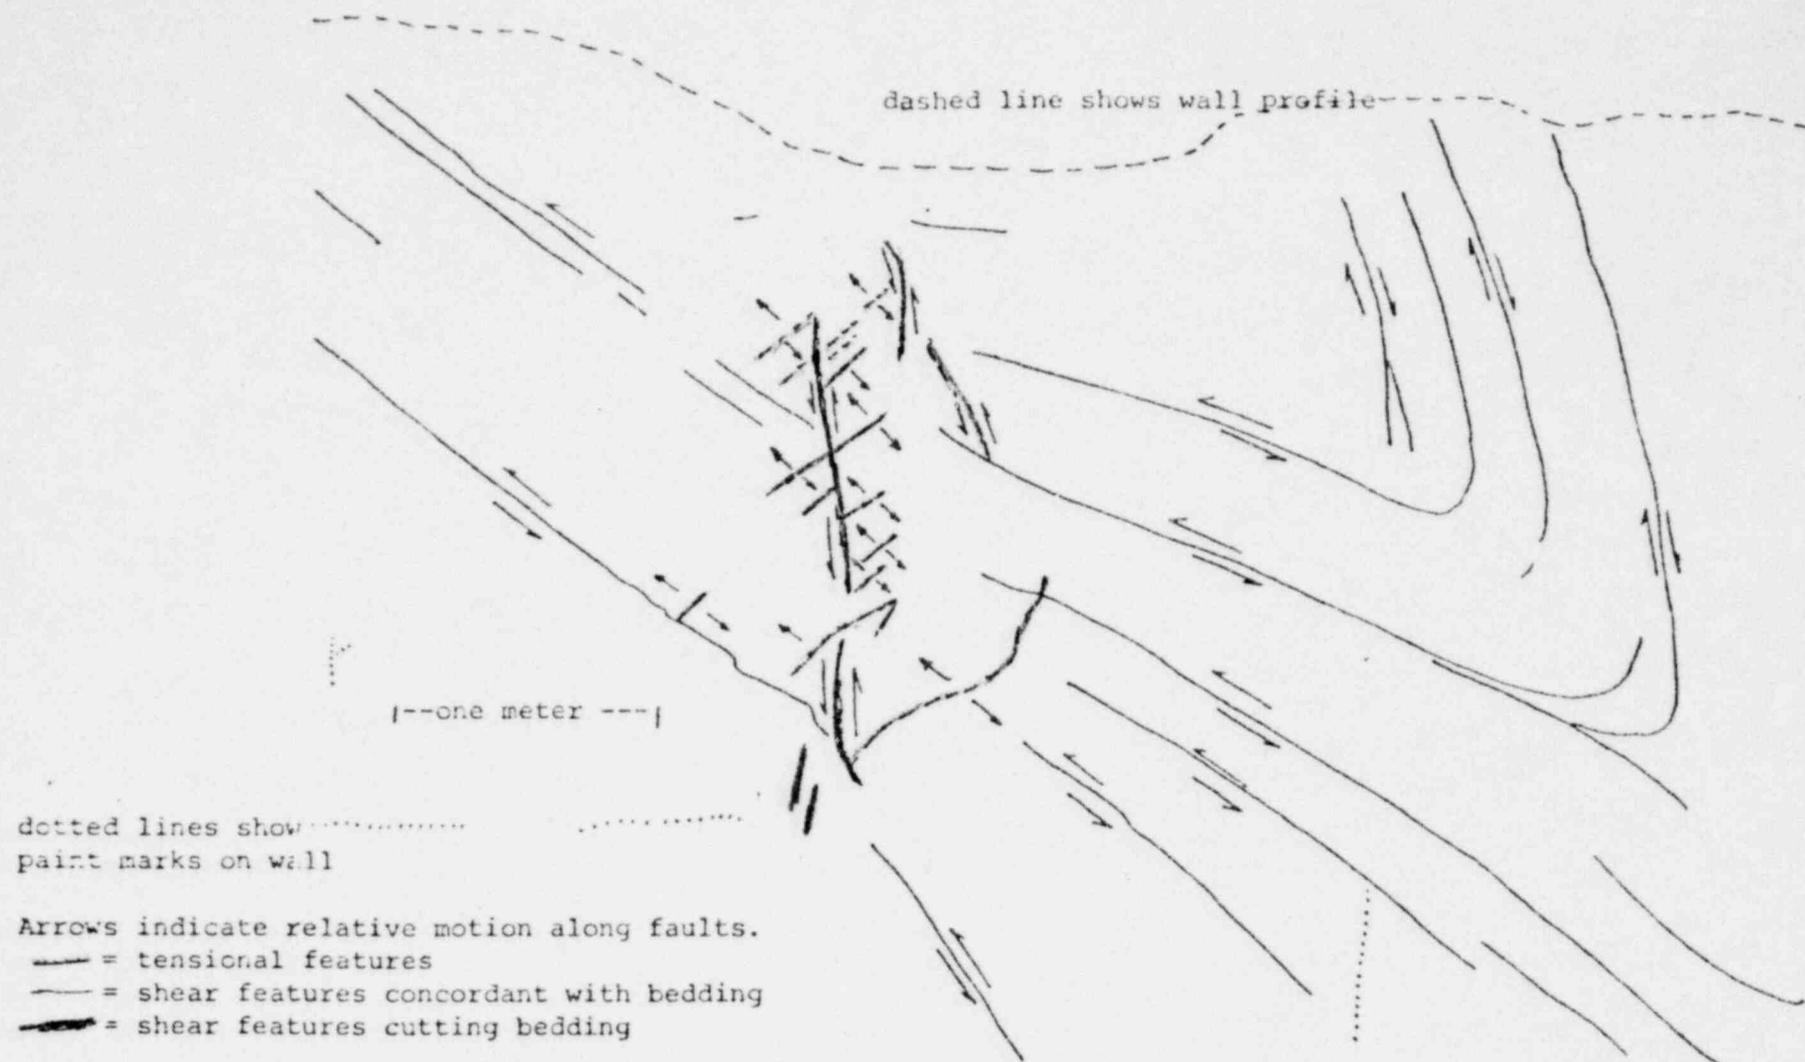
STRUCTURE SKETCH OF MAJOR FEATURES AT SITE 2.  
View is toward the northeast

This fault is located approximately 2 meters north of the axial plane of an asymmetrical syncline (north limb dip =  $40^{\circ}$  S.). Calcite-filled fractures and fault surfaces parallel to bedding were produced by shearing of beds during folding as each bed slid upward, with respect to the bed below it, toward the crest of the adjacent anticline. This is the same principle as shown in Figure 2. Thus, there was shear stress that produced fractures that are incipient small ramp faults such as those shown in Figure 5. As additional folding and slippage along bedding planes occurred, minor displacement of bedding resulted from the shearing motion shown by the disruption of calcite-filled bedding faults truncated by the near-vertical fault here. Calcite-filled fractures of lesser size and near normal-to bedding orientation

are of tensional origin. These small tension fractures were formed by the stretching of beds on the fold limb as thinning and thickening as illustrated in Figure 2 took place.

This somewhat indistinct fault extends for less than 20 feet to the east where it dies out on the excavated bedrock bench. Examination of the floor of the reactor site to the west reveals that the fault trace dies out within 15 feet of the excavation wall.

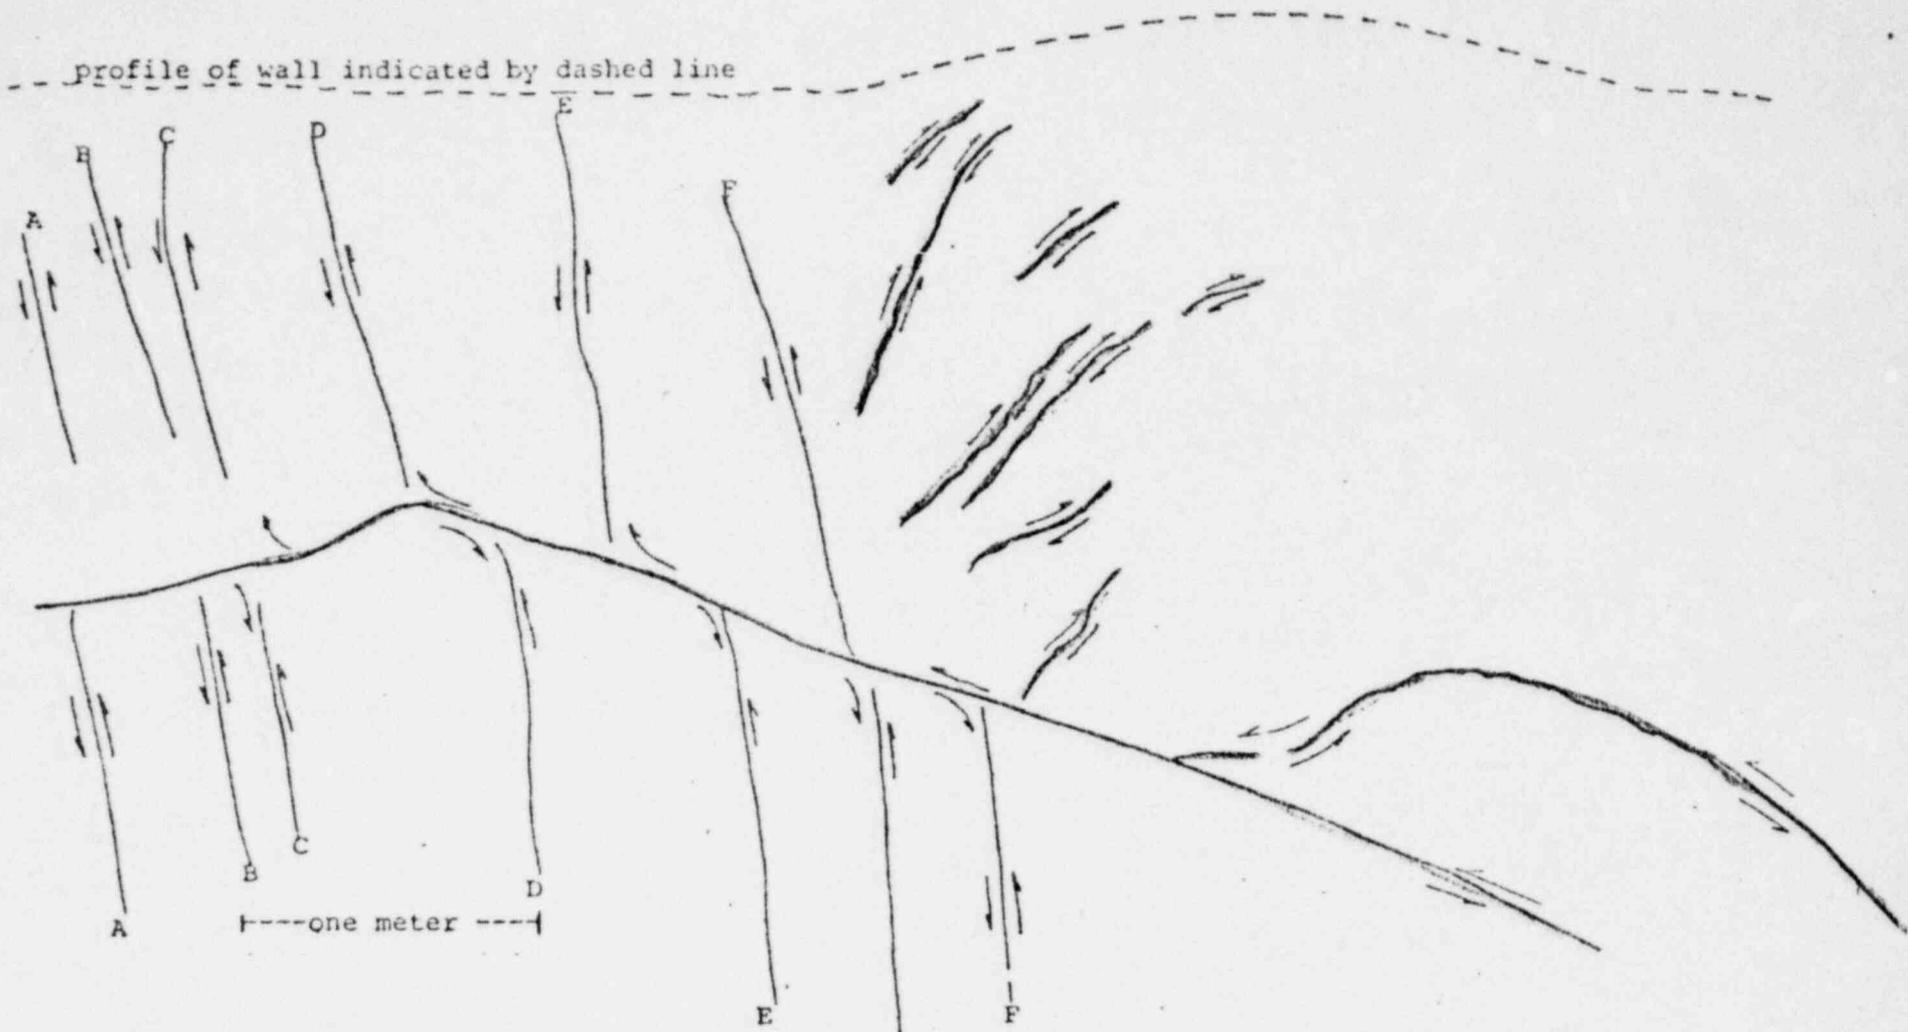
STRUCTURE SKETCH SHOWING MAJOR FEATURES AT SITE 3. View toward the northeast.

The fault at this location is an excellent example of bedding plane faulting that locally breaks across bedding by ramping upwards through beds that are slightly more brittle (see Figure 5). As displacement of overriding beds took place as these beds moved higher toward the crest of the anticline, the space necessary to accommodate the volume change that accompanied the displacement was provided at sites where the fault broke across bedding. A series of these breaks occurred here and, as is shown in the structure sketch, enough space for accommodation of the beds was produced. Thus, a combination of shear faulting along bedding planes and shear and (or) tensional faulting normal to bedding intersect to provide an integrated network of displacement avenues and space.

Arrows indicate relative motion of faults.  
Letters show correlations of bedding plane calcite-filled fractures.  
Note how displacement along fault marked in red (—) decreases toward the north where its displacement is translated into bedding plane motion by ramping upward into bedding plane faults labelled A - F. Faults shown in green (—) are folded or tilted by drag effect associated with the anticline present here.
