Millstone Nuclear Power Station, Unit No. 2
Feedwater System Piping

MILLSTONE NUCLEAR POWER STATION, UNIT NO. 2

RESPONSES TO
ADDITIONAL INFORMATION REQUIRED
TO ASCERTAIN ACTIONS NECESSARY
REGARDING THE FEEDWATER SYSTEM PIPING

ASSESSMENT OF GROWTH OF FEEDWATER LINE FLAWS

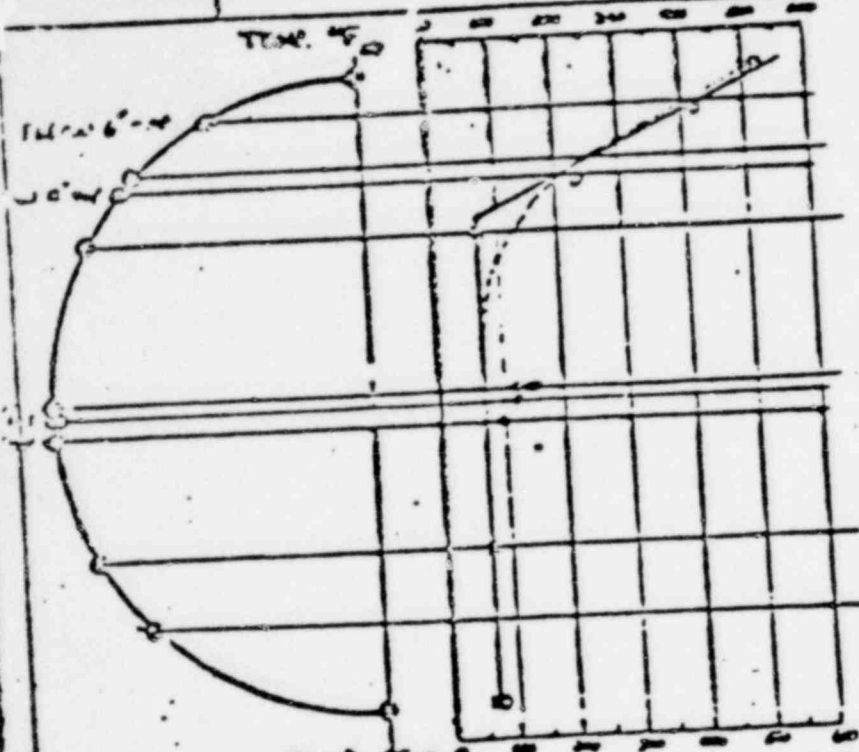
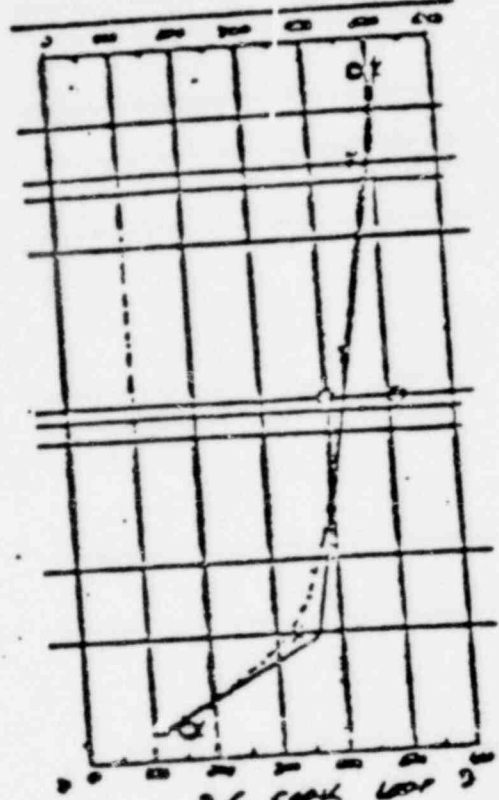
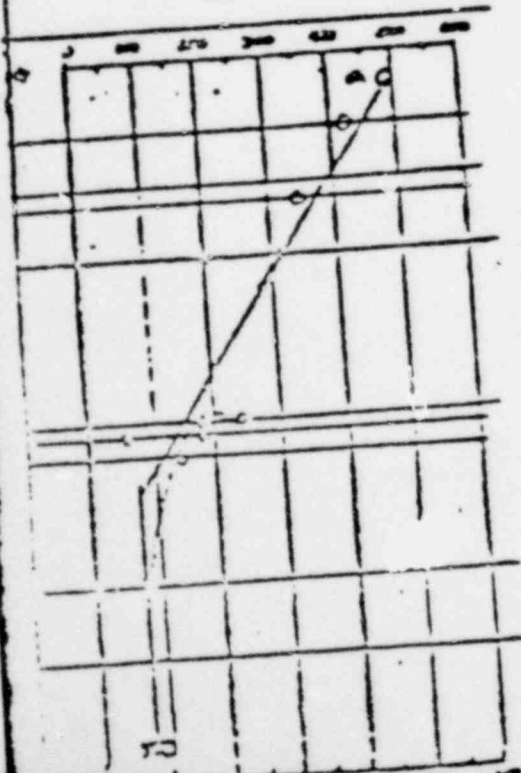
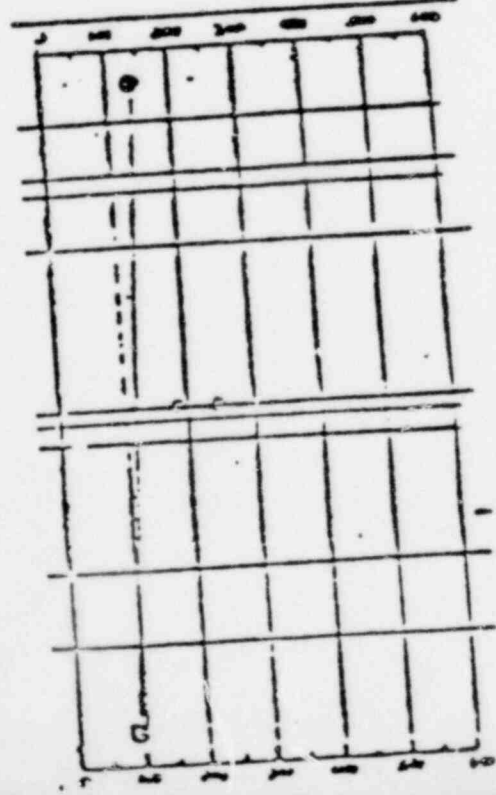
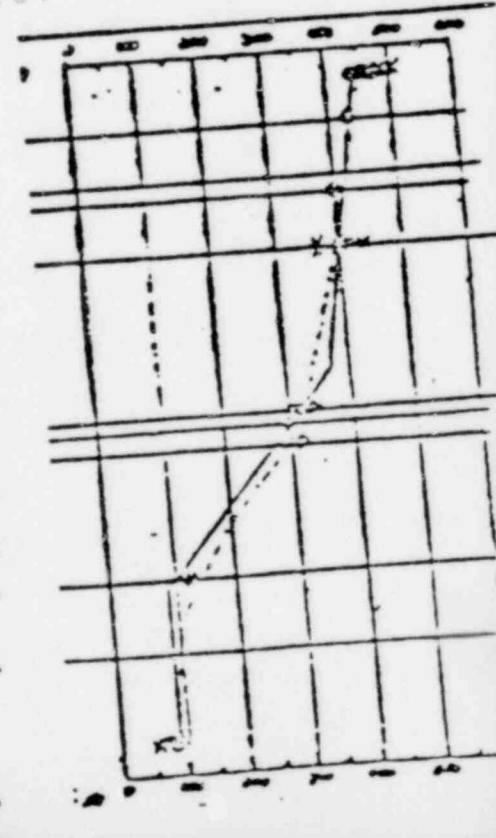
FIGURE 1.

A three dimensional finite element stress analysis has been completed for each of the five temperature profiles in Figure 1, and transient studies have shown that the five profiles represent limiting conditions compared with the stress results obtained for any transient step in between the profiles.

STEADY STATE TEMPERATURE DISTRIBUTIONS

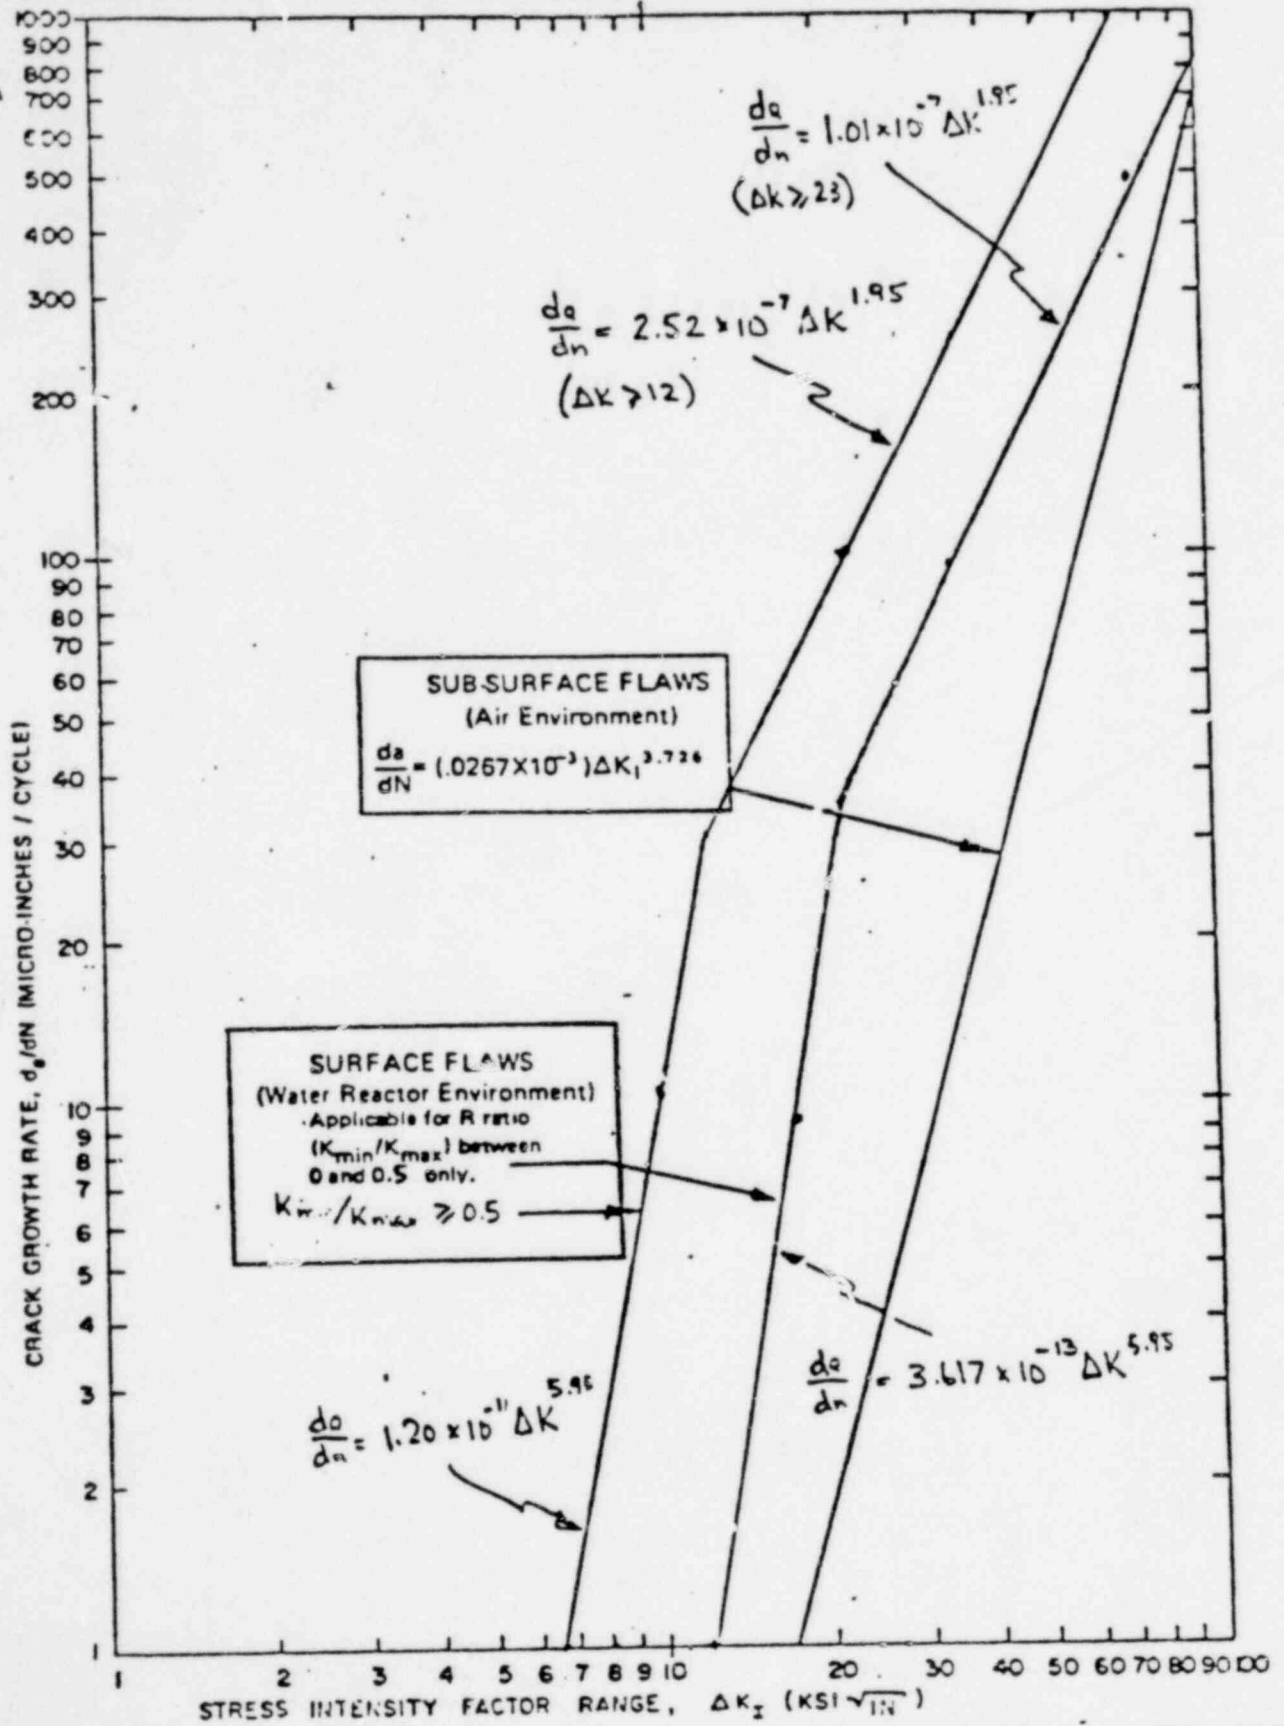
FIGURE 3 FATIGUE CRACK GROWTH DATA FOR SA-509, CLASS 2 AND CLASS 3 AND SA-553, GRADE B, CLASS 1 STEELS

A fatigue crack growth law which accounts for mean stress or R ratio ($\sigma_{min.} / \sigma_{max.}$) as well as the presence of the water environment was used. The law is shown in Figure 3.

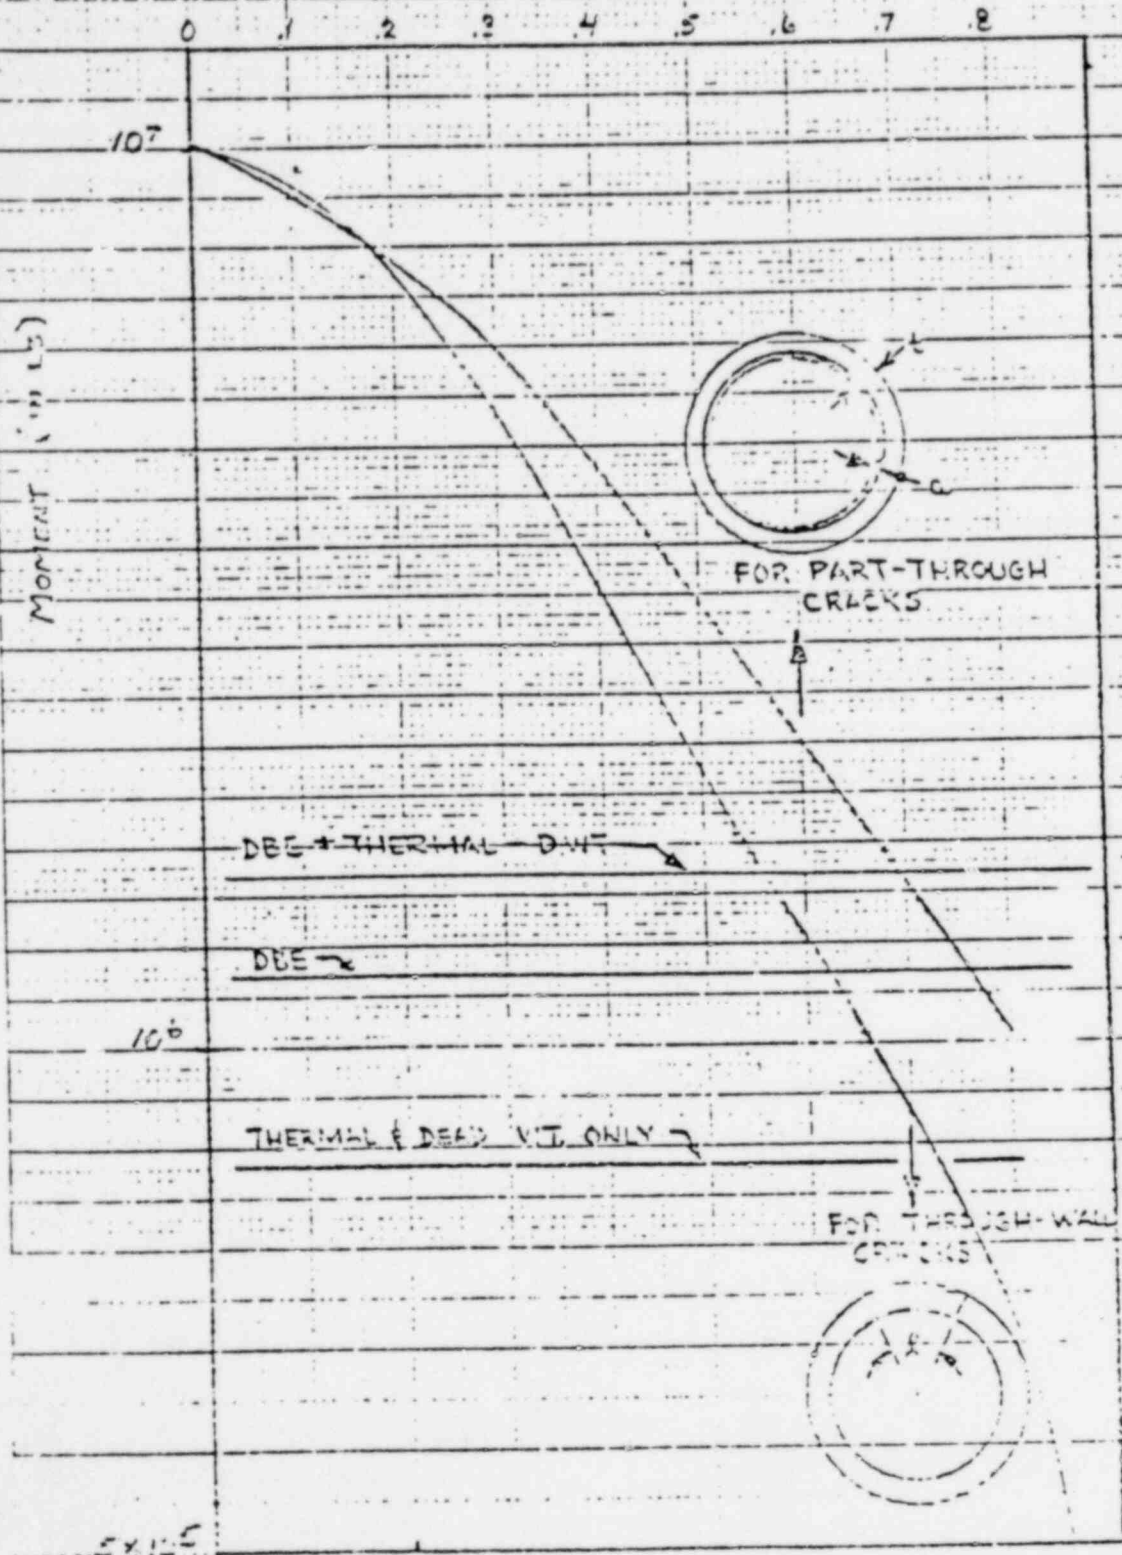
FIG. 6. FAILURE PREDICTIONS - 18" OD PIPE 0.75" WALL

Results of the crack growth analysis are shown in Table 6, for each of the locations considered. These results show that the observe flaws will not grow significantly during the next years service. The final flaw size for the worst location is a factor of 5 smaller than the critical flaw size for the pipe, as shown in Figure 4.
