INVESTIGATION REPORT (Attachment to IE Rpt. 50-338/79-39)

SUBJECT: VIRGINIA ELECTRIC AND POWER COMPANY (VEPCO)
North Anna Unit #1
Docket No. 50-338

Statements by VEPCO representatives to the NRC following a turbine trip/reactor trip on September 25, 1979 that a release of radioactive gases (to the Auxiliary Building atmosphere) was in part caused by a control room switch being blocked with a pencil and paper binder clamp and failure to connect/ reconnect an orifice flange in the vent line from the High Level Waste Drain Tank.

DATE OF INVESTIGATION: October 2-17, 1979

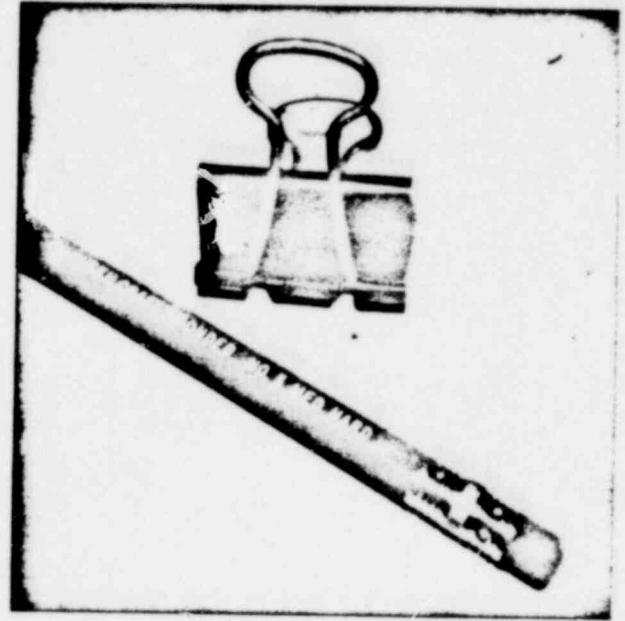
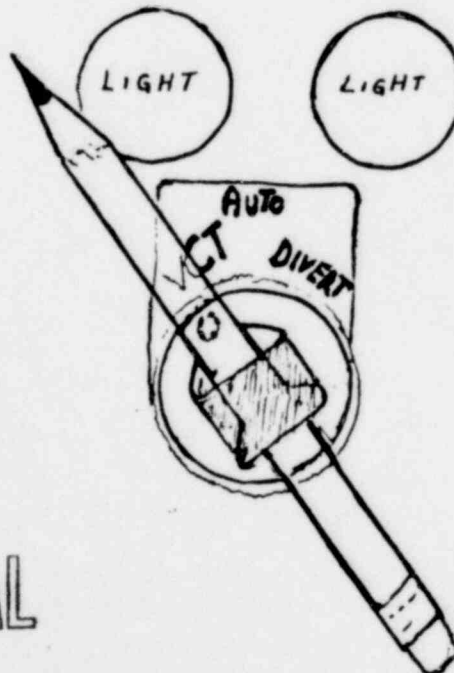
Exhibit 2
Page 1 of 1

1. The blockage of the control switch for the VCT level control valve, LCV-1115A with a paper binder clamp and pencil has been a routine practice known and condoned by the North Anna supervisory staff for a period in excess of six weeks. However, the switch was in its normal "AUTO" position immediately prior to and during the turbine trip and subsequent release of radioactive gases and did not contribute to the incident.

The above depicts the Unit 2 equivalent (LCV 2115A) VCT Level Control Switch and the components of the blocking device utilized. The manner of installing the blocking mechanism is illustrated below.

The Station Manager stated he and his staff accepted full responsibility for the failure to analyze and document the use of the blocking mechanism utilized on the control switch for LCV-1115A and, further, that this practice had been abolished and written directives to this end had been issued.
