SAFETY EVALUATION BY THE OFFICE OF NUCLEAR REACTOR REGULATION

SUPPORTING AMENDMENT NO. 47 TO LICENSE NO. DPR-49

DOCKET NO. 50-331

DUANE ARNOLD ENERGY CENTER

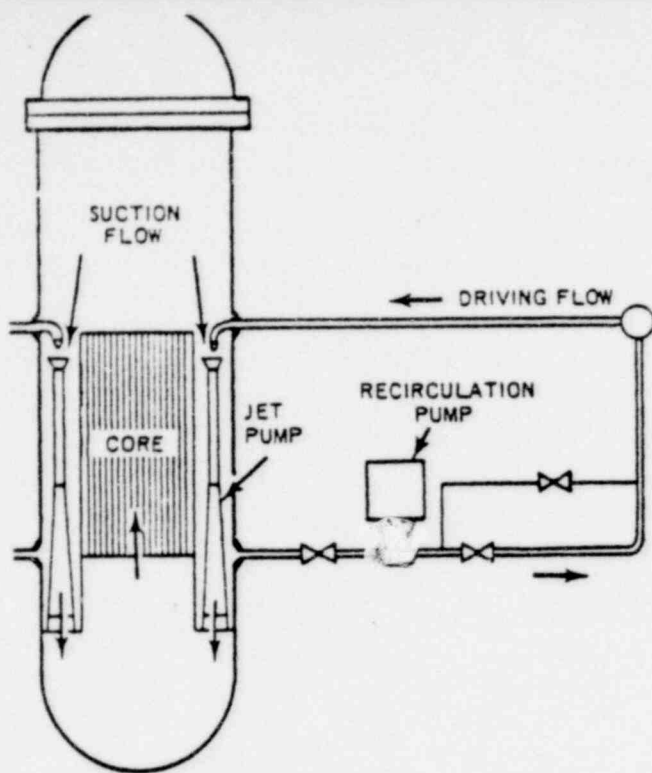
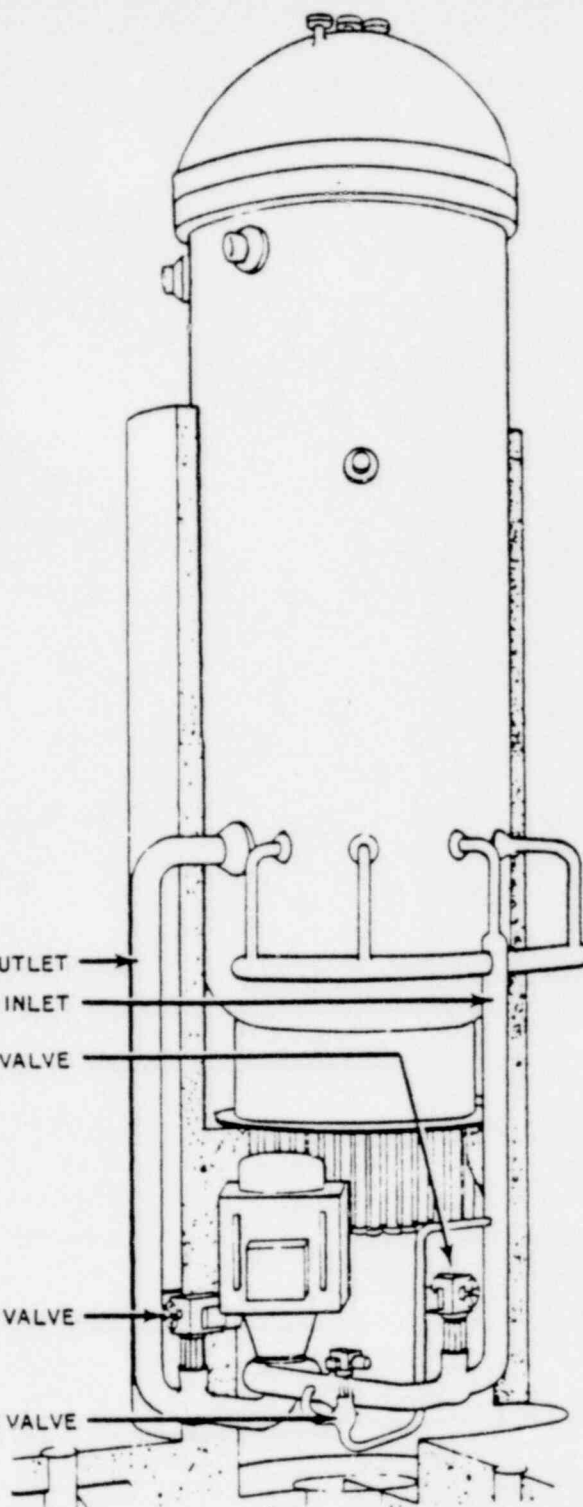
Figure -1

The modification consists of replacing the existing eight cracked recirculation inlet nozzle safe-ends with redesigned safe-ends and thermal sleeve adapters. The safe-ends were fabricated from SB-166 (Alloy 600) material.** They function as transition pieces between the stainless steel reactor recirculation piping and the carbon steel reactor vessel nozzles, and as attachment points for the internal thermal sleeves, that carry the recirculation flow to the jet pump risers (see Figure 1).

Recirculation System Elevation
 and Isometric

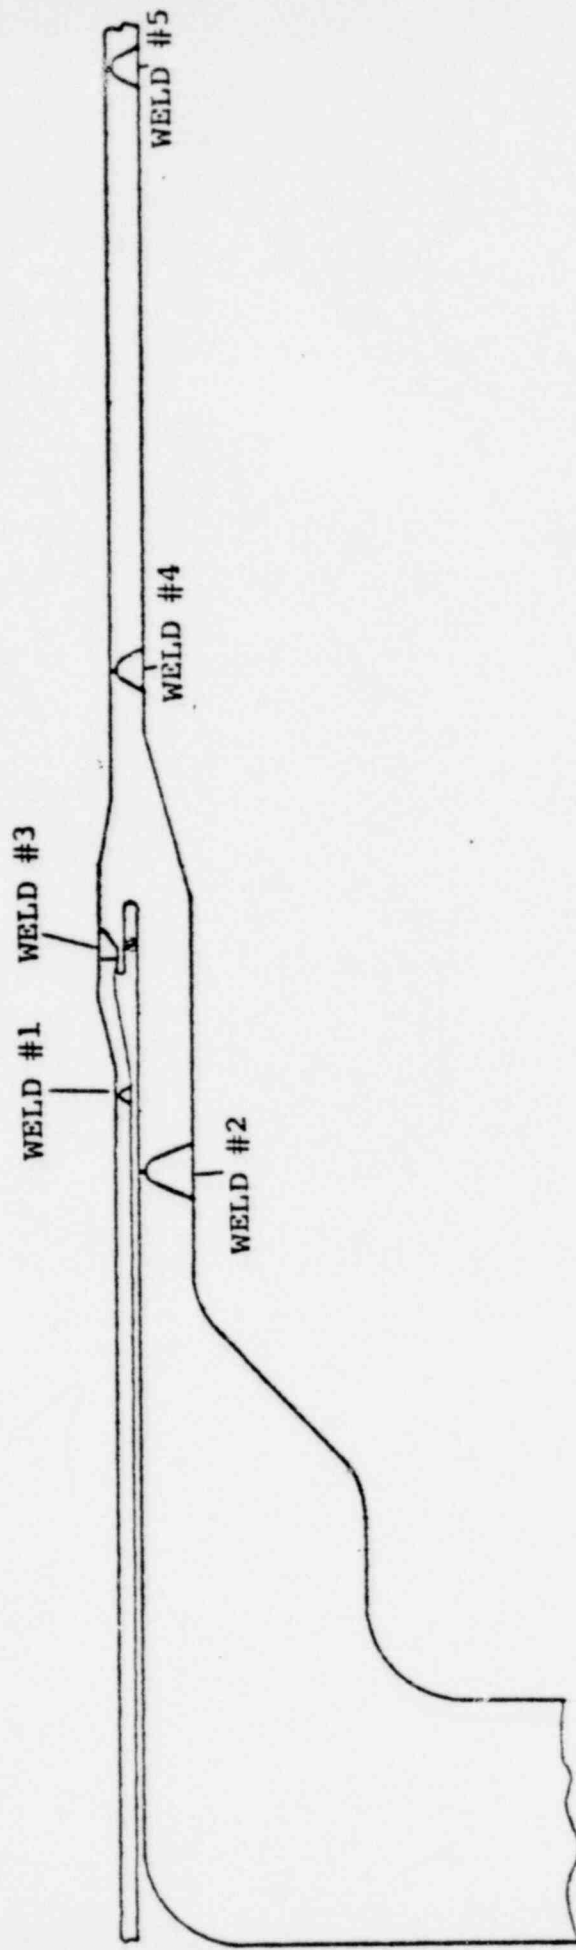
WELD BEQUENCE FOR REPLACEMENT SAFE END ASSEMBLY

The new safe-end design removes the thermal sleeve attachment weld from the primary pressure boundary and eliminates the sharp crevice in the high residual tensile stress area. In the new design, the thermal sleeve is welded to the safe-end at a point away from the pressure boundary wall (see Weld #3, Figure 2). The new safe-end design improves the in-service inspection access at the nozzle attachment end by maintaining longer straight inside and outside surfaces, thus simplifying ultrasonic angle beam examinations.

The installation of the new assemblies involves five separate welds at each safe-end (see Figure 2). Prior to installation, each weld was mocked up to demonstrate reproducibility of welding and dimensional control of weld shrinkage. Because the root of the production weld between the thermal sleeve and the safe-end could not be examined after welding to confirm that complete fusion was achieved, the mockup weld was sectioned, etched and examined. Although it was observed that the backing ring deformed against the thermal sleeve creating a crevice-like condition, the joint is not located on the primary pressure boundary of the safe-end, therefore if the condition were to induce IGSCC the pressure boundary integrity would be unaffected.

The installation procedure consisted of machining weld preps on the reactor vessel nozzle and thermal sleeve using witness marks to obtain accurate dimensional tolerances between the safe-end and the thermal sleeve adapter. The weld prep on the vessel nozzle was made on the existing Ni-Cr-Fe weld butter to avoid dissimilar metal field welding during installation and the necessity for post-weld heat treatment. The weld root pass was made with a consumable insert in place thus minimizing the likelihood of forming a crevice through incomplete penetration. While the root pass of the nozzle to safe-end weld was being laid down, the annular region between the weld joint and the thermal sleeve was flushed with an inert gas mixture. The inert gas was used as a precaution against the formation of oxide inclusions on the I.D. surface. After completing the weld, the two small ($< 1/4$ in. diameter) chamfered purge gas holes in the thermal sleeve adapter were seal welded.

After the adapter to thermal sleeve and safe-end to nozzle welds were completed, the weld gap at the root of the thermal sleeve adapter to safe-end was measured. The thermal sleeve was then positioned to compensate for the weld shrinkage prior to welding, thereby minimizing the net residual tensile stress at the joint. Once the safe-end and thermal sleeve were welded in place, the closure spool piece was templated and machined for fitup, and the final two closure welds were made.
