UNITED STATES  
NUCLEAR REGULATORY COMMISSION  
WASHINGTON, D. C. 20555

FACILITY: Arkansas Nuclear One, Unit 2

SUBJECT: SUMMARY OF MEETING FOR ARKANSAS NUCLEAR ONE AND THE INCIDENT OF SEPTEMBER 16, 1978 REGARDING OVERLOAD CONDITIONS ON STARTUP TRANSFORMER NO. 2 AND THE CONSEQUENT UNIT 2 CONTAINMENT SPRAY

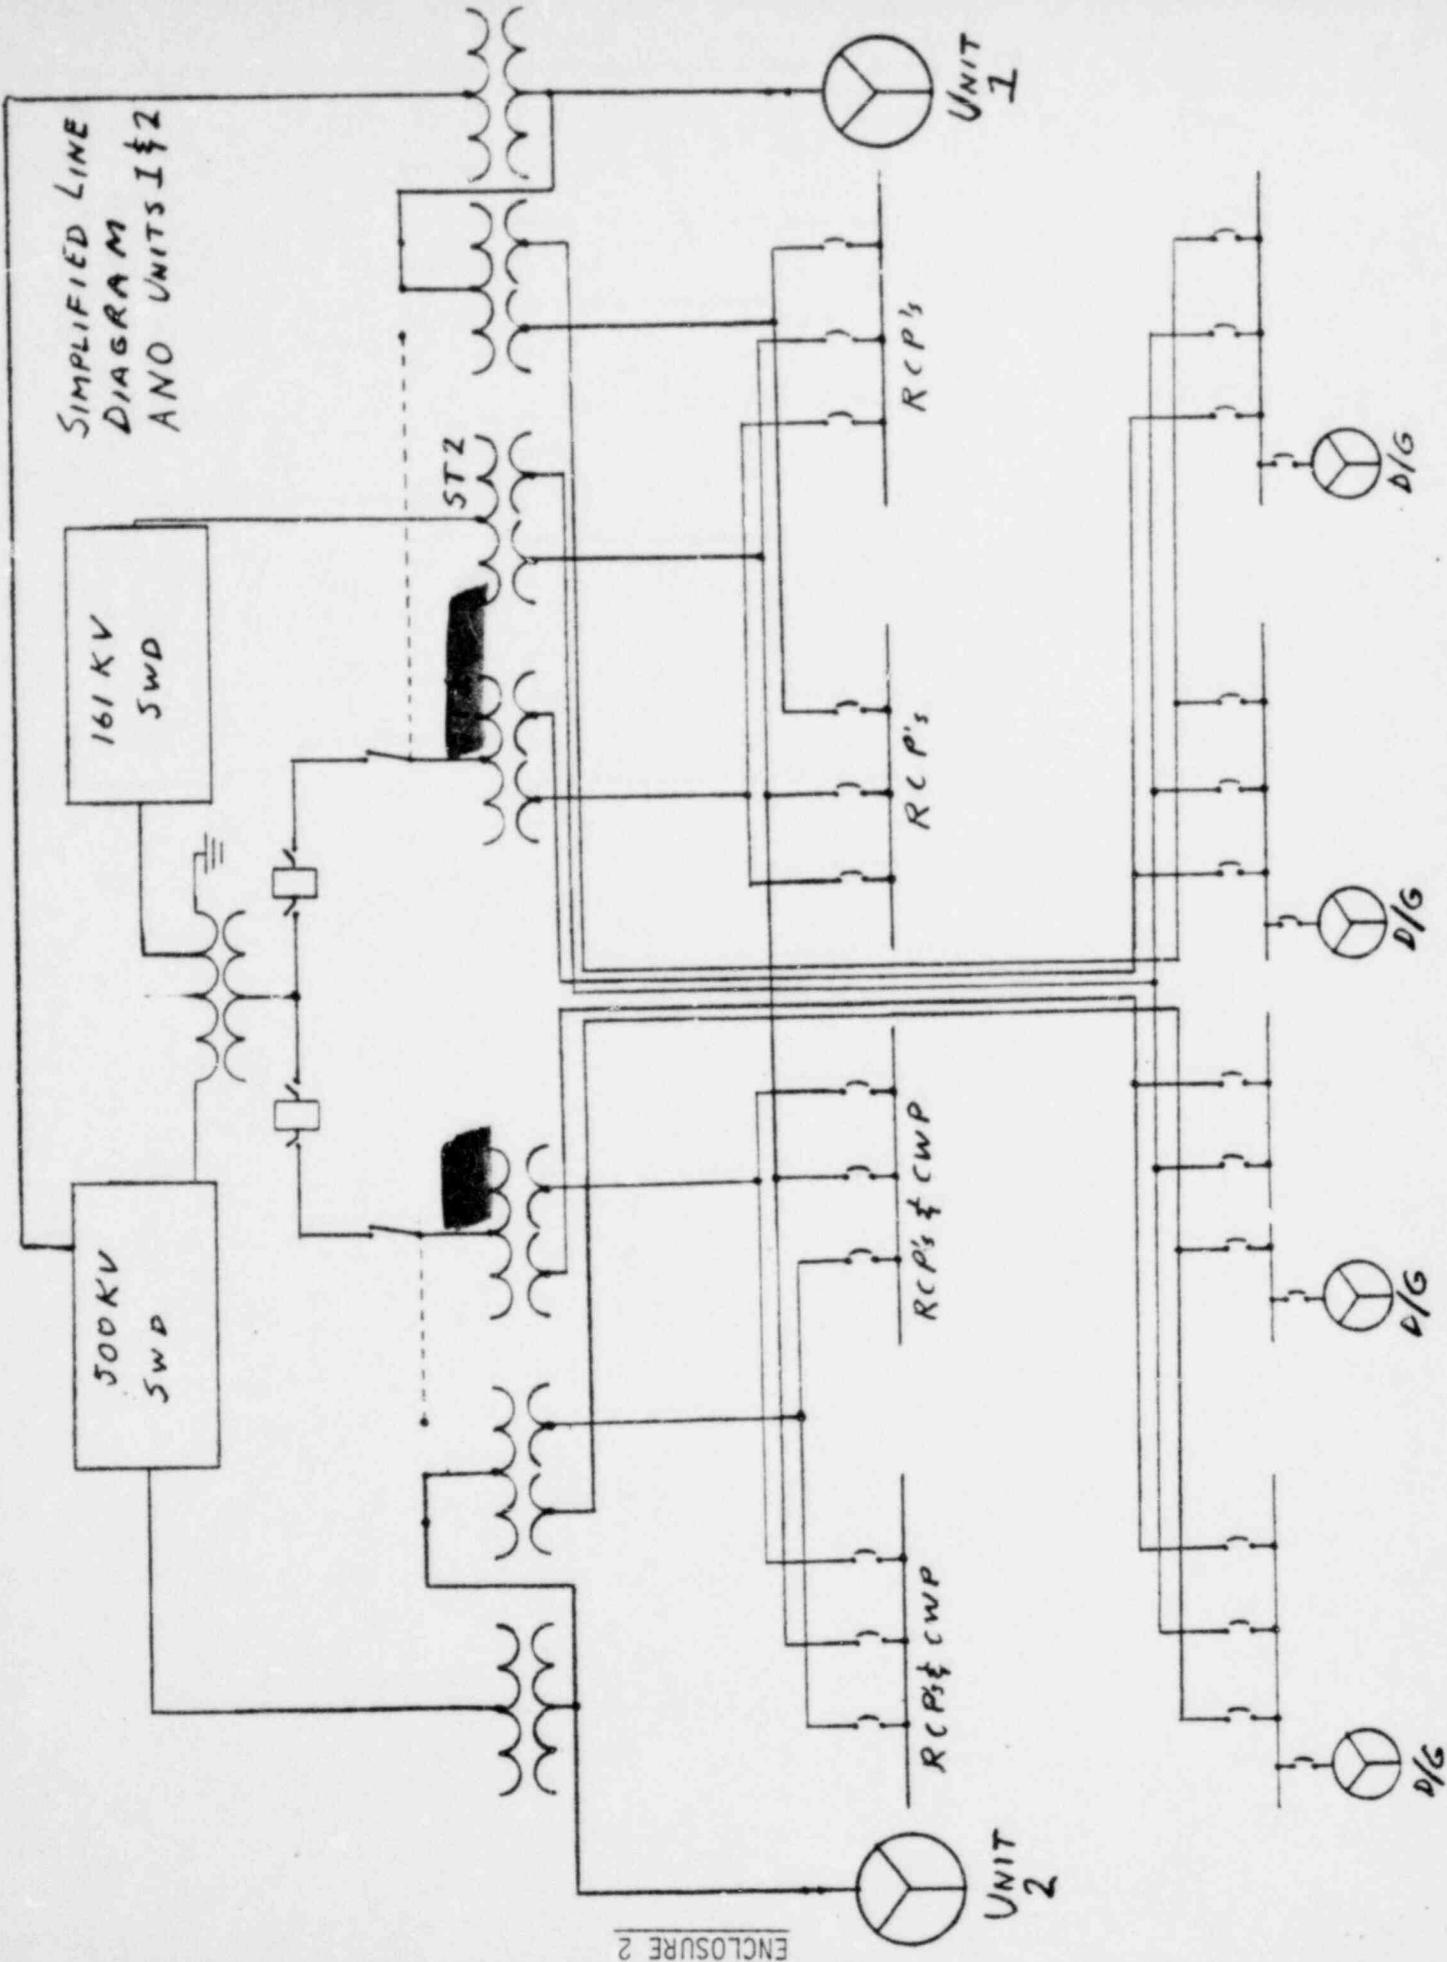
SIMPLIFIED LINE  
DIAGRAM  
AND UNITS I & 2

Each of the two units of Arkansas Nuclear One, i.e., Unit 1 and Unit 2, have a dedicated unit auxiliary transformer and a dedicated startup transformer, each of which can supply the necessary alternating - current power to all of the respective unit auxiliaries, including both safety and non-safety loads. The unit auxiliary transformers are supplied from their respective unit generator. The unit startup transformers are both supplied through a single auto-transformer which is linked to the 500 kilovolt and 161 kilovolt sections of the station switchyard (See Enclosure 2).

In addition, a backup Startup Transformer No. 2 is provided which can serve both Unit 1 and Unit 2. This transformer is supplied directly from the 161 kilovolt section of the switchyard. However, Startup Transformer No. 2 does not have the capacity for carrying the full auxiliary loads of both units at the same time.
