ENCLOSURE Suppl to Lic. Event Rpt 76-42-1P concerning the concrete pipe installations described in the FSAR & with attached piping layout in the vicinity of intake screen house....(1cy enci rc'd)

PLANT NAME: Three Mile Island Unit 1

March 10, 1977
GQL 0308

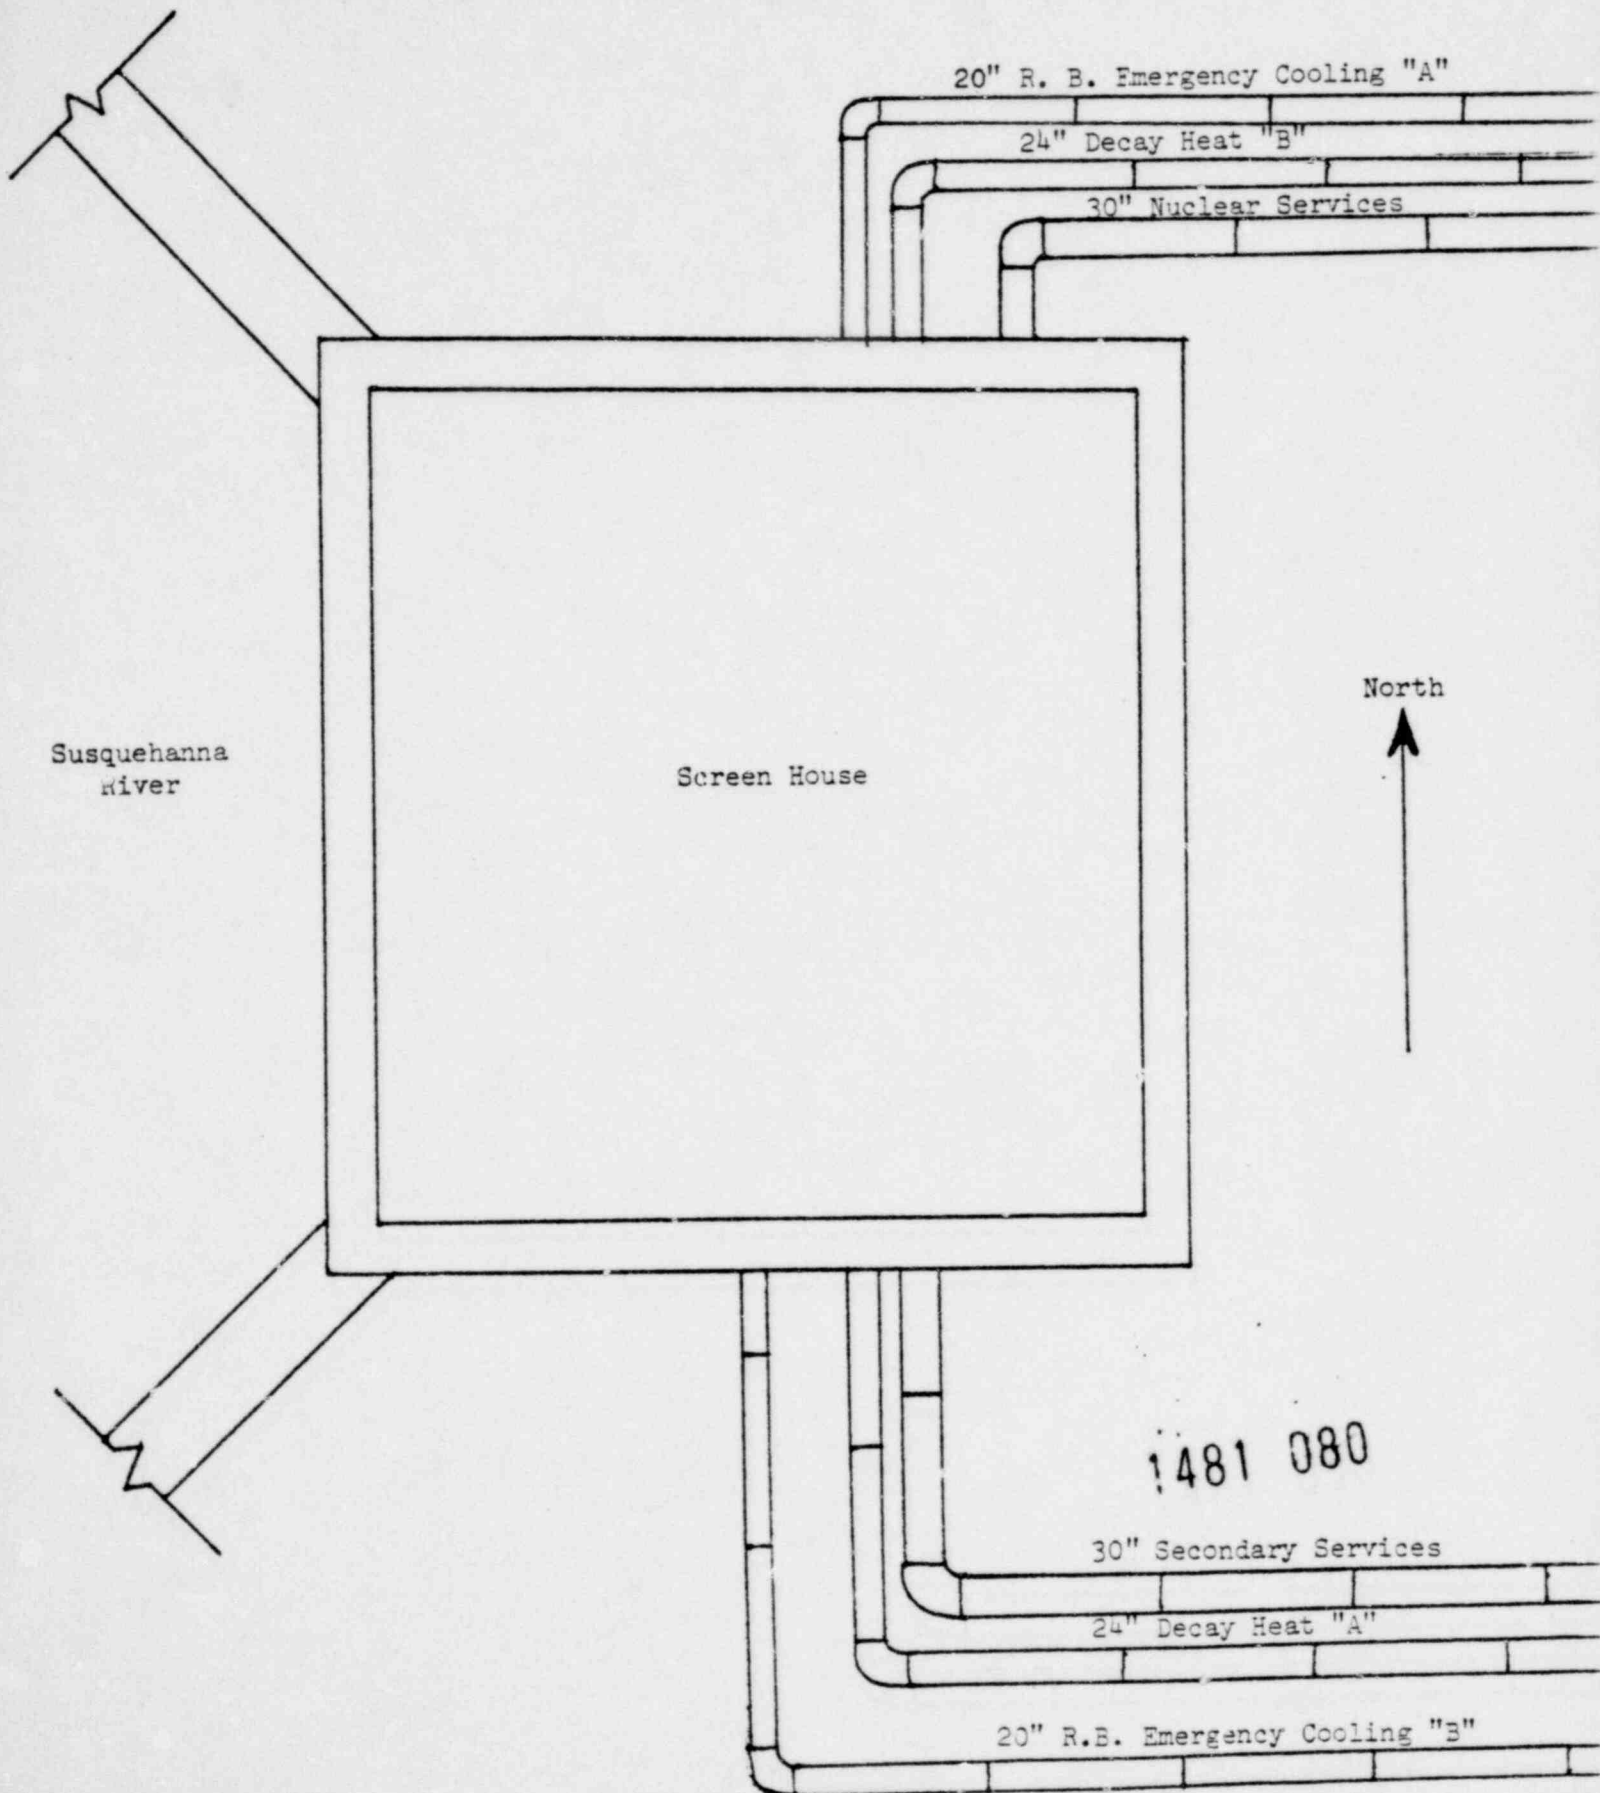
PIPING LAYOUT IN THE VICINITY OF INTAKE SCREEN HOUSE

There are six separate underground River Water pipe lines between the Intake Screen House and the Heat Exchanger Vault. These are all seismic class 1 with the exception of the 30" Secondary Services line which is seismic class 3. The attached sketch shows the layout of these lines in the vicinity of the Screen House. The 20" Reactor Building Emergency Cooling "A" line, the 24" Decay Heat "B" line, and the 30" Nuclear Services Supply line all emanate from the north side of the Screen House. Those which are to the south side are the 20" Reactor Building Emergency Cooling "B" line, the 24" Decay Heat "A" line, and the 30" Secondary Services line. All lines are constructed from lengths of prestressed concrete pipe having an embedded steel cylinder. All piping was supplied by the Price Brothers Company in accordance with the American Water Works Association (AWWA) Standard C301-64. Piping sections consist of either straight lengths or elbows, all joined by bell and spigot connections. The longest straight section being 20 feet.

It should be noted that the calculated overburden and seismic deflection was approximately 1/2 inch based upon proper soil compaction. The pipe deflections on the north side of the Screen House were 1.2, 4, and 6 inches due to thrust block settlement. As a result, the piping failed due to excessive stresses. The original analysis shows that such deflections would result in unacceptable levels of stress. There is, therefore, no reason to doubt the validity of the original calculational techniques. That is, if the required soil compaction exists under the pipes, stresses in excess of the original design calculations will not occur.

Our evaluation of the River Water pipe problems experienced indicated that in the area of the failed piping the required soil compaction did not exist. Because of this, test borings were taken on the south side of the Screen House where the underlying virgin soil was also removed and recompacted. This was done in order to establish the adequacy of the soil compaction in that area. These test borings showed that the soil compaction beneath the thrust blocks and piping was properly compacted.

The piping away from this immediate area of the Screen House was excavated from virgin soil and is therefore not considered to be susceptible to settlement. As a result, we concluded that settlement of the lines to the north of the Screen House was a singular and isolated case. As a result of the repairs performed on these north side lines, the previous piping stresses were relieved and all of these nuclear safety related lines now meet all seismic class 1 requirements.

As a result of the repairs performed on these north side lines, the previous piping stresses were relieved. Because of the increased flexibility of the replacement pipe sections for the failed 20" and 24" pipes, these lines can settle an additional 1" at the thrust blocks and still retain their seismic class 1 flexibility. The 30" line may experience settlement of 1/2" at the thrust block and still retain its seismic class 1 flexibility.
