ANNUAL OPERATING REPORT FOR 1978
AS REQUIRED BY THE TECHNICAL SPECIFICATIONS FOR THE
WESTINGHOUSE NUCLEAR TRAINING REACTOR
FACILITY LICENSE NO. R-119
DOCKET NO. 50-87

NTR DUMP TANK FILE

DUMP TANK REPAIR

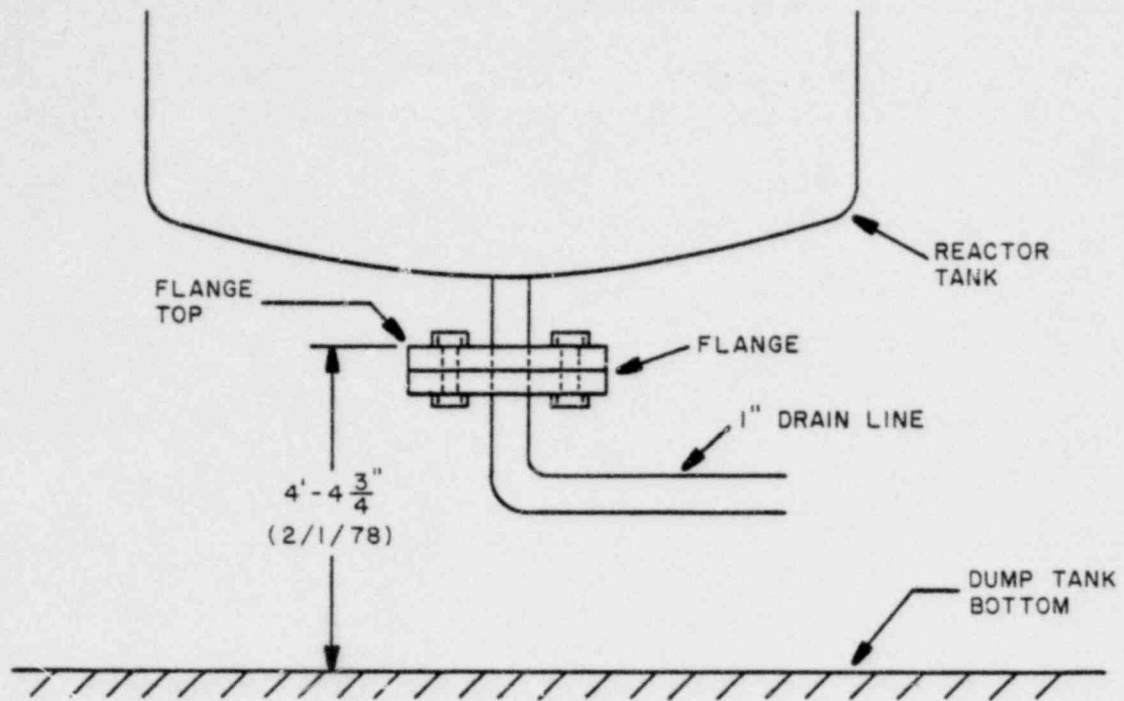
FIGURE 1

<u>Date</u>	<u>Activities</u>
January 13, 1978	Commenced removing the original bottom.
16	The original bottom was removed and cleanup of the crud commenced.
18	Cleanup of the concrete pad completed and the old sump removed.
19	Preparing the concrete pad to accept the backing bars and support pins.
26	Backing bars secured and welded in place.
30	New sump installed, tubular alumina and fine media in place. NSD QA present for inspection.
31	Commenced welding bottom plates to backing bars.
February 2	Commenced welding the circumference of the new plates. The first of three passes was completed. The bottom became sealed at this time.
6	Completed welding bottom plate in place.
7	Reinforced original weld segments on the tank bottom where previous joint seams existed. NSD QA present for visual inspection.
8	Measured the distance from the 1" drain flange to the tank bottom. Distance measured at 4' 4 3/4". (See Figure 1).

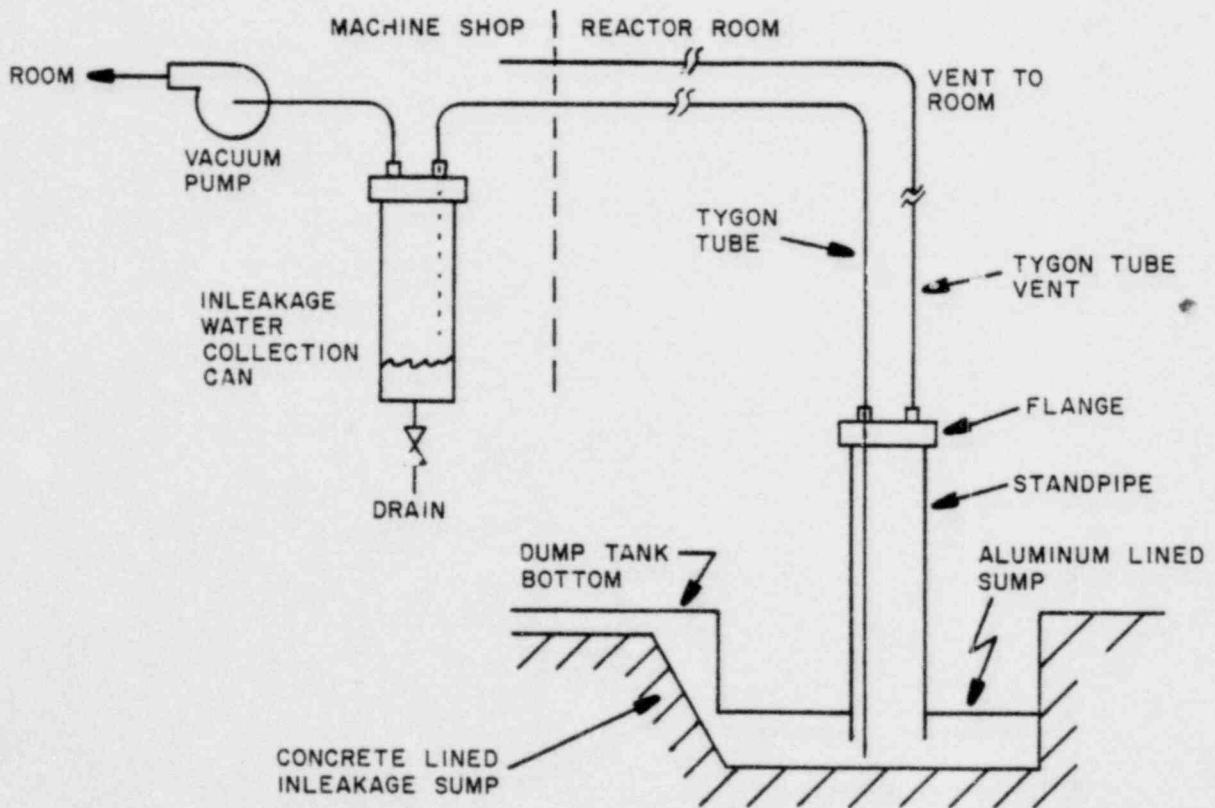
FIGURE 2

<u>Date</u>	<u>Activities</u>
February 9	Completed the ultra-sonic test. ¹ Commenced adding water to the reactor and dump tank.
10	Completed the "Helium bubble" test. ² Commenced surveillance testing. Pumped out the inleakage sump. (See Figure 2).
14	Completed testing and maintenance. Fuel loaded and reactor startup completed.
27	Notified NRC Region III, Jim Barker, of the completion of this project and the operating status of the facility.
