MCGUIRE NUCLEAR STATION

Report No.: SD-370/79-03

Facility: McGuire Nuclear Station - Unit 2

Identification of Deficiency: Westinghouse 4 KV Motors  
Defective End Finger Spotweld

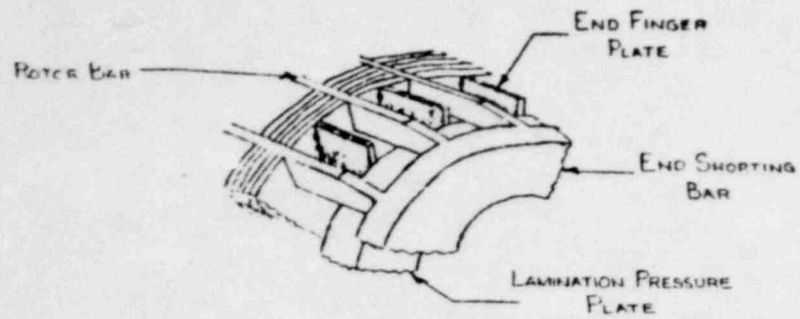
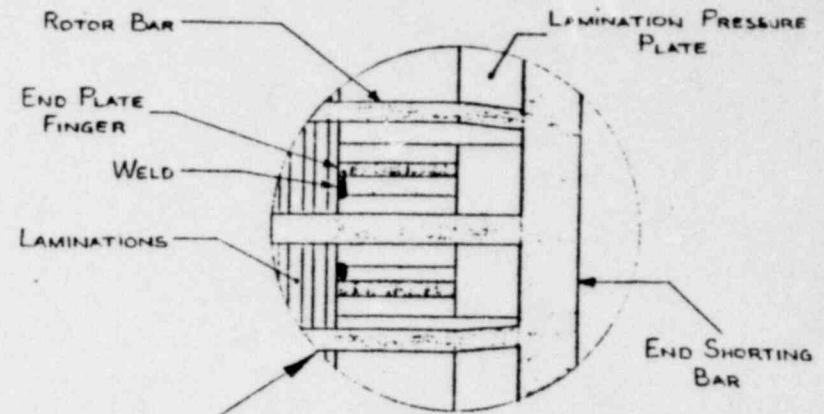
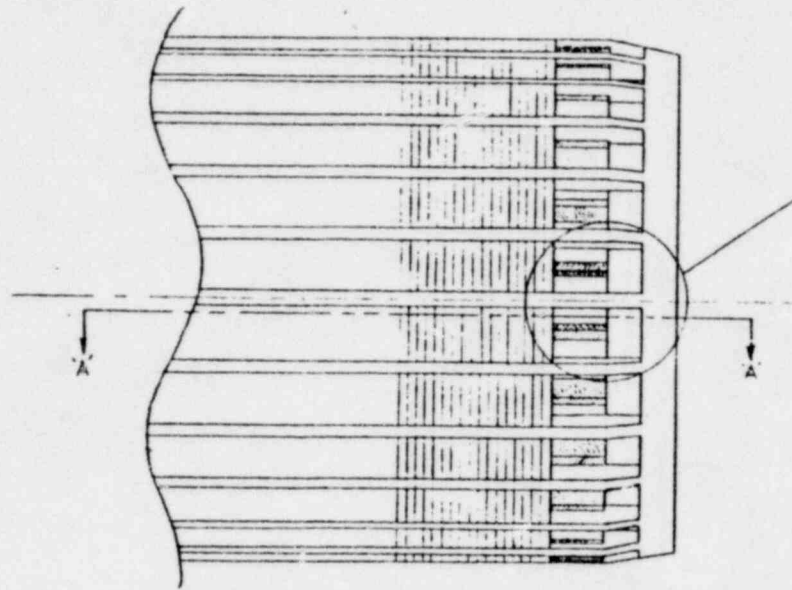
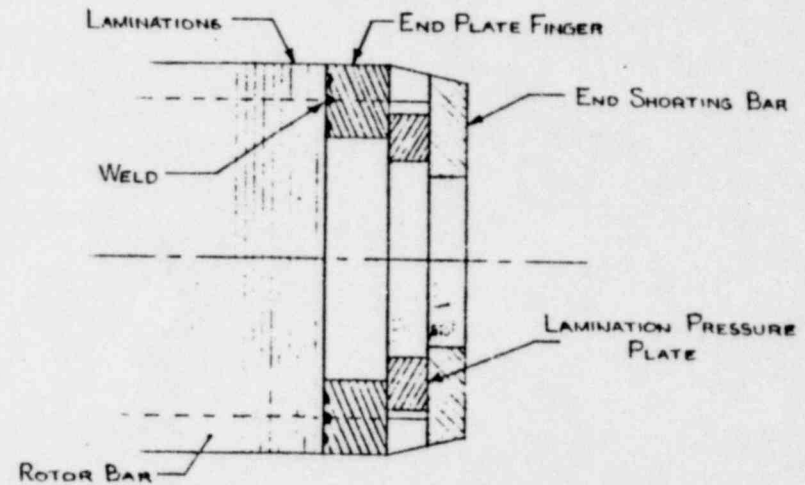
Sketch #1  
 SD-369-370/79-03

During replacement of an electrical lead on a 400 Horsepower, 4000 Volt Motor, at the manufacturer's maintenance facility, a lamination "end plate finger" from the rotor was found in the bottom of the motor's oil pot. These "end plate fingers" are straight rectangular metal pieces approximately 3 1/2 by 3/8 by 1/8 inches which are attached to the end lamination plate by three spotwelds. In addition, they are secured in place by a round lamination pressure plate which applies pressure through the plate fingers to the end rotor laminations. This is illustrated in Sketch #1. The end fingers are to prevent lamination separation at the circumference of the motor. On each end of this rotor, there are 79 slots where end fingers can be used for this purpose. An inspection of the rotor revealed 12 slots that did not contain the end plate finger, however, 11 slots had rotor bars that had been swaged. In instances where the installation of the end fingers during the manufacturing process does not conform to inspection requirements, (i.e. can be flexed by applying an external force which causes inferior welds to break) swaging of a limited number of the rotor bars outside of the last lamination is acceptable in lieu of the end fingers. During the inspection, all fingers on the rotor were tested by applying pressure to the finger's outer edge to determine if any fingers displayed any signs of looseness. Several fingers exhibited some degree of looseness and upon application of additional pressure, five other fingers broke completely loose and were removed. No damage was done by the loose fingers.

The manufacturer is to provide a new rotor for this motor. It is expected that this rotor will be received and installed by January 1, 1980.
