Battelle
Columbus Laboratories

Exhibit A to Report No. IE-116
by PARAMETER, Inc.
NRC Contract 05-77-186
PAR: NRC-IE-78/79, Task 03

EXAMINATION OF INCONEL
SAFE END FROM DUANE ARNOLD

January, 1979

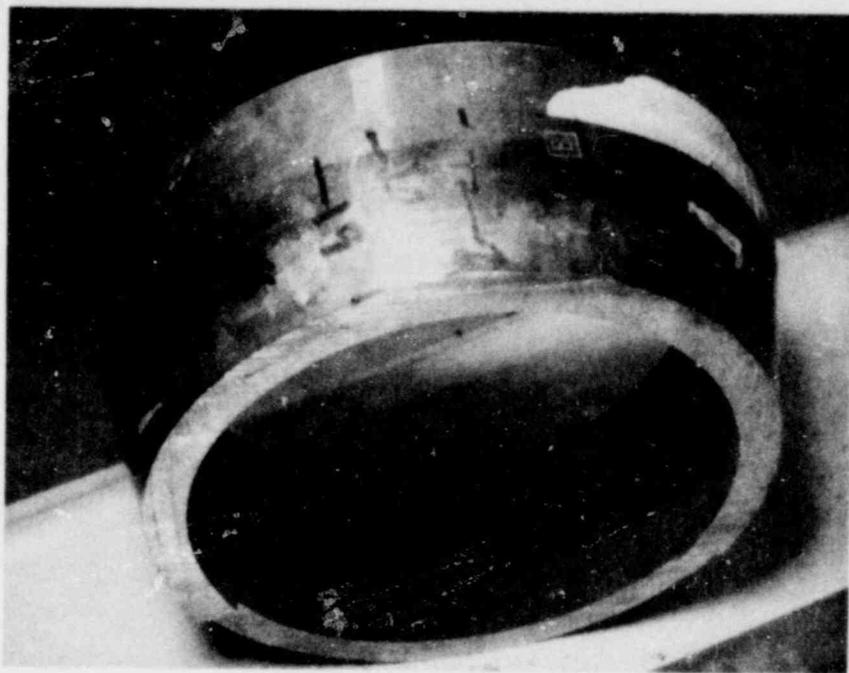
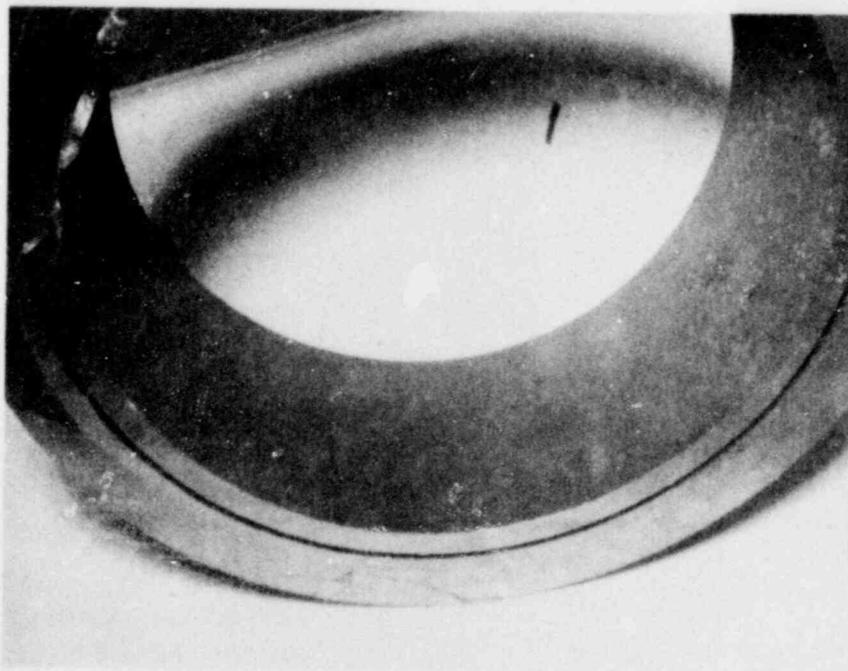
FIGURE 1. APPEARANCE OF DUANE ARNOLD INCONEL SAFE END IN THE AS-RECEIVED CONDITION

A visual examination of the sample was made using a magnifying glass. Care was taken not to disturb the deposits on the specimen surface. The outer surface of the specimen was relatively clean with azimuthal orientation marks 0-20 around the circumference of the safe end. These markings had been made with a felt tip marker and corresponded to the locations of radiography films.

In addition to these marks, the piece also contained a hose clamp containing the specimen identification number plate showing N2E. The location of the repair weld could be clearly seen on the outer surface. The inner surface of the specimen had a rust colored coating of loose powder. This powder could be easily scraped off. Careful examination of the inner surface failed to reveal any cracks. The as-received condition of the specimen was documented by photography in detail. Figures 1a and 1b show the appearance of the specimen.

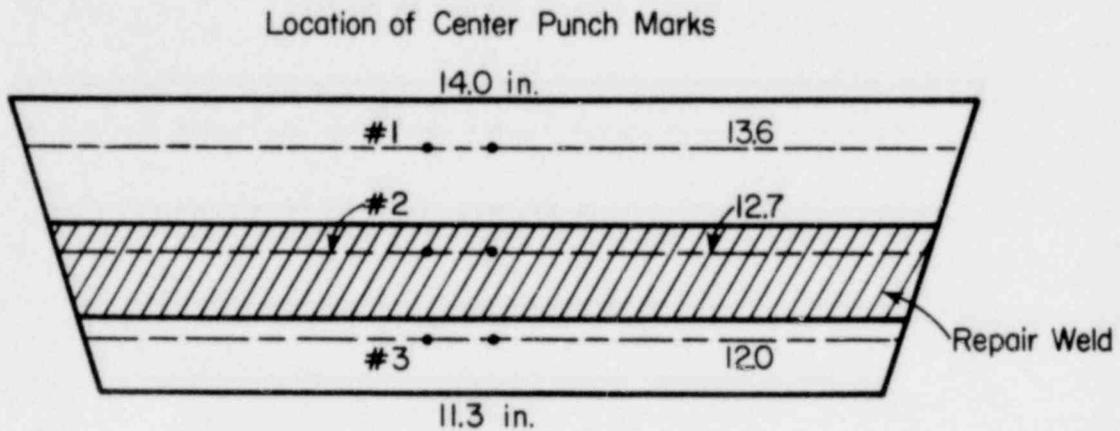
FIGURE 4. CHANGE IN OUTER CIRCUMFERENCE DURING SECTIONING OF DUANE ARNOLD SAFE END

While the first cut for Sample No. 1 was being made, it was found that the cut closed tightly and the band saw blade could not be pulled out. The frame was removed and the blade was left in the cut. A new blade was inserted and the second cut made. After completing this cut the sample had to be pried loose. The distance between the centerpunch marks was measured after the sample was cut out. The measurements obtained before and after are shown in Figure 4. Also shown are the locations of the marks.

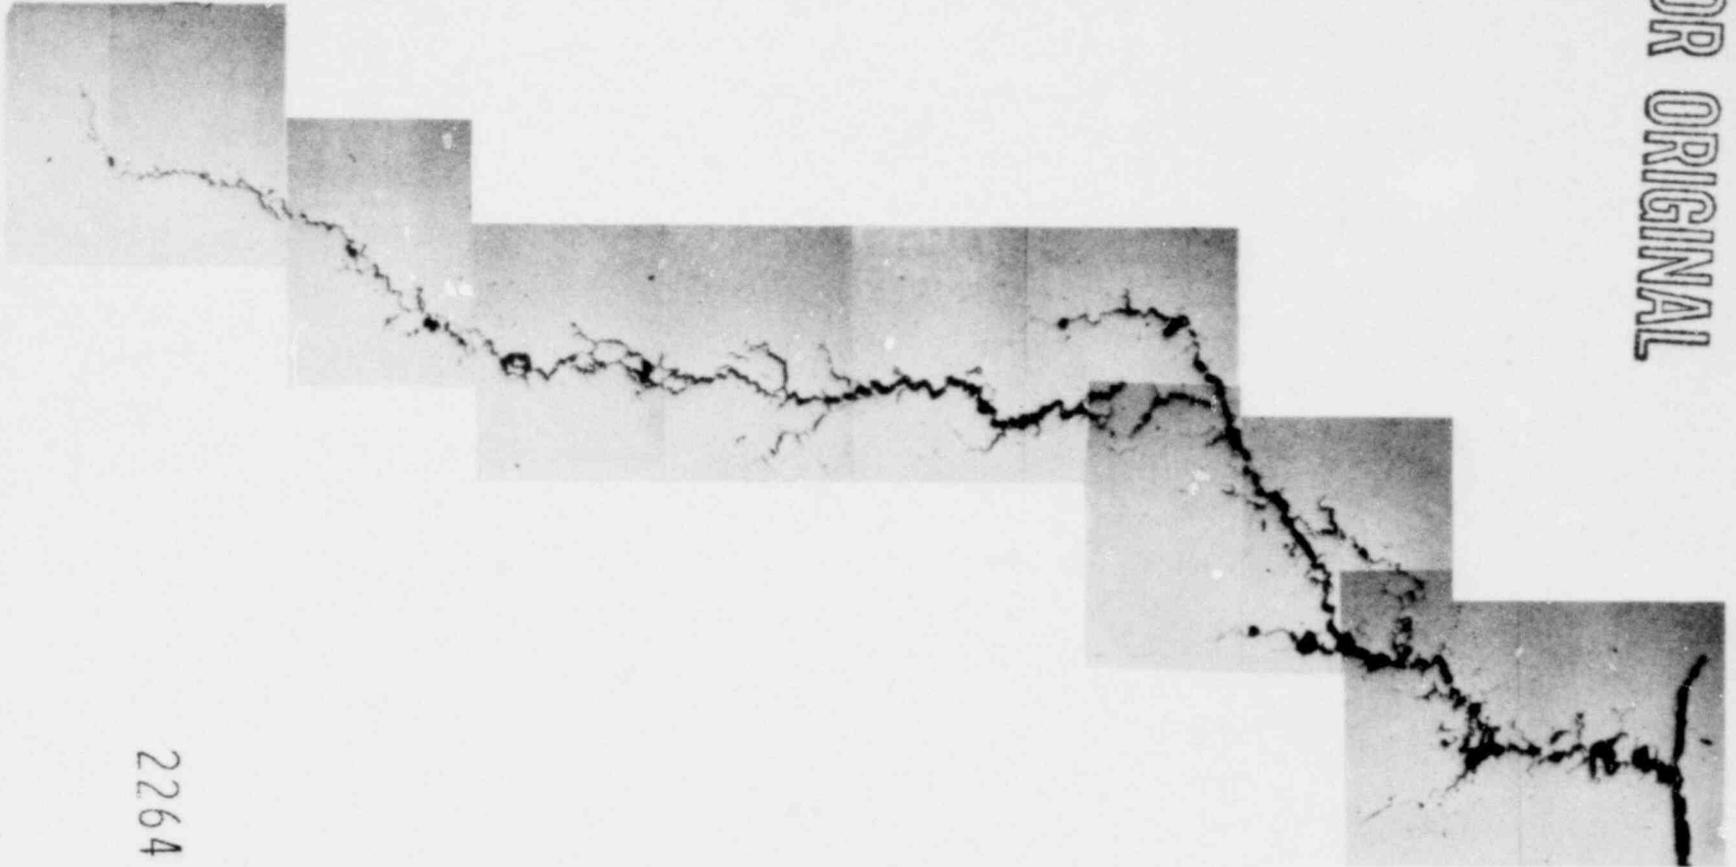
FIGURE 5. MICROGRAPH MONTAGE OF CRACK IN SAMPLE 2

All three samples contained cracks. The cracks were all intergranular in nature. In all samples, the initiation site of cracks was in the region of tight crevice between the sleeve and the safe end and radiated outward. The length of the tight crevice was found to be in the range 0.2-0.3 in. and the width was 0.002-0.005 in. No cracks were observed in the sleeve. In Samples 2 and 4 some grey areas were observed adjacent to tight branches of the cracks. These areas appeared to be of different composition. Similar areas were also observed along "tunnels" radiating from the cracks. The source of this grey phase area is not known.

The crack did not penetrate through the cross section of the safe end in any of the samples examined. In Samples 2 and 3 the crack had penetrated approximately 80% of the wall. In Sample 4, which was obtained

from the opposite quadrant, the crack penetration was about 30%. The crack characteristics were documented by photography. Figures 5 and 6 show the results from Samples 2 and 4, respectively.

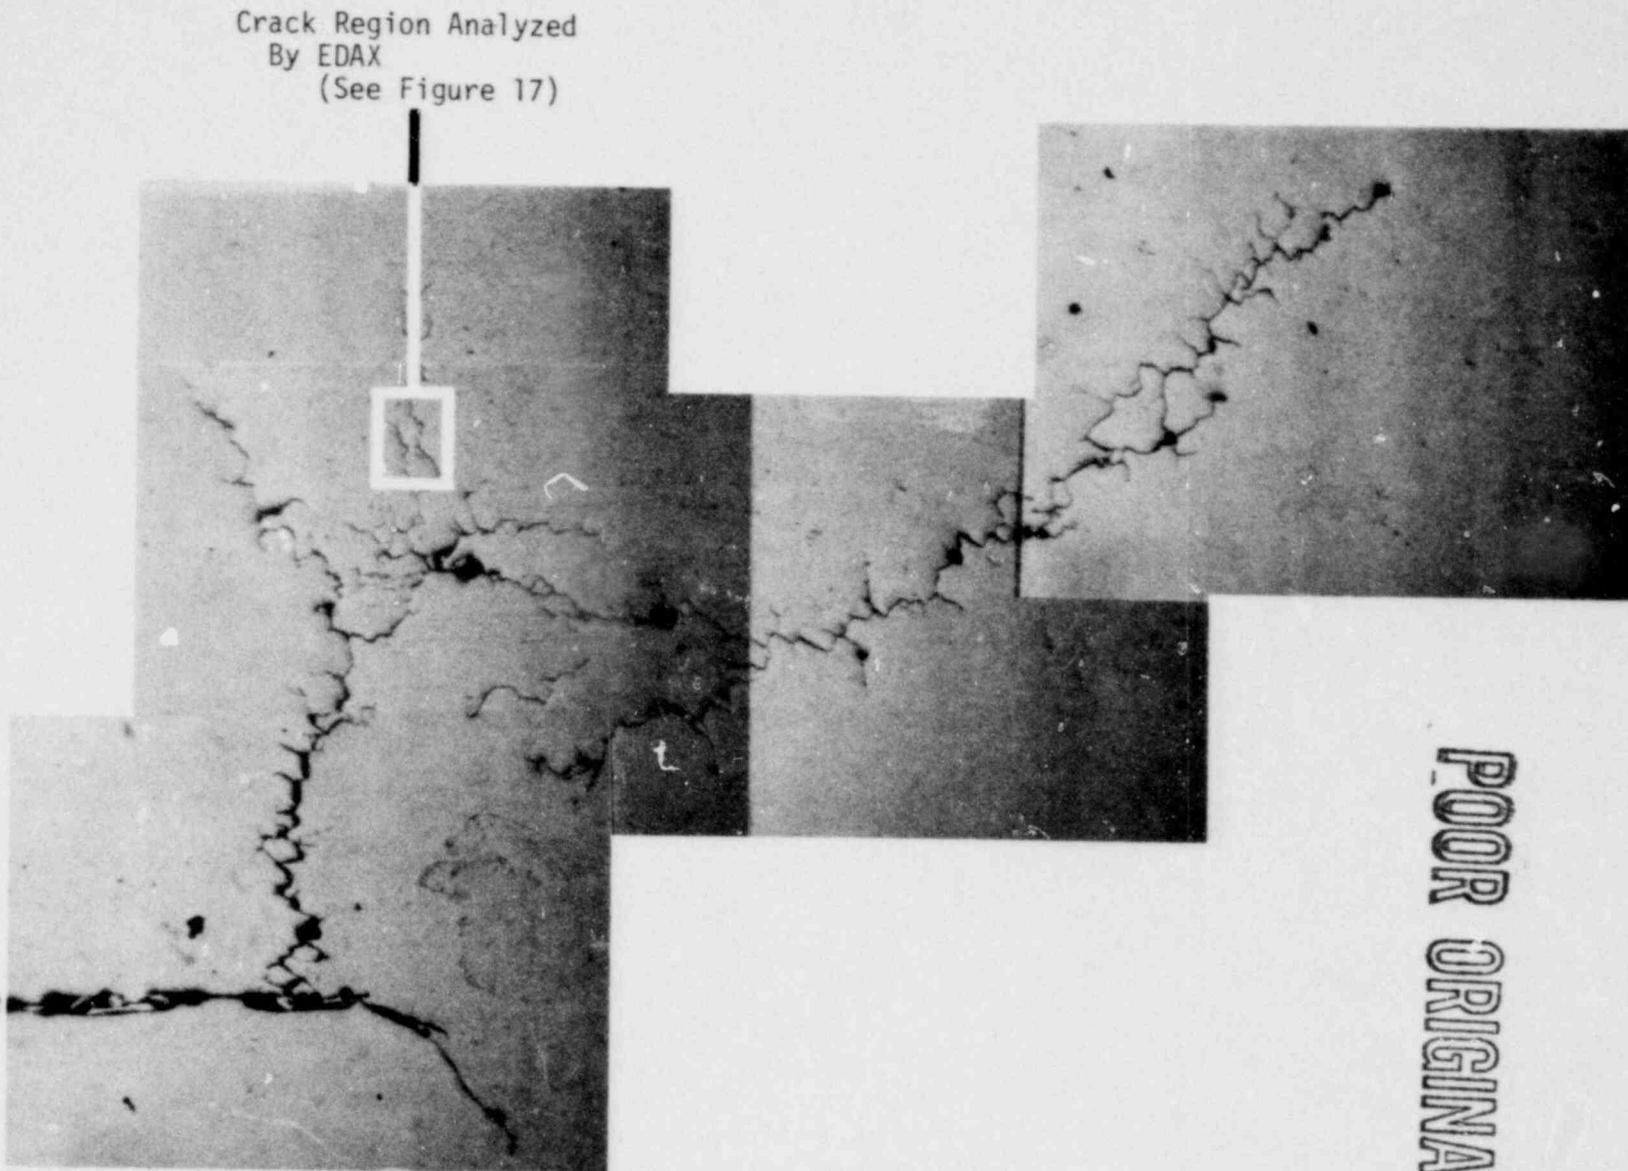
FIGURE 6. MICROGRAPH MONTAGE OF CRACK IN SAMPLE 4

2.7.1 Polished Samples, SEM Examinations. SEM examination and Energy Dispersive X-Ray Analysis (EDAX) of the fractures and fracture areas of Samples 2 and 4 provided several interesting results. As can be seen from Figures 5 and 6, the cracks observed in both samples contain numerous branches or tributaries. In addition, the cracks appear to originate in the weld heat affected zone at the crevice between the safe end and the thermal sleeve.

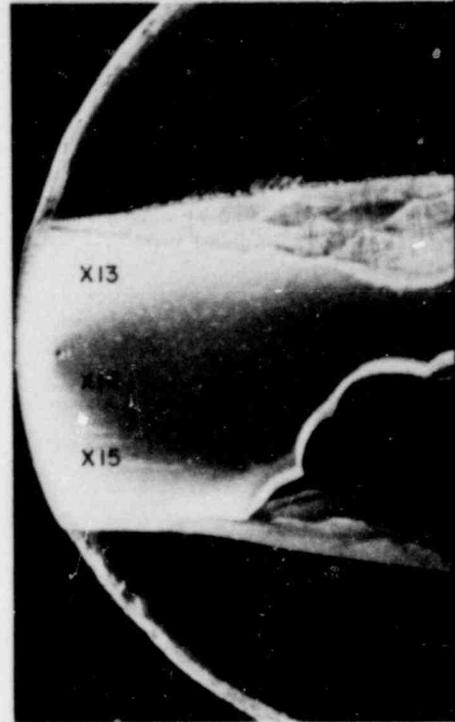
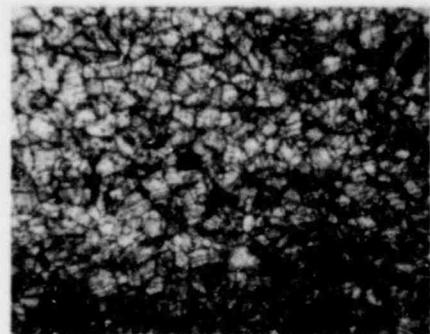
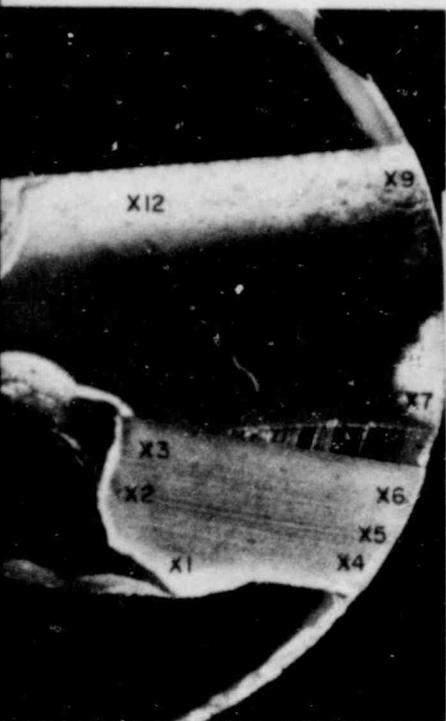
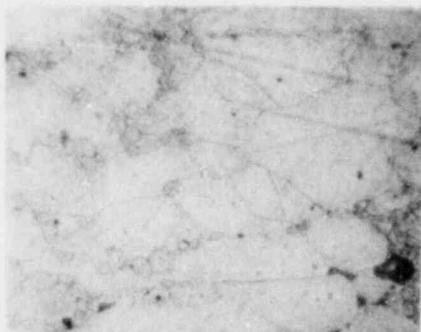
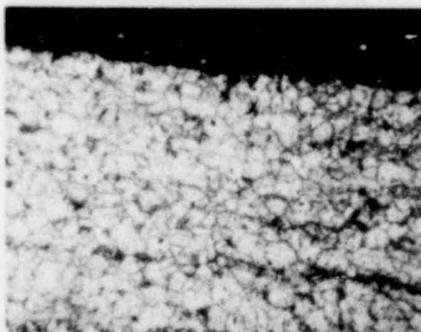
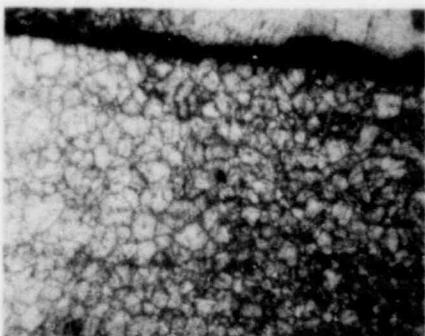
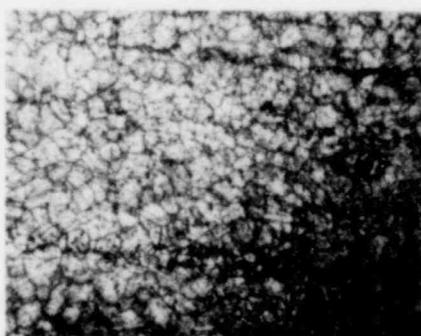
FIGURE 7. TYPICAL MICROSTRUCTURES AT VARIOUS LOCATIONS OF SAMPLE 3 CROSS SECTION

Sample 3 was examined in detail to characterize the microstructure of various parts of the sample. Figure 7 shows the results. The photomicrographs show that no major abnormalities are apparent in the microstructure of the safe end with the exception of sensitization near the sleeve to safe end weld. However, it appears that the thermal sleeve is sensitized (as evident from carbides precipitated at grain boundaries) rather uniformly even away from the weld.

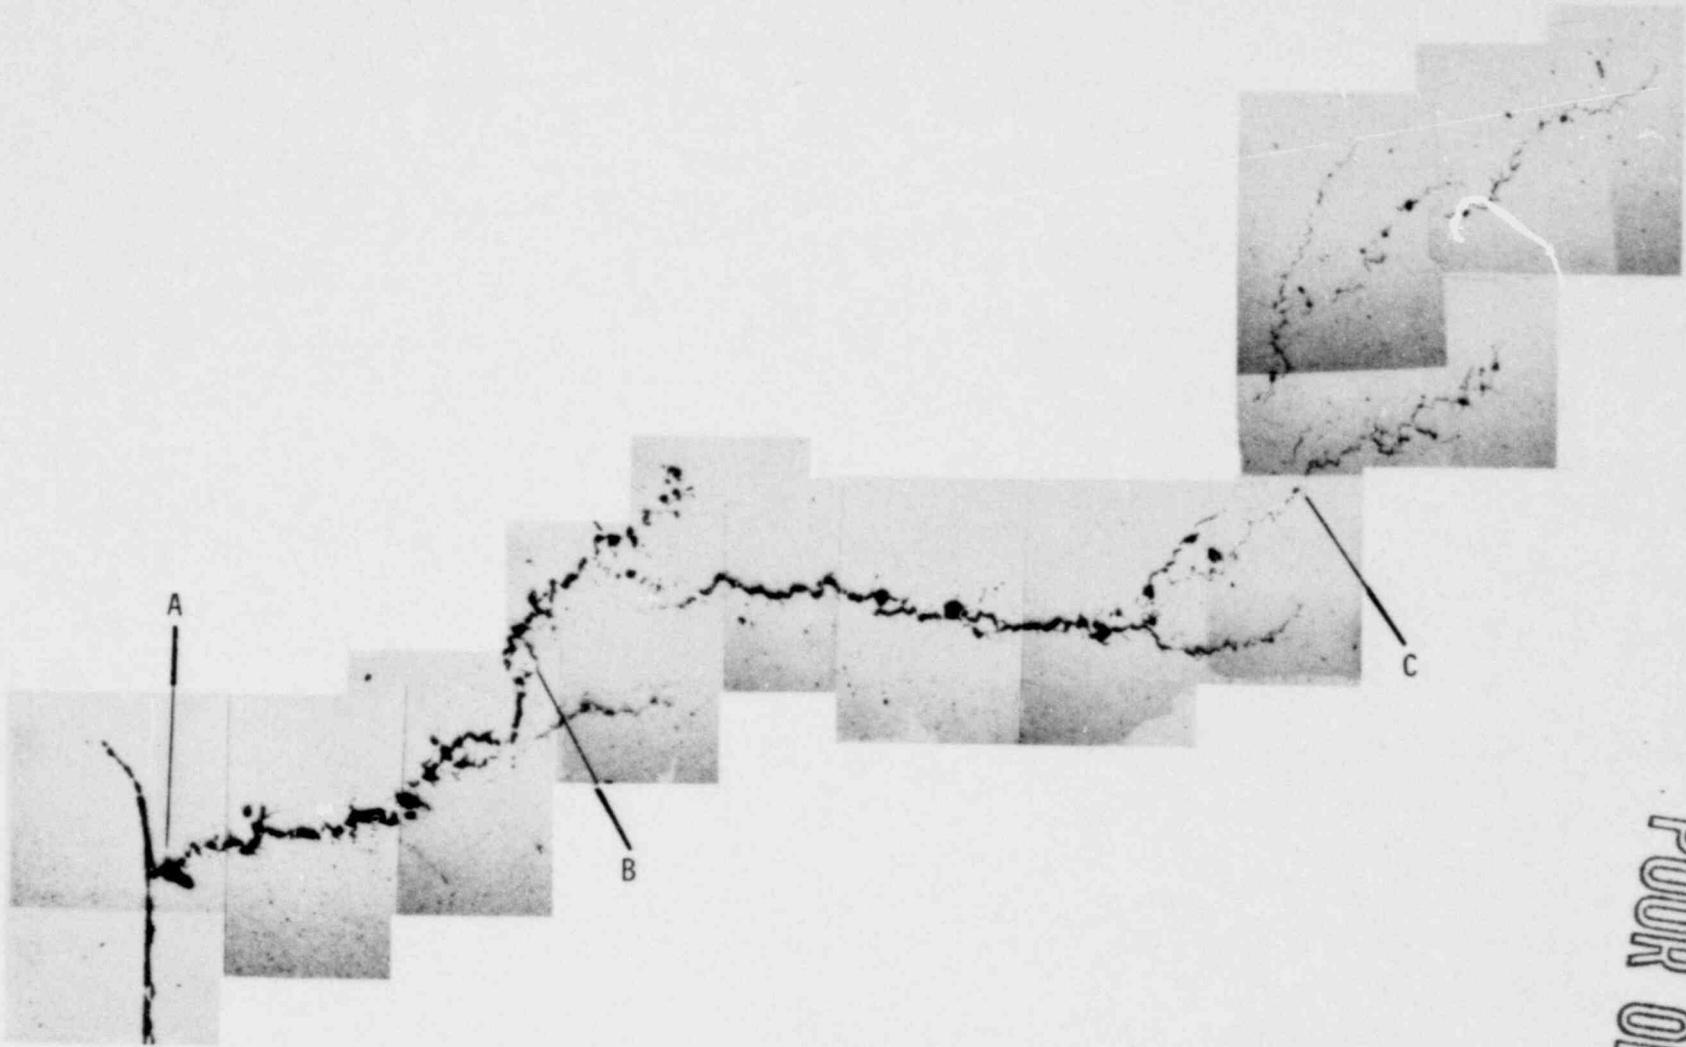
FIGURE 8. MICROGRAPH MONTAGE OF CRACK IN SAMPLE 3 AFTER ETCHING
Details of areas labeled A, B, and C are presented at
higher magnification in Figures 9 and 10.

Sample 3 was subsequently reprepared and etched with a mixture of 20 ml H_2O , 20 ml HNO_3 , and 80 ml HCl . The purpose of this procedure was to clearly identify the location of the crack with respect to the weld and heat affected region. With this technique, the crack initiation site was found to be in the re-solution treated region of the heat affected zone. Figures 8 through 10 show details of the crack location and crack characteristics.

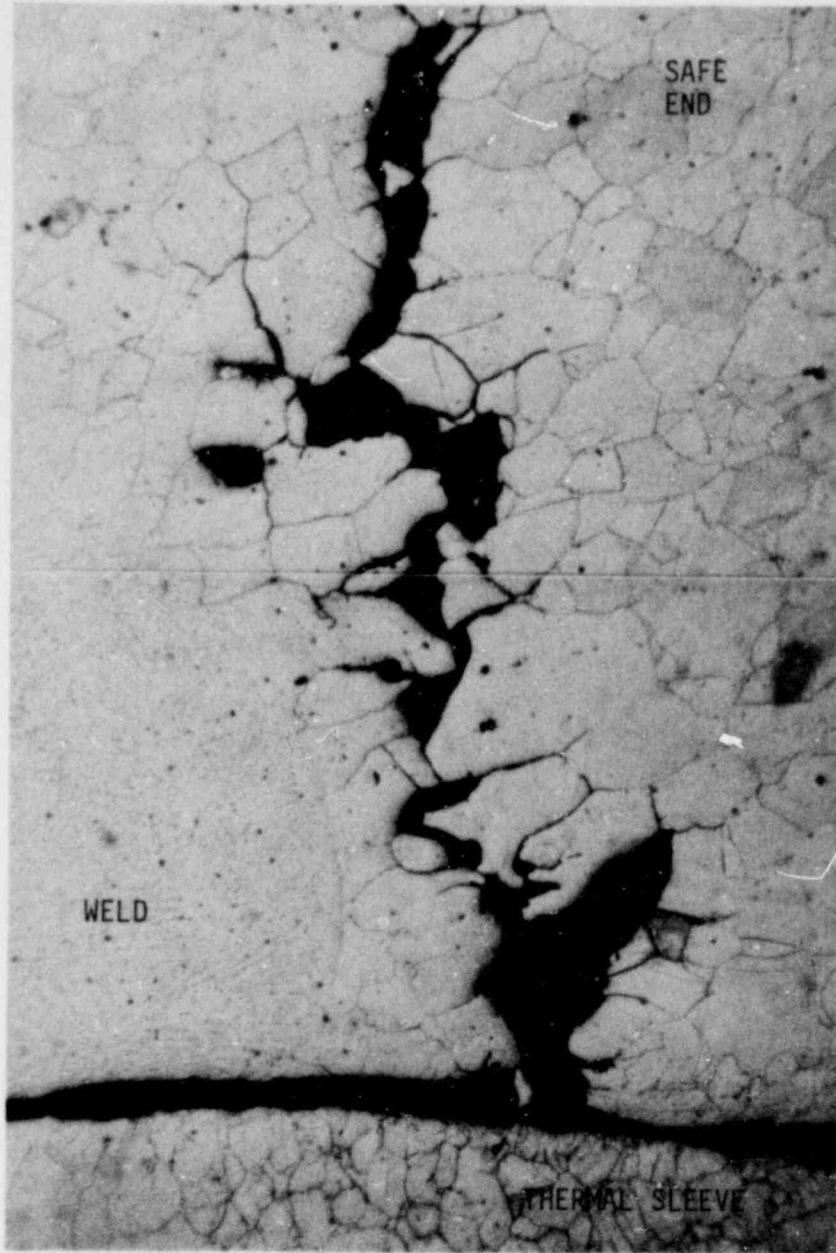
FIGURE 9. MICROGRAPH OF AREA A ON FIGURE 8 FROM ETCHED SAMPLE 3

- In all samples, the crack originated in the crevice between the sleeve and the safe end and radiated outward. No cracks were observed in the sleeve.
- The location of the cracks in all cases were in the re-solution treated region of the heat affected zone of the weld joining the safe end to the sleeve. See Figures 9 and 11.

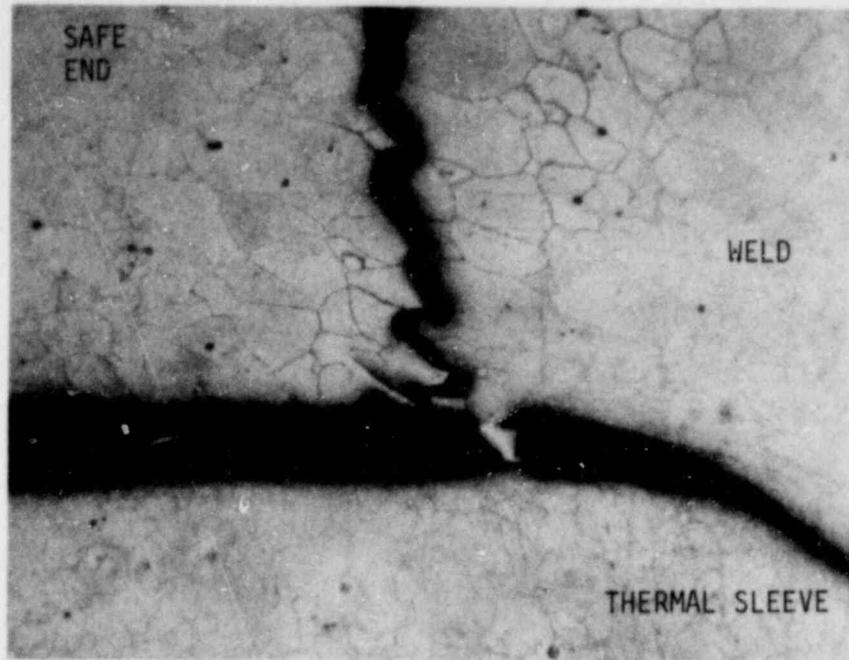
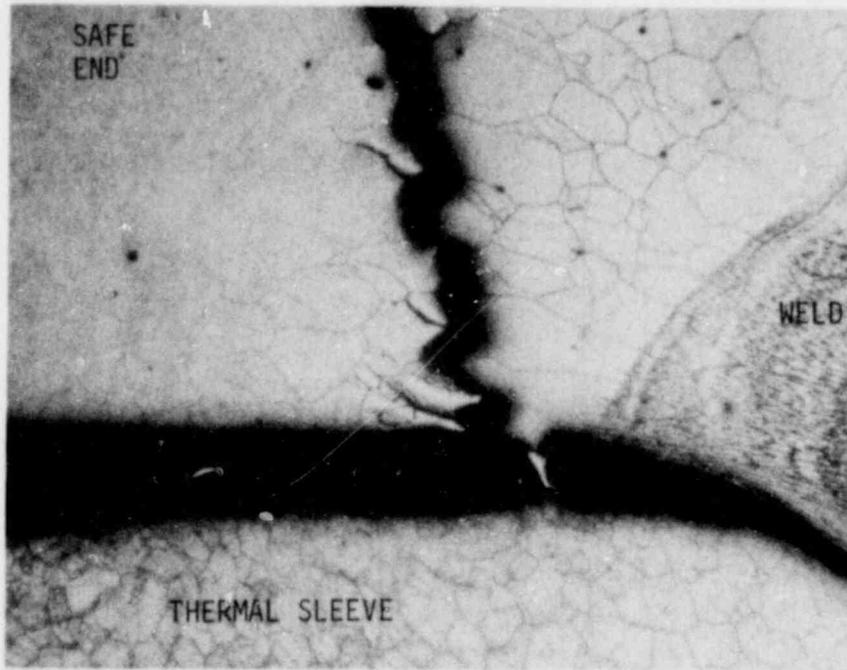
FIGURE 11. MICROSTRUCTURE OF THE CRACK INITIATION SITE IN SAMPLE 4

In order to further characterize the extent of sensitization of the safe end in the vicinity of the crack, sample 4 was repolished and electrolytically etched with 10% Nital. This procedure is expected to show grain structure in the material regardless of the degree of sensitization. After examination, the sample was repolished and etched electrolytically with a 15% solution of phosphoric acid. This etching process preferentially attacks carbides in the grain boundaries and the matrix. Figure 11 shows a comparison of the microstructure at the crack initiation site with the two etching procedures. Examination of the photomicrographs shows that the sensitized region in the safe end is rather narrow and that the crack initiation site is located in the re-solution treated region adjacent to the weld. The thermal sleeve also appears to be sensitized to a greater extent in comparison to the safe end.

Additional experiments were carried out on sample 4 using modified glyceresia as the etchant. The etching solution consisted of 10 ml HNO_3 , 10 ml acetic acid, 20 ml HCl and 30 ml glycerine. This process was expected to delineate chromium depleted regions along grain boundaries.⁽¹⁾

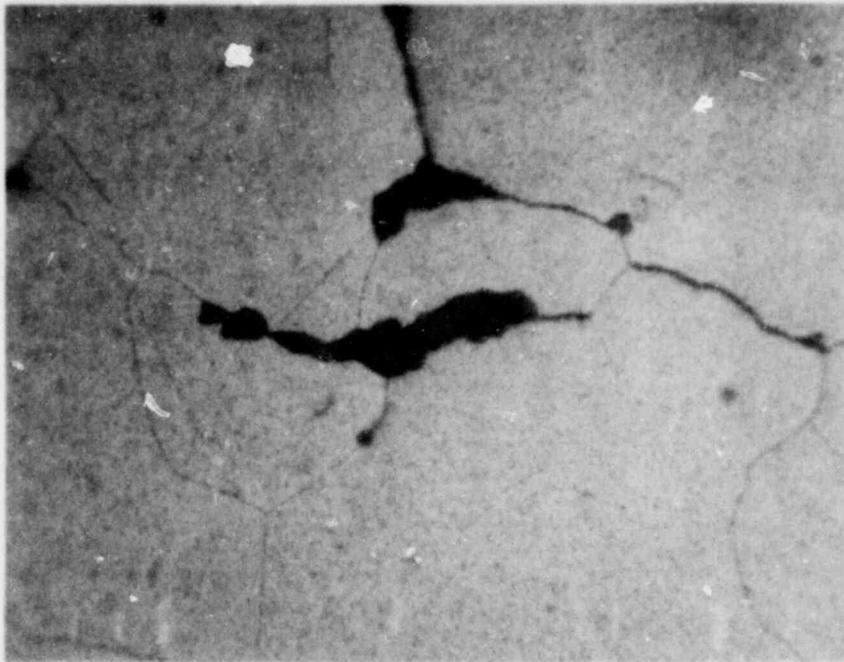
FIGURE 12. APPEARANCE OF THE GREY PHASE ADJACENT TO A TIGHT CRACK BRANCH

Examination of the specimens showed extremely narrow and barely discernible regions (probably chromium depleted areas) in the relief adjacent to the grain boundaries in the heat affected region. Initially, it was planned to analyze this region using the scanning electron microscope to determine if the composition was different from the grain matrix. This plan was abandoned because of the difficulty in discerning these regions. The etching procedure, however, was found to define more clearly areas previously identified as grey phase. Figure 12 shows one such area in the sample.

Sample was etched with aqua regia glycerine and acetic acid mixture to reveal chromium depleted regions.

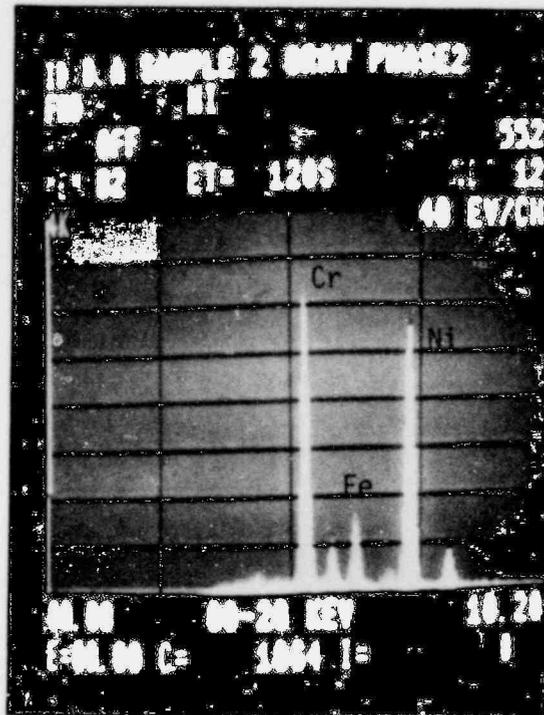
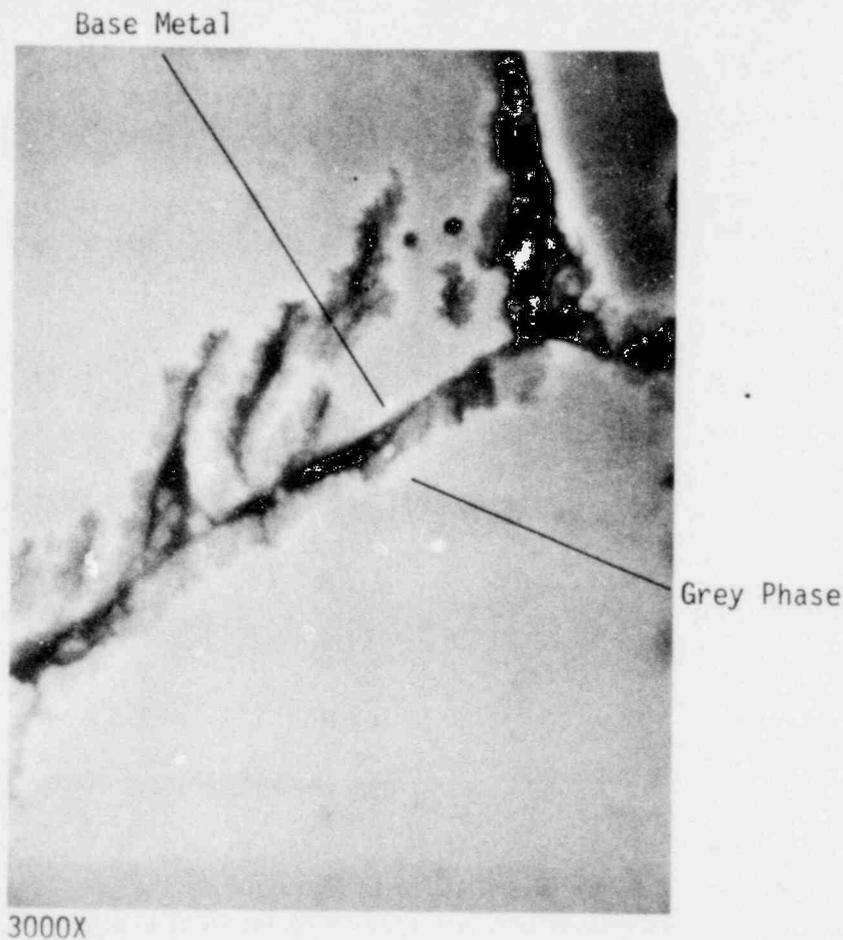
FIGURE 16. SEM MICROGRAPH OF GREY PHASE AND CORRESPONDING EDAX ANALYSES OF BASE METAL AND GREY PHASE

SEM examination of many of the tight crack tributaries in Samples 2 and 4 indicated that a phase different from the Inconel base metal was present directly adjacent to the crack. A typical SEM micrograph of this phase with its corresponding X-ray spectrum is presented in Figure 16. EDAX analysis indicated that this grey phase was chromium rich. The chromium enhancement of the grey phase was determined to be approximately 60-80% relative to the base metal material. In addition to the composition variation of the grey phase, numerous instances, of what appears to be transgranular tunneling (shown in Figure 16) were observed in areas where grey phase was found.

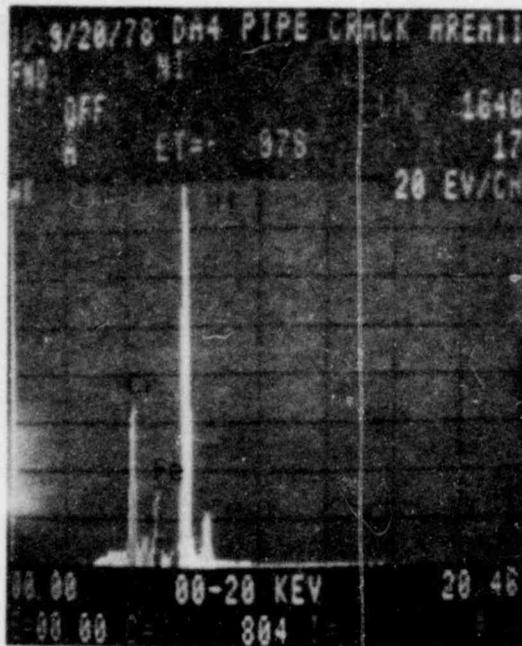
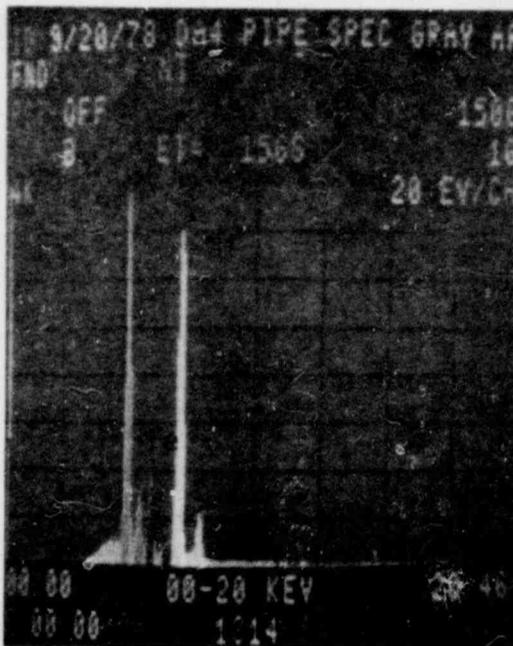
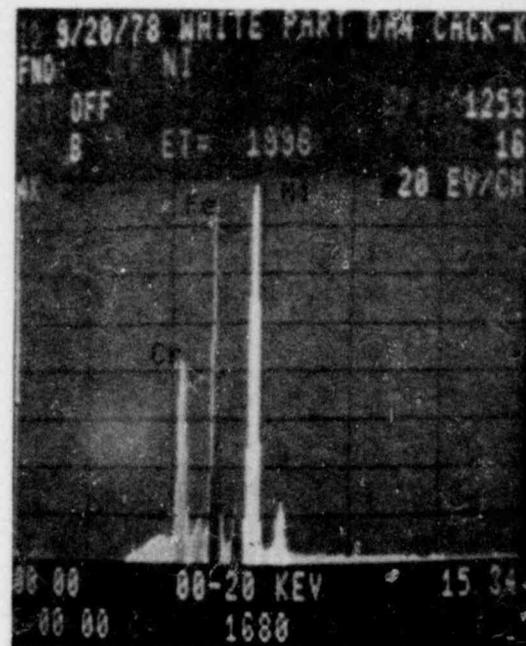
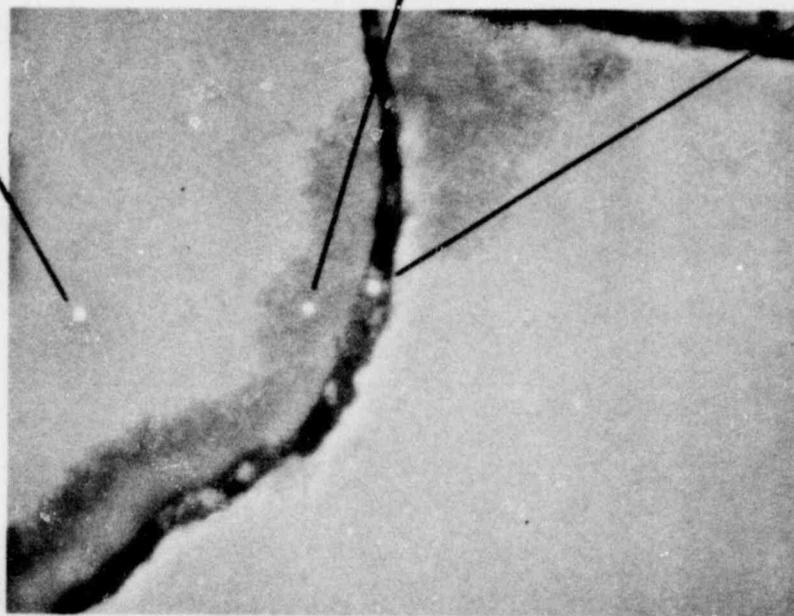
FIGURE 17. SEM MICROGRAPH AND CORRESPONDING EDAX ANALYSES FROM SAMPLE 4
 Area shown is located within the rectangular region highlighted in Figure 6

EDAX analysis of material observed within the crack both adjacent to the grey phase and in areas where no grey phase is found indicate an iron rich material relative to base metal compositions. Figures 17 and 18 present SEM micrographs and EDAX spot analysis performed well within the crack and at the crevice on Sample No. 4. As can be seen in Figure 17 the EDAX analysis of material within the crack indicates excessive iron relative to base metal analysis. However, no iron depletion can be observed in the material adjacent to the crack. EDAX analysis performed on material within the crevice (Figure 18) at a location near the crack origin indicate similar iron rich material. Comparison of the two relative iron contents from EDAX analysis at the crevice with analysis in the crack indicate a significantly higher iron content of material well within the crack.

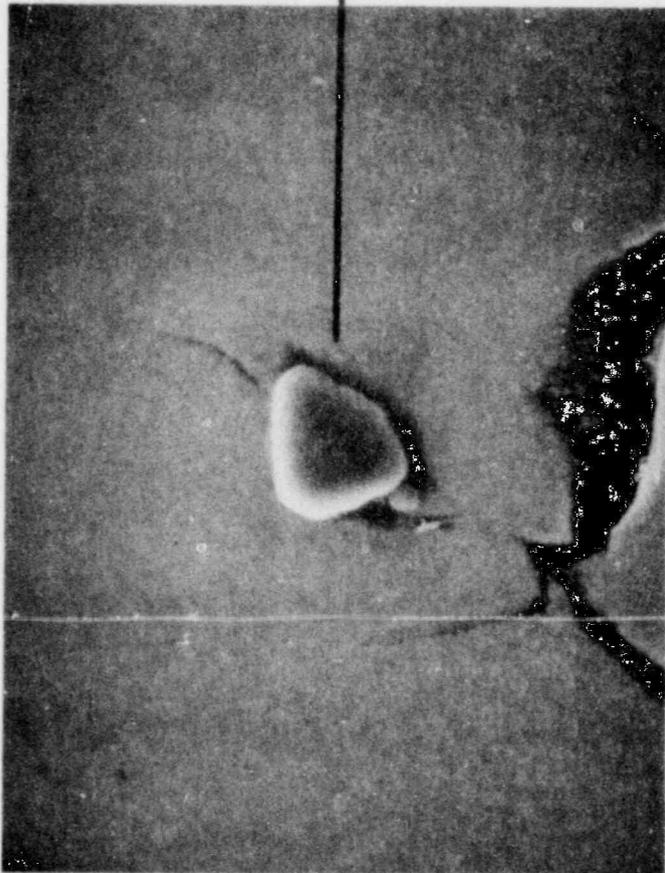
FIGURE 19. SEM MICROGRAPH AND CORRESPONDING EDAX ANALYSIS OF TITANIUM INCLUSION FROM SAMPLE 4

Numerous titanium inclusions were observed throughout the base metal on Samples 2 and 4. A typical titanium inclusion observed in Sample 4 is illustrated by SEM micrograph in Figure 19 in conjunction with its X-ray spectrum.

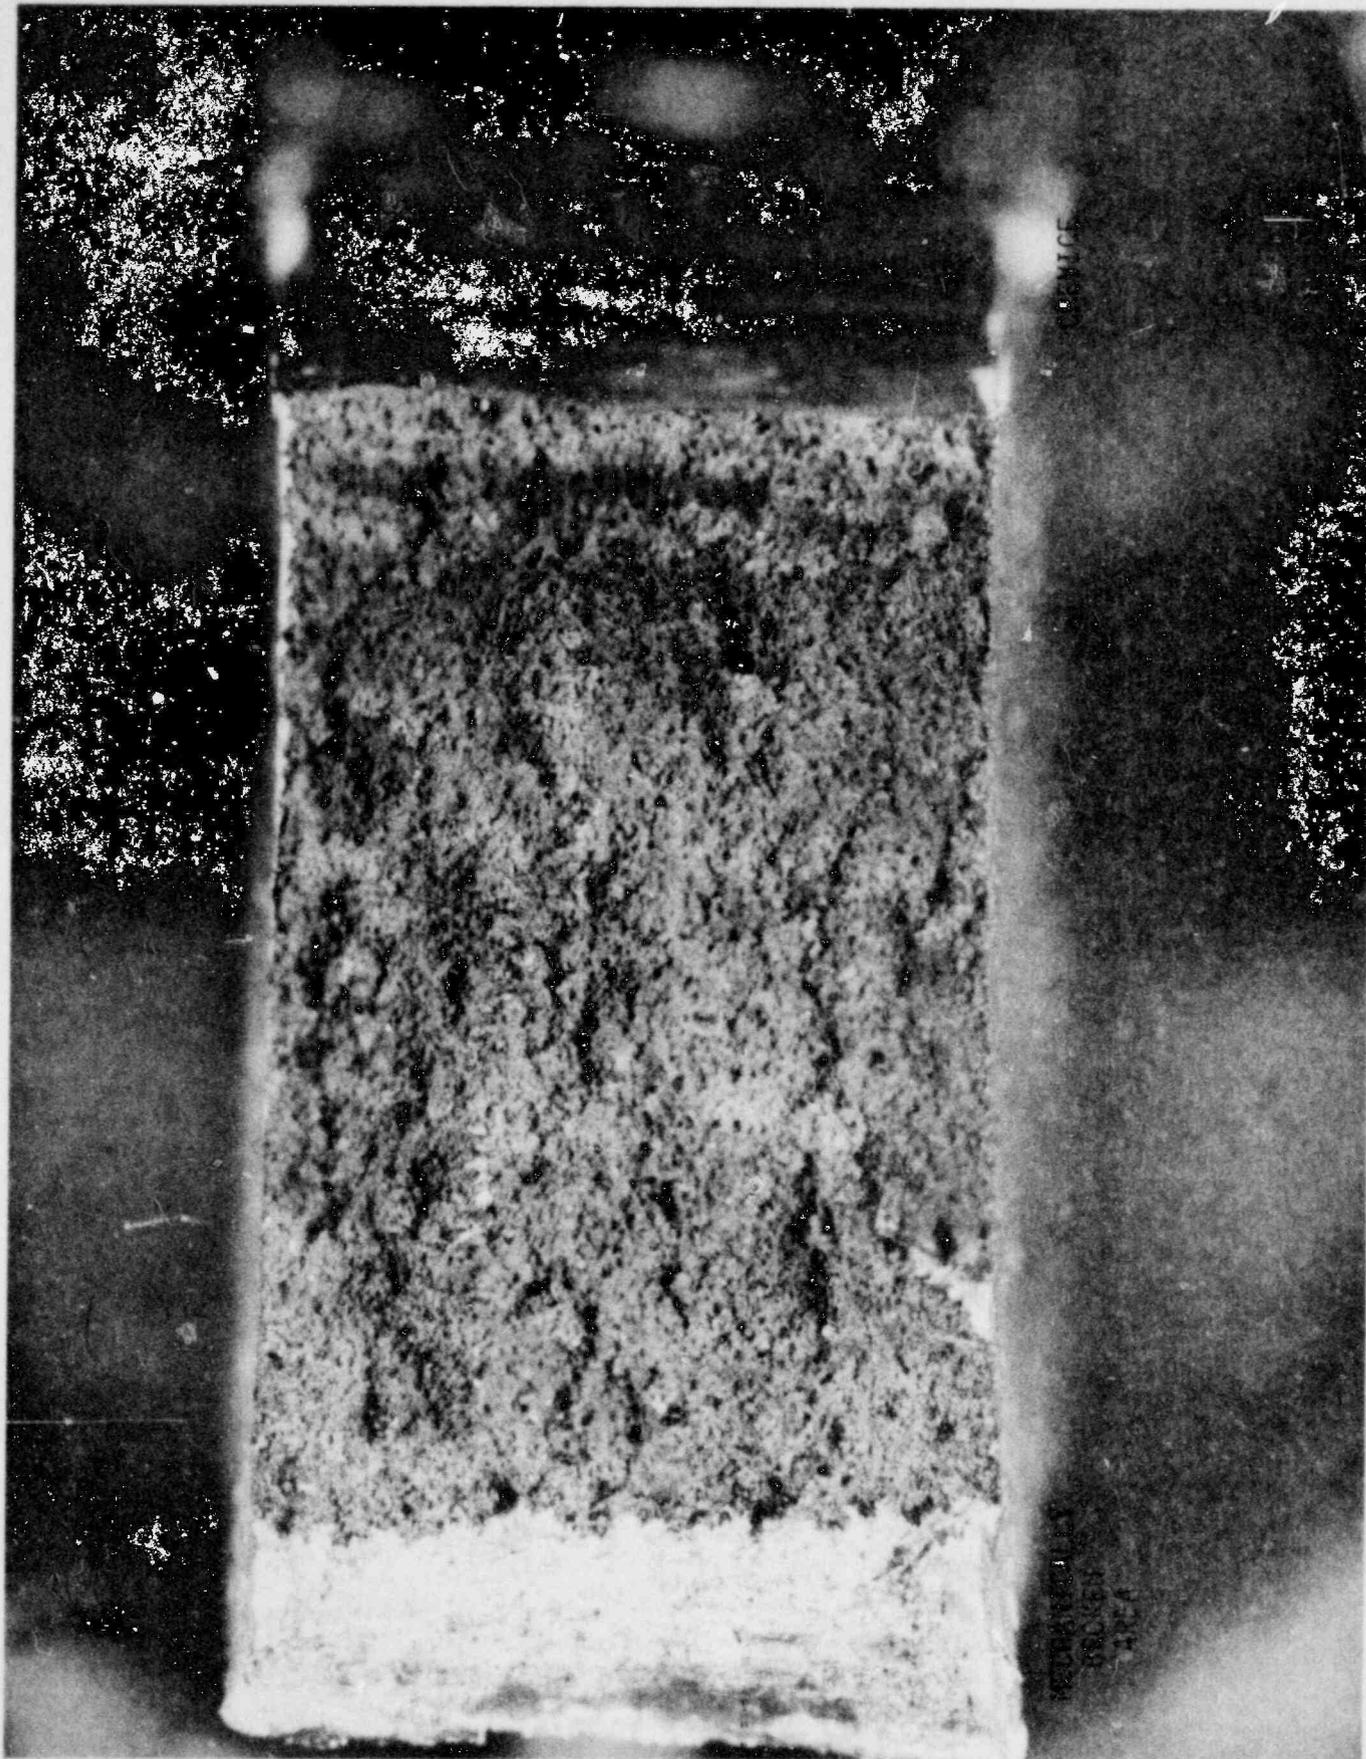
FIGURE 21. PHOTOMICROGRAPH OF FRACTURE SURFACE FROM SAMPLE 5

2.7.2 SEM Fractography. As stated previously, safe end Sample No. 5 was examined by SEM. Figure 20 presents a schematic of Sample No. 5 showing the fracture surface examined. In order to expose the fracture surface for examination the specimen was mechanically fractured. Figure 21 presents a photomicrograph of the fracture surface examined. The bright material to the left is the region of uncracked safe end wall thickness which was mechanically fractured. Examination of this region following fracture indicated the material to be ductile.

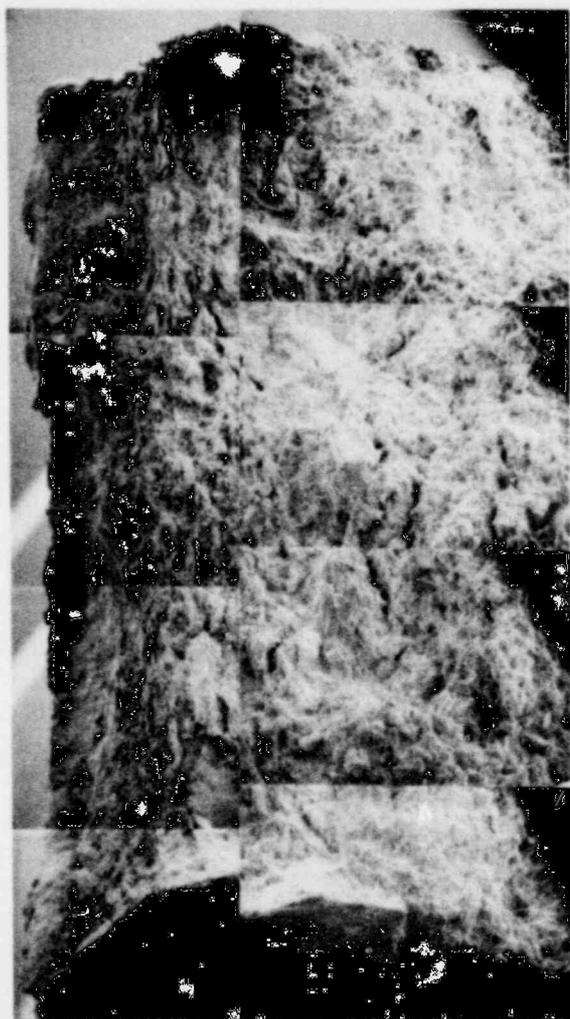
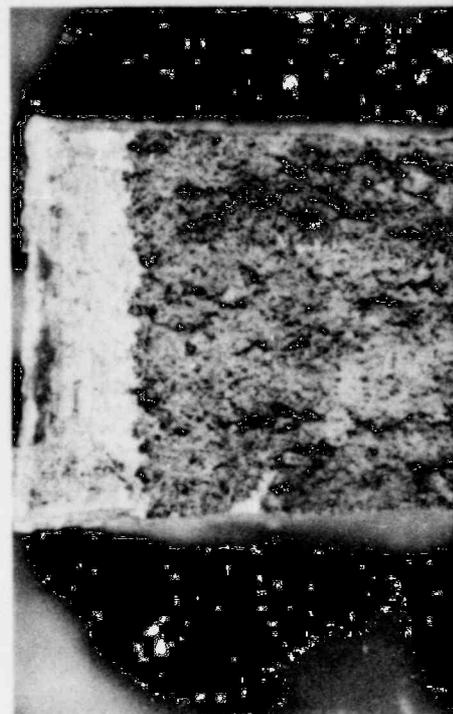
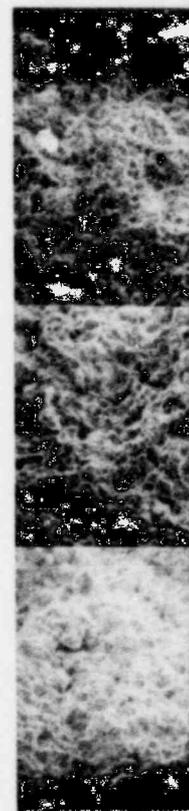
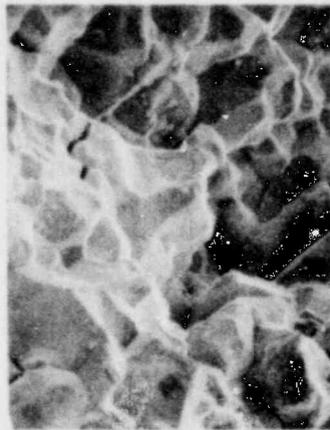
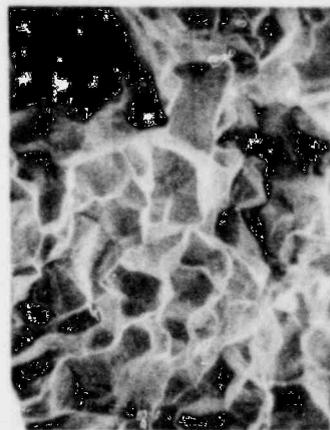
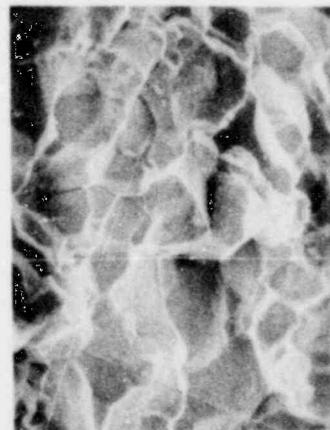
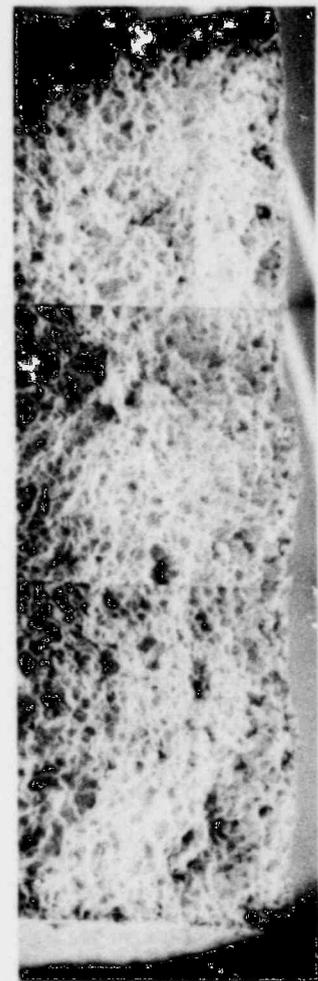
FIGURE 22. SEM MICROGRAPH MONTAGES OF SAMPLE 5 FRACTURE SURFACE (a) Crack Tip, (b) Mid Fracture, (c) Near Crevice

Detailed SEM examination was performed on the entire fracture surface. Figure 22 presents SEM fractograph montages at the beginning (near crevice) middle, and tip of the crack along the fracture surface. The mode of cracking, as indicated by the SEM fractographs, was intergranular fracture.

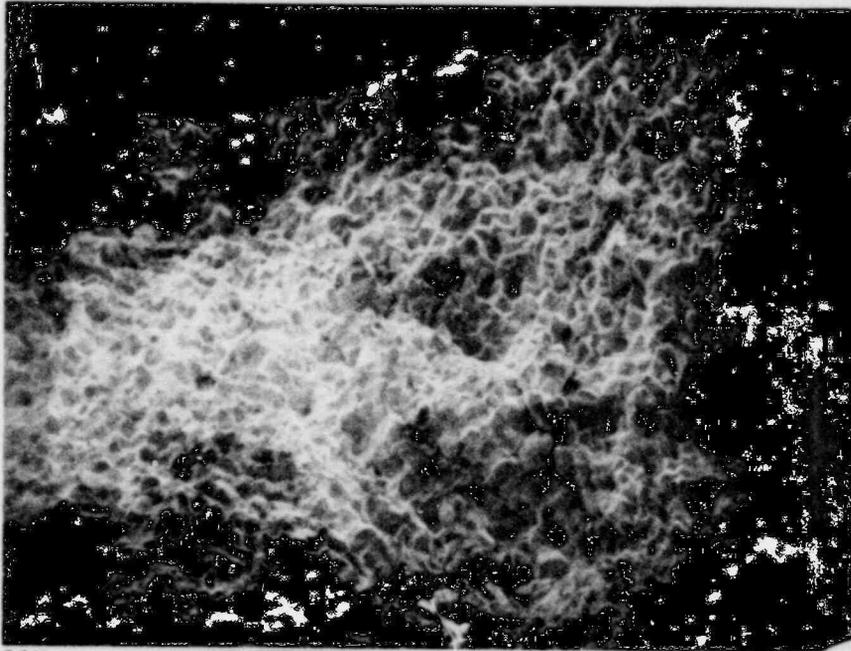
FIGURE 23. SEM FRACTOGRAPHS OF SAMPLE 5 NEAR CREVICE

Numerous EDAX analyses were performed on several areas of the fracture and crevice. Figures 23, 24, and 25 present SEM fractographs illustrating typical areas chosen for EDAX analysis (i.e., Figures 23b, 24a, and 25b present actual areas examined by X-ray near the crevice, in the middle and at the tip of the fracture, respectively). In addition, Figure 24b presents a SEM micrograph of a grain facet (from Figure 24a) showing a network of needle-like corrosion products on which a spot EDAX analysis was performed.

Results from EDAX analysis of Figures 23, 24, and 25 and other areas not shown indicate no significant variations from base metal composition. However, small amounts of sulfur were detected in almost all of the fracture and crevice EDAX analyses. Figure 26 presents SEM micrographs taken on the fracture surface near the crack tip. The crystalline material, magnified to 2000X in Figure 26b, was subjected to spot EDAX analysis. Results indicate high sulfur contents (-8 times greater than the highest sulfur content detected in area EDAX scans on the fracture surface). Similar crystalline structures were observed and analyzed on the crevice surface, and they too indicated relatively high sulfur content.
