Battelle
Columbus Laboratories

Exhibit A to Report No. IE-116
by PARAMETER, Inc.
NRC Contract 05-77-186
PAR: NRC-IE-78/79, Task 03

EXAMINATION OF INCONEL
SAFE END FROM DUANE ARNOLD

January, 1979

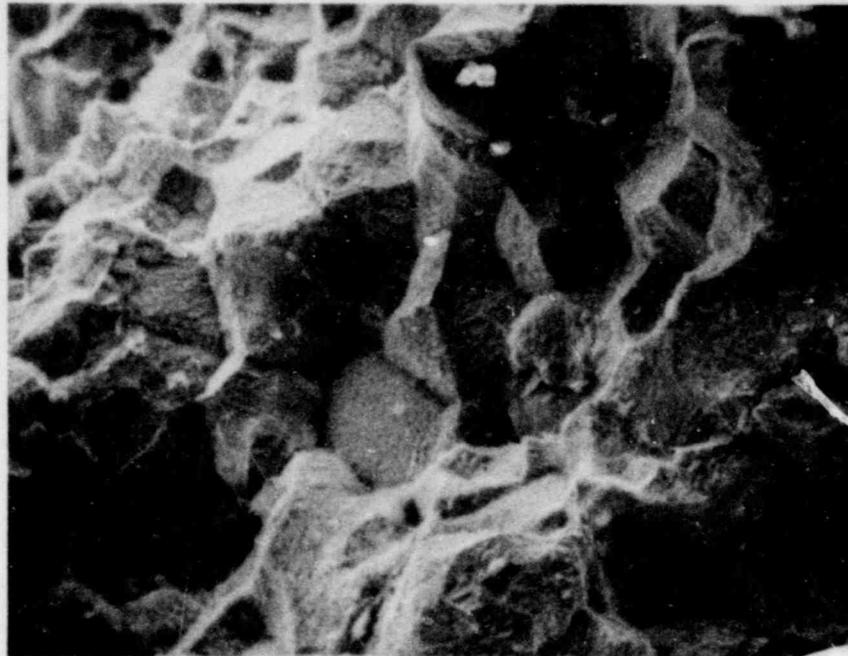
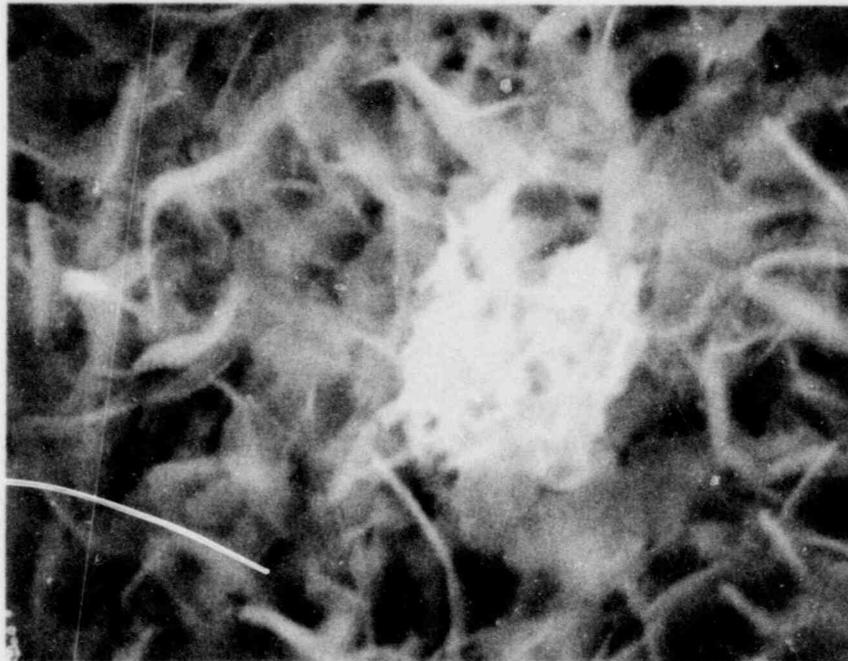
FIGURE 24. SEM FRACTOGRAPHS OF SAMPLE 5 AT MID FRACTURE

(b) Needle network of corrosion products on grain facet. Spot EDAX analysis indicated high sulfur content.

Results from EDAX analysis of Figures 23, 24, and 25 and other areas not shown indicate no significant variations from base metal composition. However, small amounts of sulfur were detected in almost all of the fracture and crevice EDAX analyses. Figure 26 presents SEM micrographs taken on the fracture surface near the crack tip. The crystalline material, magnified to 2000X in Figure 26b, was subjected to spot EDAX analysis. Results indicate high sulfur contents (-8 times greater than the highest sulfur content detected in area EDAX scans on the fracture surface). Similar crystalline structures were observed and analyzed on the crevice surface, and they too indicated relatively high sulfur content.

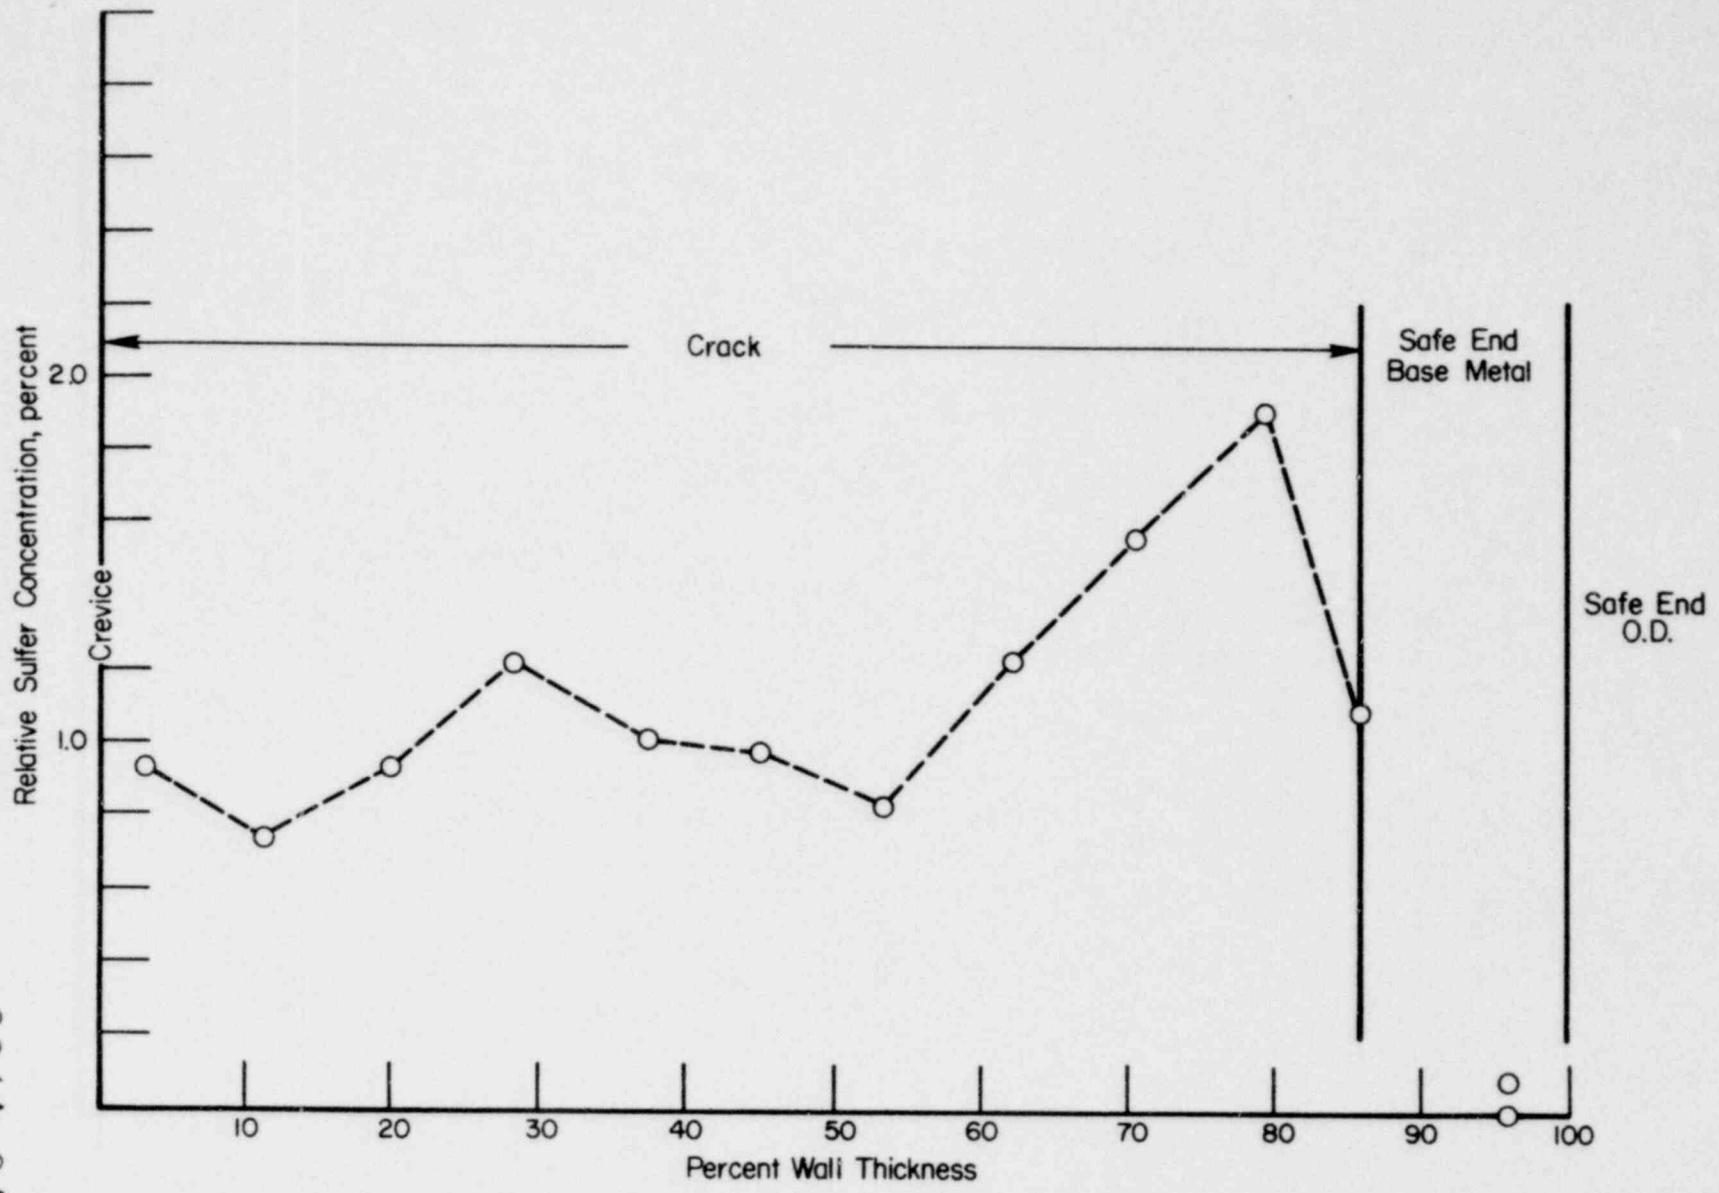
FIGURE 27. DUANE ARNOLD SAFE END SULFUR PROFILE ON FRACTURE SAMPLE No. 1

In order to characterize the sulfur distribution along a fracture surface and determine the source of the sulfur contaminants Sample 1 was mechanically fractured in the same manner as Sample 5 and examined by SEM. EDAX analyses were performed along the fracture surface at designated intervals to quantify local sulfur concentrations. A total of 11 EDAX scans were performed along a radial axis from the crevice to the tip of the crack. In addition, two EDAX analyses were performed on the mechanically broken ductile material. Each EDAX scan examined in surface area of approximately $1.6 \times 10^{-2} \text{ cm}^2$. The results of the EDAX analyses are presented as Figure 27. The relative sulfur concentration data presented in Figure 27 are plotted versus wall thickness. Based on this data an increase in relative sulfur concentration was observed with increasing crack penetration (with the exception noted directly at the crack tip). The relative sulfur concentrations measured in the ductile material beyond the crack tip indicate a significant concentration deviation from the fracture surface*. Based on the difference in relative sulfur concentrations on the fracture surface and the ductile material and the appearance of the sulfur rich particles and the high concentration of sulfur in them, it is believed that the source of sulfur in the cracks was external to the base metal material.

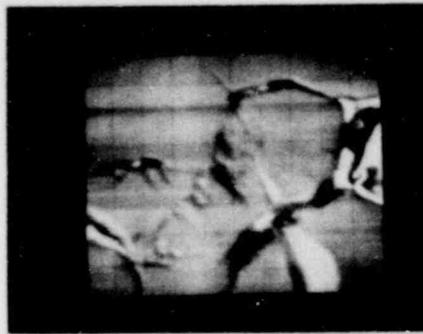
X-ray mapping, as shown in Figure 28, compares the Ni, Cr, and Fe distribution in a grey phase-crack location. For orientation purposes the X-ray images must be compared with the electron backscatter (EBS) image, which in turn can be compared with the adjacent photomicrographs. The Ni X-ray map shows a decrease in Ni content in the Cr rich phase. The Cr image appears to indicate a slight intensity increase. Iron appears to follow the general area topography with relatively uniform distribution.
