June 19, 1979

Reference: Docket No. 50-243, License No. R-106

On June 7, 1979, the shutdown margin of our TRIGA reactor was \$0.48, nine cents less than our Technical Specifications (Part 3.2) limitation of \$0.57. This was reported to your office by telephone on June 8, 1979, as required by our Technical Specifications (Part 6.7.a). This written report, required by Part 6.7.b of our Technical Specifications, provides more details of this occurrence.

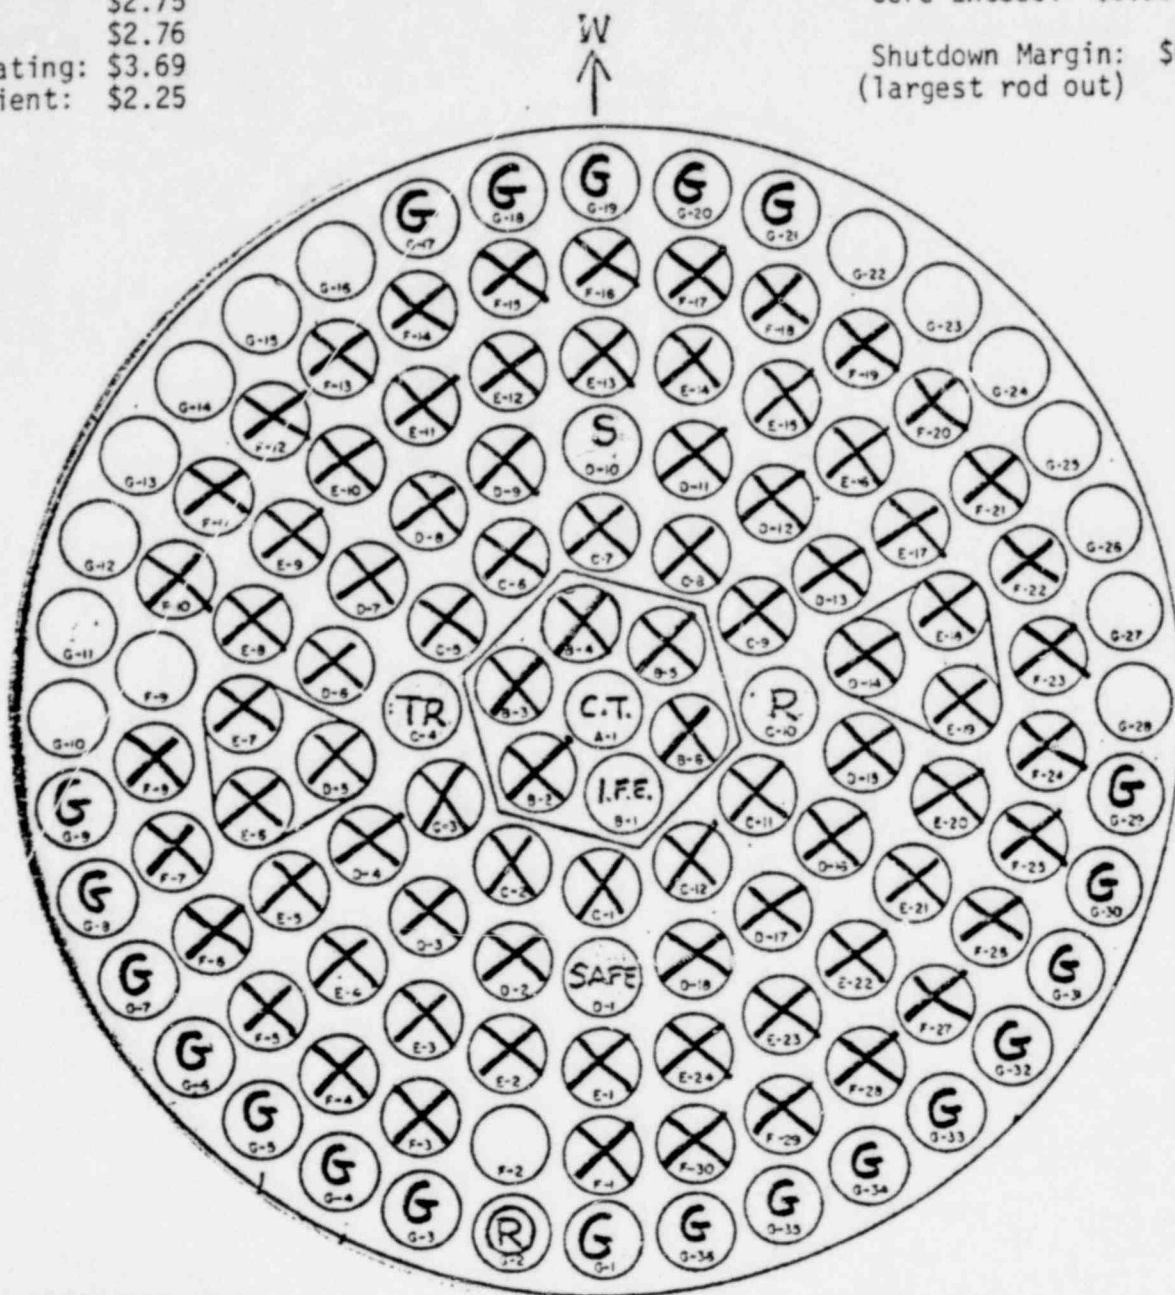
Fig. 1. Core Before Configuration Change

The core, prior to these changes, was quite symmetrical (see Fig. 1). An experimenter wanted the core skewed toward beamport #4 (the upper left quadrant on Fig. 1) to enhance the flux for his experiment. This change was discussed and approved by the ROC on March 6, 1979.

Safe: \$2.75  
Shim: \$2.76  
Regulating: \$3.69  
Transient: \$2.25

Core Excess: \$6.90

Shutdown Margin: \$0.86  
(largest rod out)

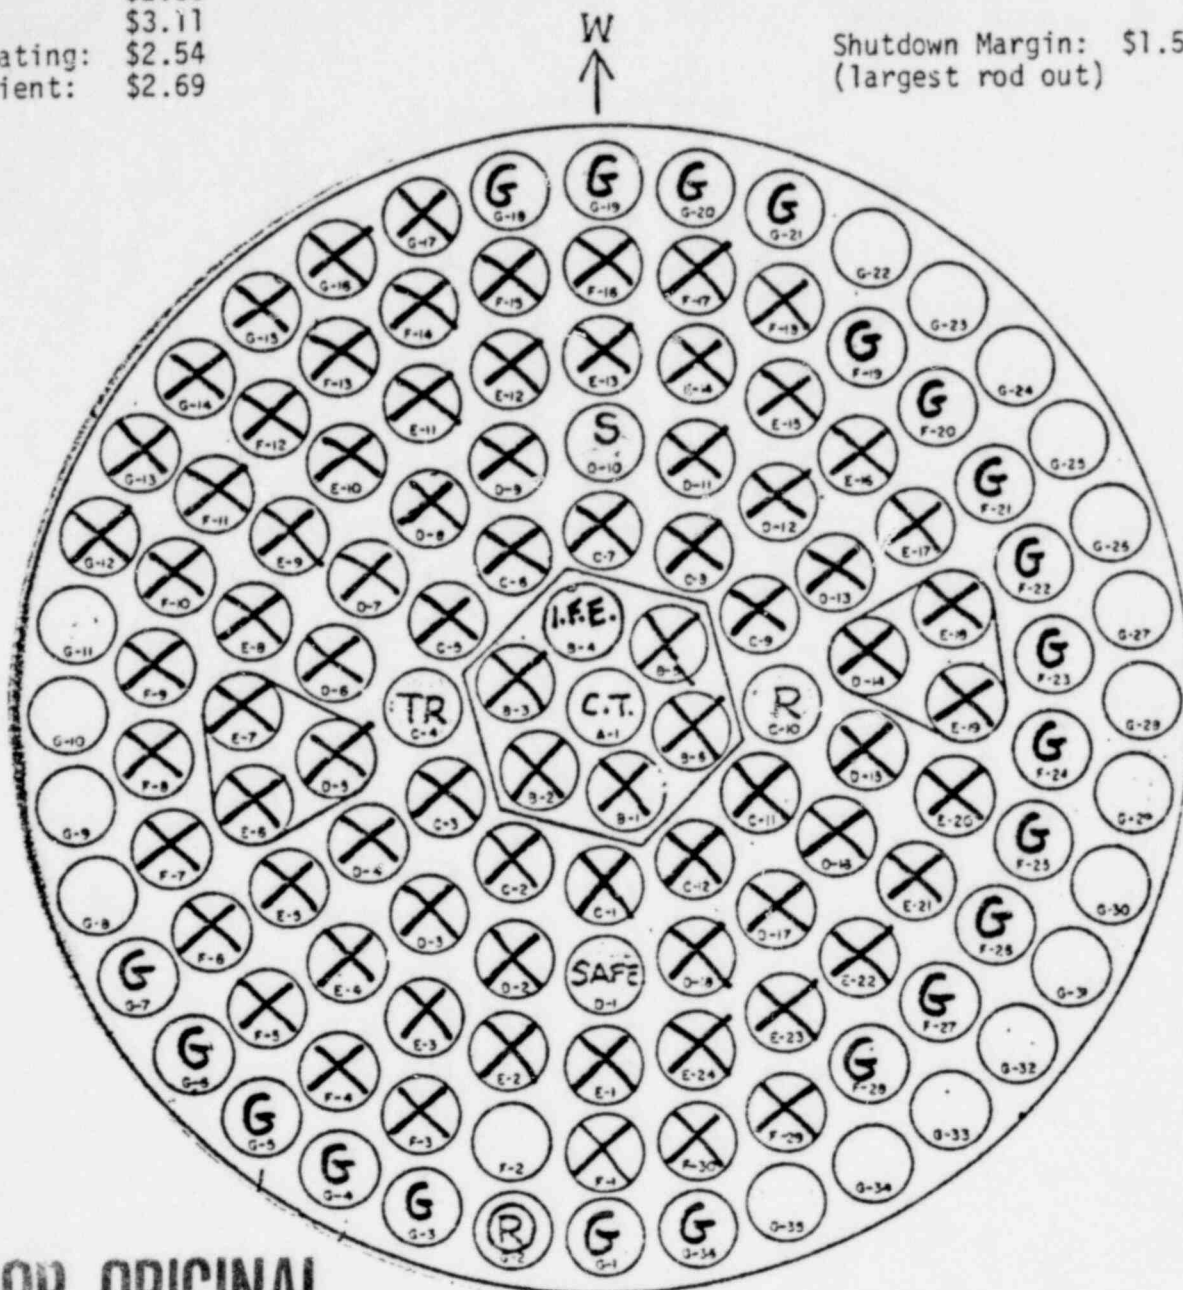
Fig. 2. Core After Change #1

The first change (see Fig. 2) was performed with three fuel elements left out of the core (i.e., the core in Fig. 2 has three less fuel elements than the original core in Fig. 1). This was done to be conservative, as it was hard to estimate how much the rod worths and core excess would change in this new configuration. As expected, the worths of the regulating and safe rods went down and the worths of the shim and transient rods went up. The total rod worth went down (\$10.64 vs. \$11.45) in going from Fig. 1 to Fig. 2, and the core excess went down, due to the poorer core geometry and the loss of three fuel elements.

The worth of the fuel element in position G-12 was then measured and found to be worth \$0.31. This number was very consistent with previous measurements of fuel element worth. If the three remaining fuel elements were added to the G-ring in positions G-9, G-10, and G-11, we estimated that this would increase the core excess by about  $3(31¢) = \$0.93$ . If the rod worths did not change at all, the shutdown margin should be  $\$1.58 - \$0.93 = \$0.65$ , still within the Technical Specifications limits. Furthermore, we estimated that the transient rod worth would increase by this fuel addition, and the worths of the other three rods would be basically unchanged. If this were the case, it would increase our shutdown margin even more.

Safe: \$2.30  
Shim: \$3.11  
Regulating: \$2.54  
Transient: \$2.69

Core Excess: \$5.95

Shutdown Margin: \$1.58  
(largest rod out)

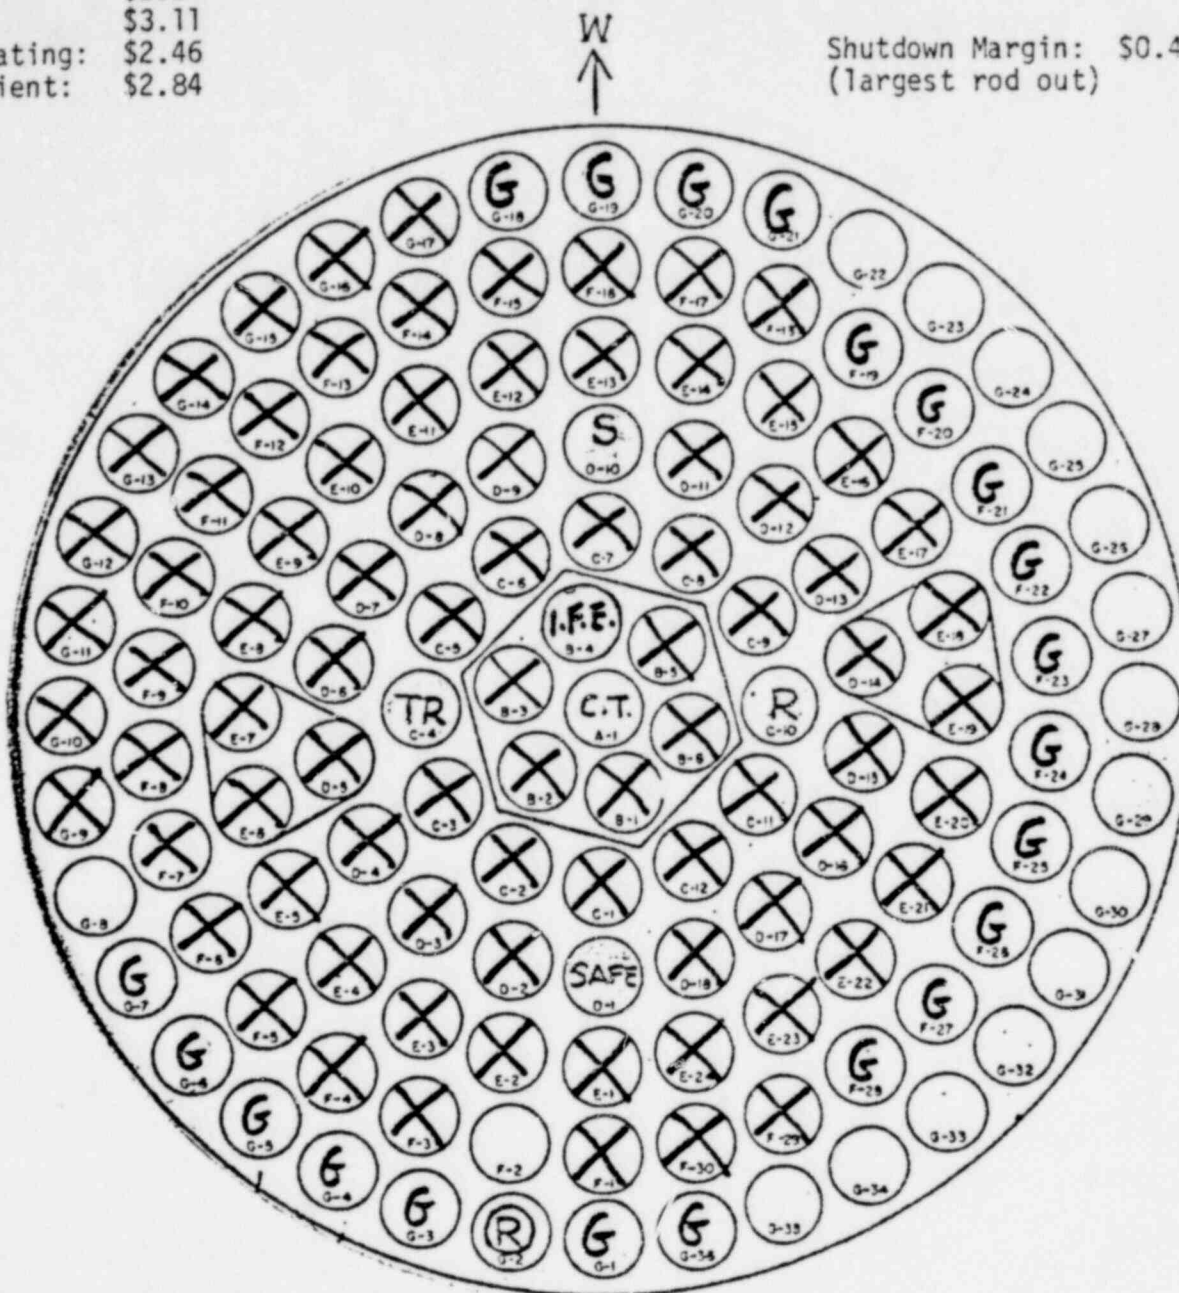
Fig. 3. Core After Change #2

On June 7, 1979, during a core configuration change to accommodate an experimental request, our shutdown margin (with the most reactive rod out) dropped to \$0.48, nine cents less than the Technical Specification limit of \$0.57.

Thus, we decided to add the remaining three fuel elements to the G-ring (see Fig. 3). After the rods were calibrated in this configuration, we discovered that the core excess had increased by \$1.11, rather than the \$0.93 as predicted, and the shutdown margin was now only \$0.48.

Safe: \$2.24  
Shim: \$3.11  
Regulating: \$2.46  
Transient: \$2.84

Core Excess: \$7.06

Shutdown Margin: \$0.48  
(largest rod out)

As soon as the situation was discovered, two fuel elements were moved and the shutdown margin went up to \$0.74. These two fuel elements were moved on June 7, 1979. Thus, the situation was corrected physically the same day.

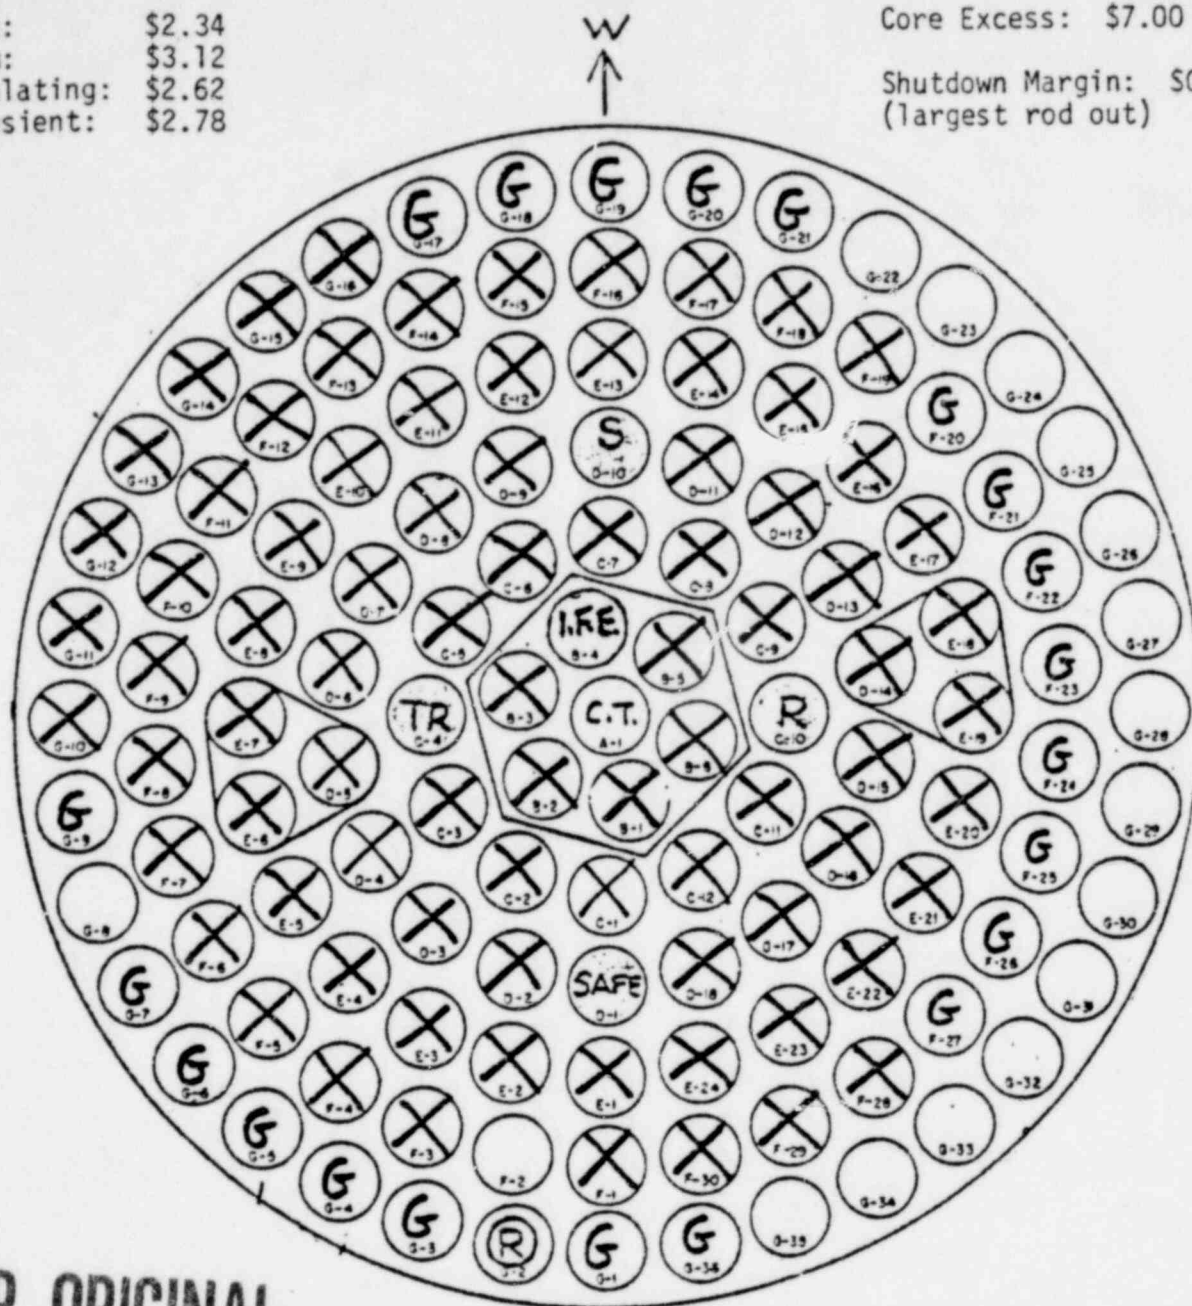
Fig. 4. Core After Change #3 (Final Core Configuration)

Safe: \$2.34  
Shim: \$3.12  
Regulating: \$2.62  
Transient: \$2.78

Core Excess: \$7.00

Shutdown Margin: \$0.74  
(largest rod out)

Two fuel elements were then moved (from G-9 to F-28 and from G-17 to F-19), and the final core configuration (see Fig. 4) has an acceptable shutdown margin of \$0.74.
