LICENSEE EVENT REPORT

PLANT E. I. HATCH UNIT II
PRIMARY CONTAINMENT COOLING MODIFICATION

E. I. Hatch Nuclear Plant Unit 2
Bechtel Job 6511-020
Drywell Cooling System Modifications
and Post-Modification Testing
File: A-29.3/SS-2102-160/SS-2115-2/B-GP-5899

DRYWELL COOLING SYSTEM PROBLEMS

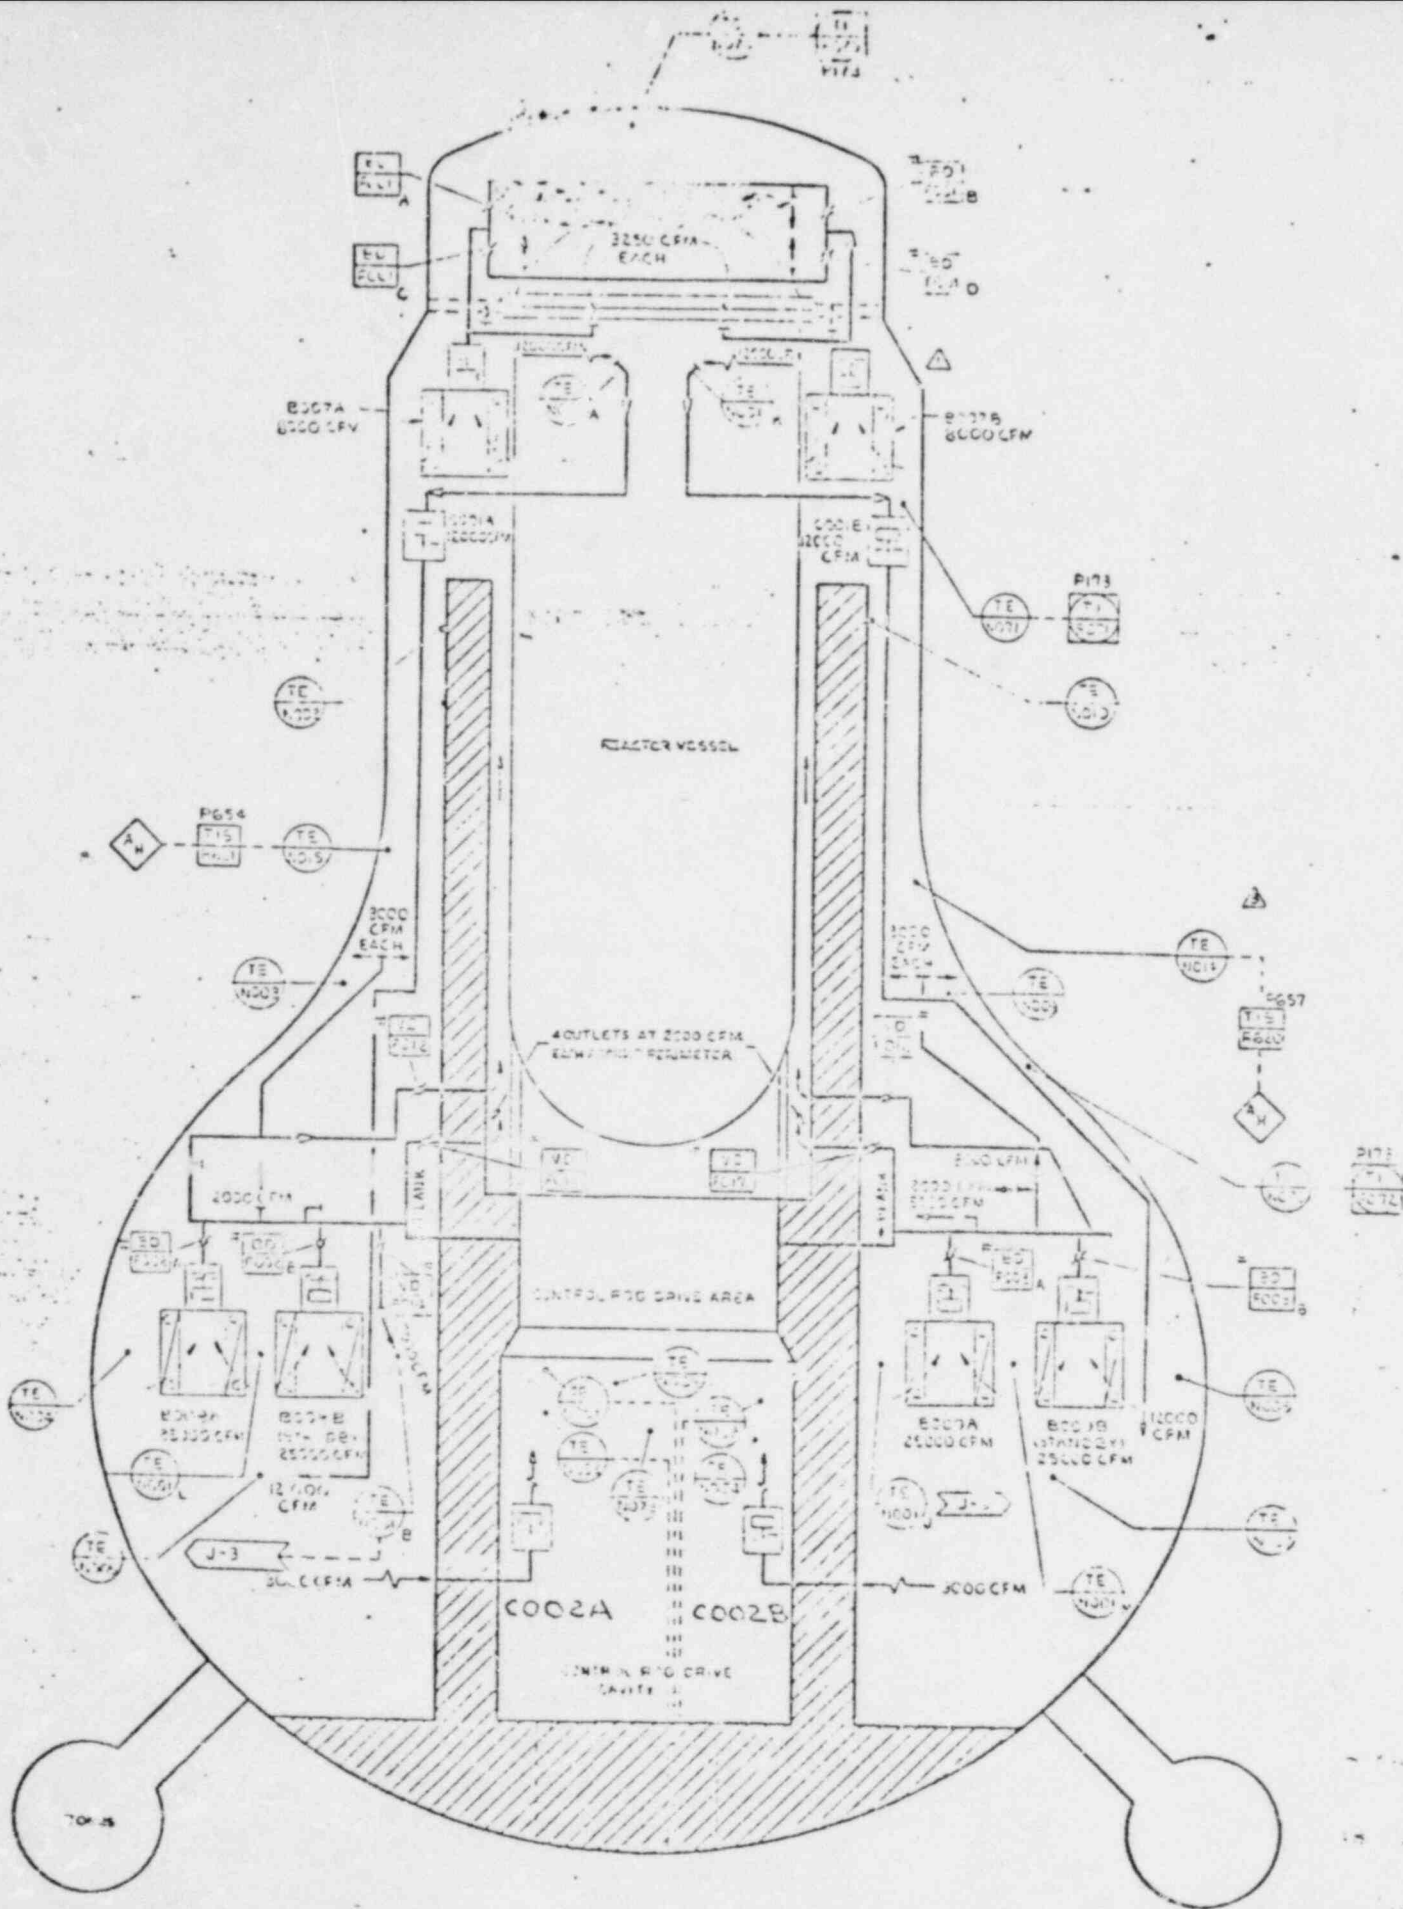
FIGURE 1

Figure 1 shows the original Drywell Cooling System design schematically. The original fan line up was to have the following fans running: 2T47-B007A, 2T47-B008A, 2T47-B009A, 2T47-C001A, 2T47-C002A and 2T47-C002B with the other four fans in standby. With this line up, 4000 cfm was being supplied to the CRD cavity area by 2T47-B008A and 2T47-B009A, 4000 cfm was being exhaust the CRD cavity area by recirculation fans 2T47-C002A and 2T47-C002B. Fans 2T47-B008A and 2T47-B009A were also to supply a total of 8000 cfm to the annular space between the sacrificial shield and the reactor vessel insulation. This 8000 cfm was to travel up the annulus picking up

heat lost from the RPV insulation, thus reducing sacrificial shield temperature, until it reached the top of the sacrificial shield where it would exit into the upper drywell region at elevation 185'. The remaining 38,000 cfm supplied by 2T47-B008A and 2T47-B009A was directed at other locations of drywell between the 130' and 158' elevations. Air movement between elevations 158' and 185' was to be by natural circulation. In the upper elevation of the drywell, 2T47-B007A supplied 5000 cfm through a ring header in the drywell dome and 1000 cfm into the drywell below the bellows at elevation 200'. Recirculation fan - C001A removed 5000 cfm from the drywell dome through a single inlet and 1000 cfm from below the bellows at elevation 200' and discharged the total 6000 cfm down the drywell at elevation 182' just below the - B007A intake. The four standby fans were only to come on if an operating fan failed or if the air temperature in the CRD cavity area exceed 148 degrees F.
