In the Matter of
TENNESSEE VALLEY AUTHORITY
(Phipps Bend Nuclear Plant, Units 1 and 2)
Docket Nos. 50-553 and 50-554

SUBJECT: FAULTING IN FUEL BUILDING EXCAVATION FOR PHIPPS
BEND, UNIT 2, TAC# 4954

PHIPPS BEND NUCLEAR PLANT
DOCUMENTATION OF FAULT IN UNIT 2 FUEL BUILDING EXCAVATION

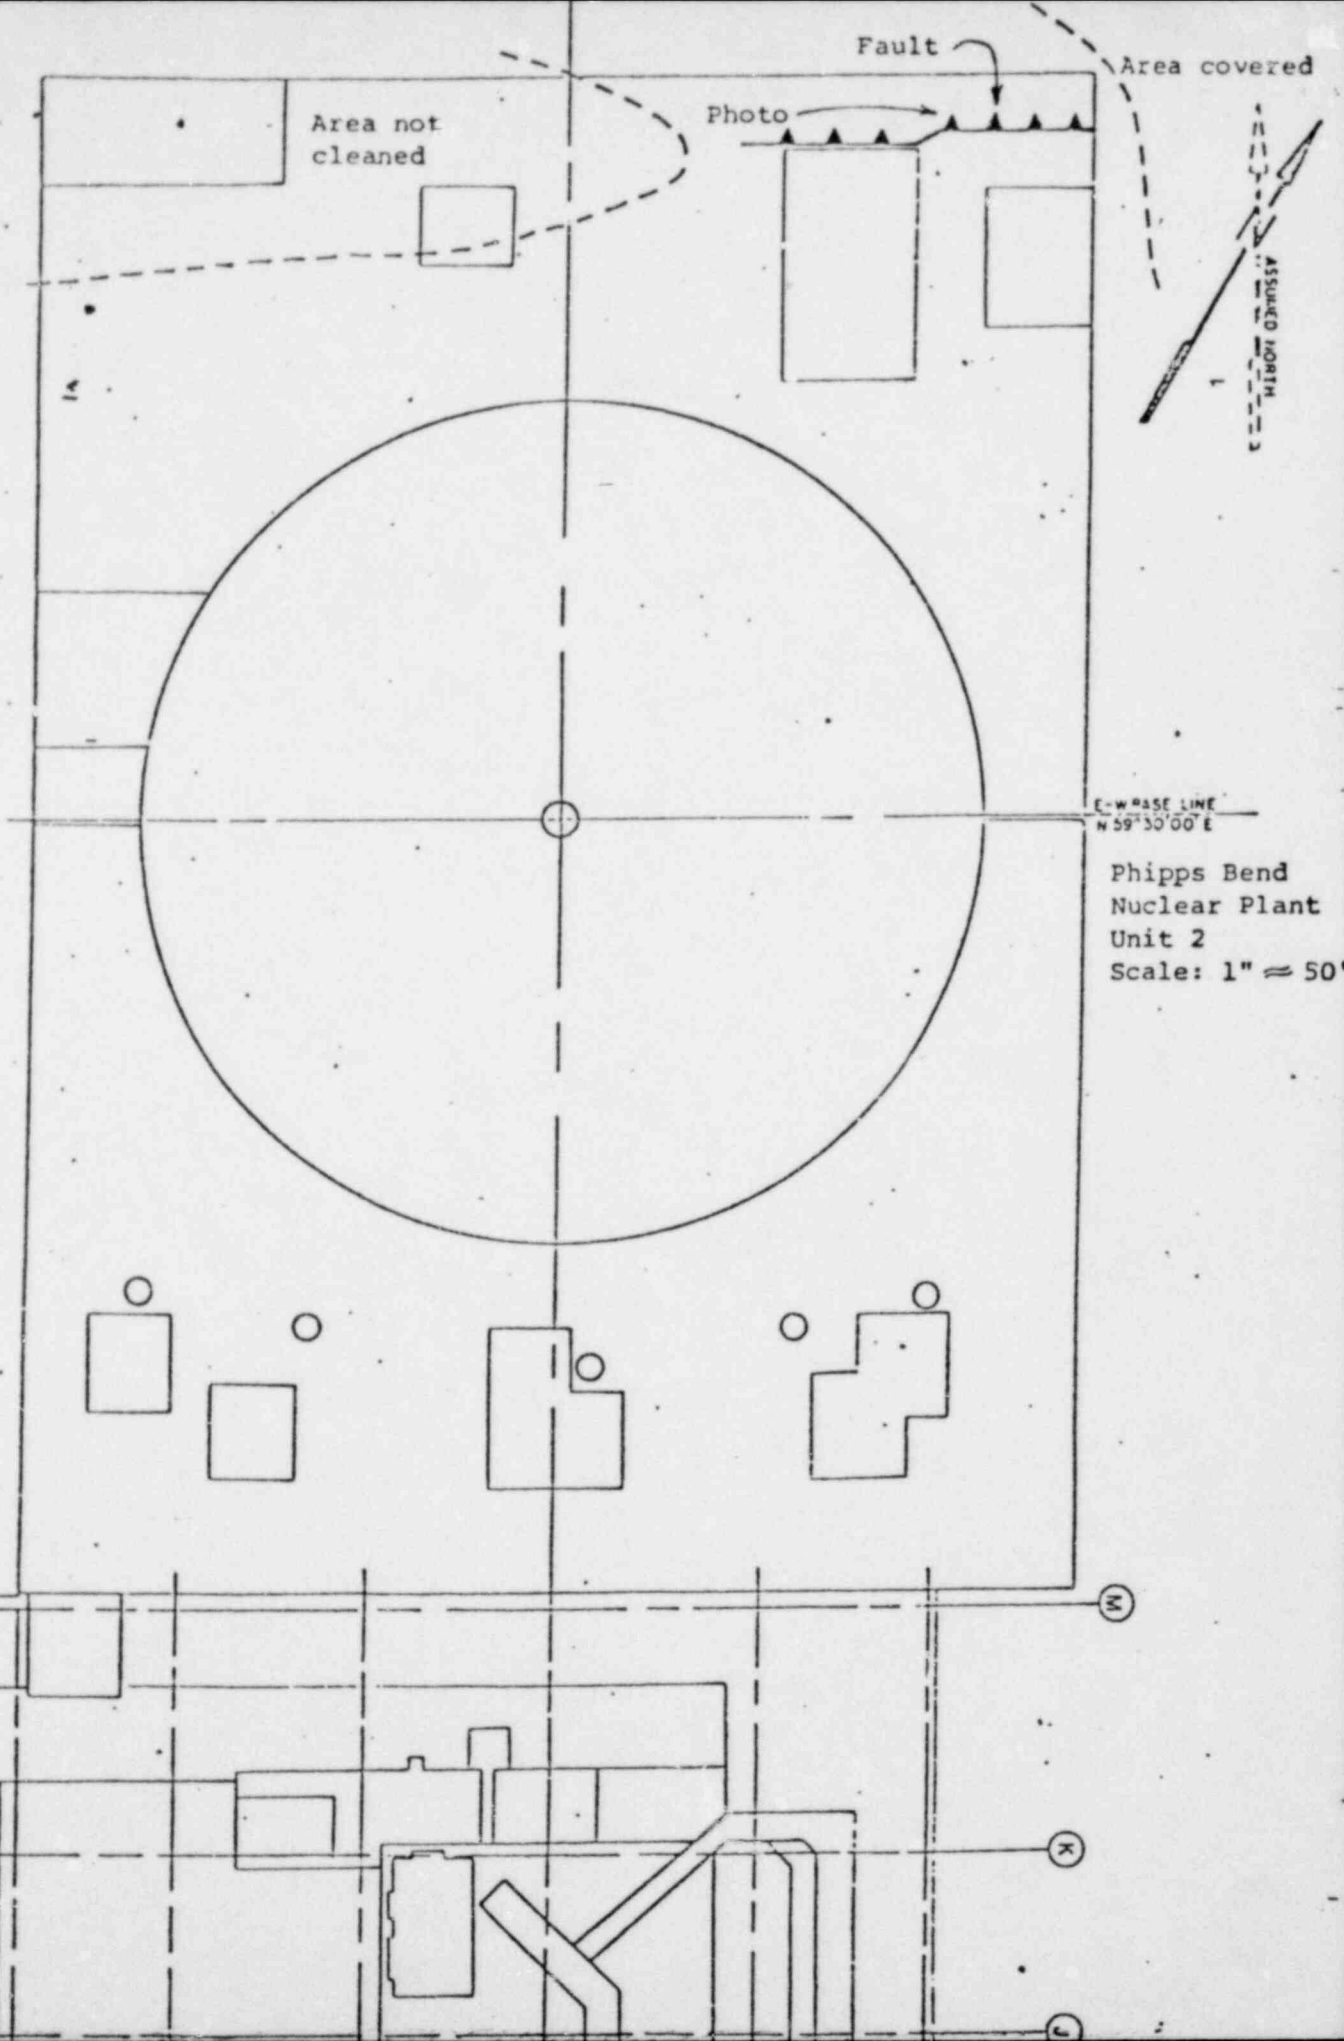
The fault is located in the northern half of the unit 2 fuel building area on the east wall of the spent fuel storage pool excavation (see attached sketch).
