JOSEPH M. FARLEY NUCLEAR PLANT-UNIT 2 ALABAMA POWER COMPANY REPORT OF 10CFR50.55(e) DEFICIENCY

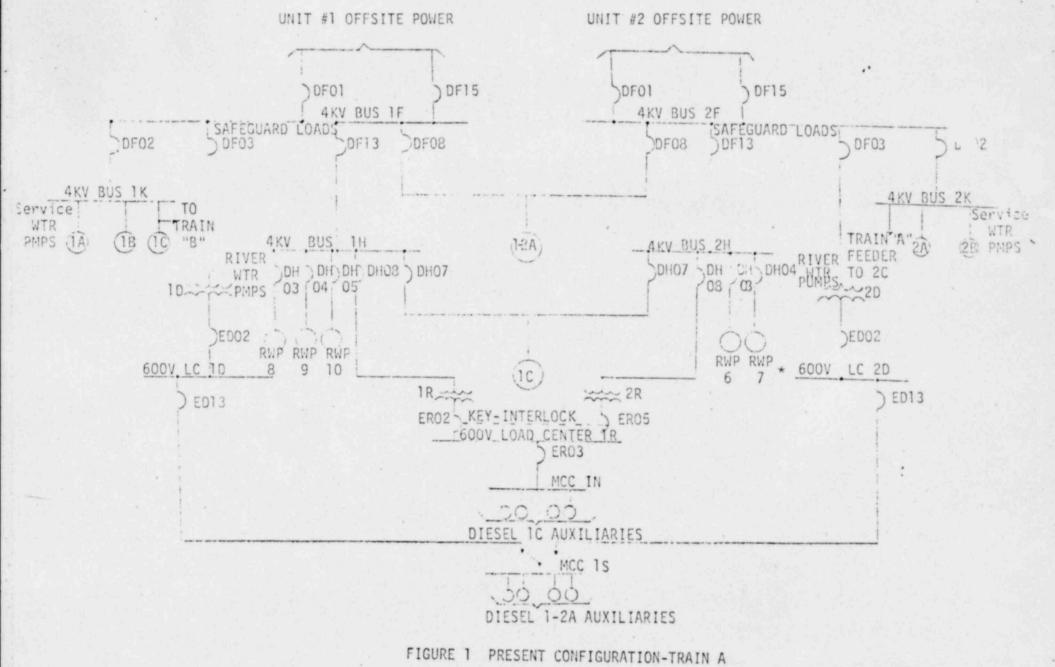
Presently, as shown in Figure 1, Diesel Generator 1C has its auxiliaries powered from emergency Motor Control Center (MCC) 1N. MCC 1N gets its power supply from emergency 600V Load Center 1R. The 600V Load Center IR is a shared load center capable of being energized from either unit. When it is energized from Unit 1 it is supplied from the 4KV Bus 1H through Station Service Transformer 1R. When it is energized from Unit 2 it is supplied from the Unit 2 4 KV Bus 2H through Station Service Transformer 2R. The two 600V incoming breakers of 600V Load Center 1R are key interlocked so that only one can be closed at any time. The alignment of Load Center 1R to Unit 1 or Unit 2 can be performed manually only, from the local control panel located in the diesel building.

As shown in Figure 1, Diesel Generator 1-2A has its auxiliaries powered from emergency MCC 1S. MCC 1S is a shared MCC capable of being energized from either unit. When it is energized from Unit 1 it is supplied from the Unit 1 600V Load Center 1D, which in turn is powered from Unit 1 4KV Bus 1F through Station Service Transformer 1D. When it is energized from Unit 2 it is supplied from the Unit 2 600V Load Center 2D, which in turn is powered from Unit 2 4 KV Bus 2F through Station Service Transformer 2D. The alignment of MCC 1S to Unit 1 or Unit 2 can be performed manually only from the MCC 1S located in the diesel building.

Under LOSP on both units or LOSP on both units and LOCA on Unit 1, Diesel 1C is a source of power for Unit 2 Train A hot shutdown loads, while Diesel 1-2A is a source of power for Unit 1 LOCA loads. If, at the accident occurrence, 600V Load Center 1R is aligned to Unit 1, it will be deenergized since 4 KV Bus 1H is deenergized, and Diesel Generator 1C loses its auxiliaries. At this time, MCC 1N

If Diesel Generator 1C is disabled, no source of power for Unit 2 Train A safeguard loads will be available, and a single failure on Unit 2 Train B can render Unit 2 incapable of being shutdown. (4 KV Bus 1H is deenergized under the postulated conditions since the tie breaker between 4 KV Bus 1F and 4 KV Bus 1H is open.)

If, under the above conditions MCC 1S is aligned to Unit 2, it will be deenergized and Diesel Generator 1-2A loses its auxiliaries. If Diesel Generator 1-2A is disabled, no source of power for Unit 1 Train A LOCA loads will be available. In this case, if we apply the single failure criterion to Unit 1 Train B instead of Unit 2 Train B, Unit 2 will meet the hot shutdown requirements, while Unit 1 cannot meet the LOCA requirements.

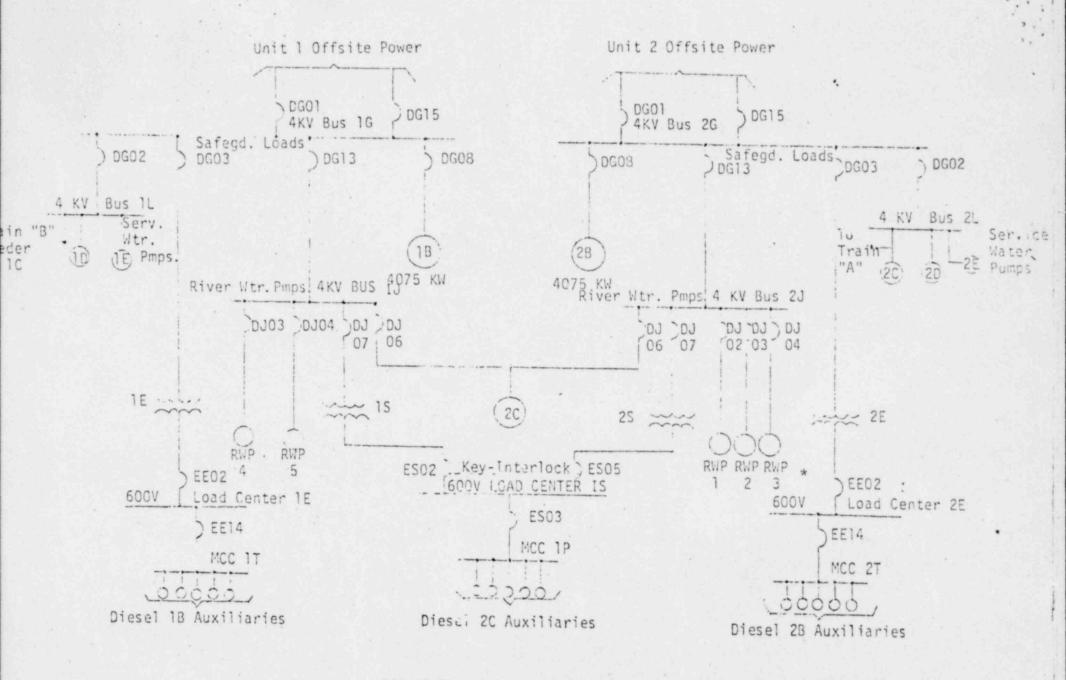
FIGURE 3 PRESENT CONFIGURATION -TRAIN B

(The corrective action necessitates no change to this figure.) * Manually Loaded

In order to correct the second problem, the following changes to the logic, schematic, and wiring concerning the diesel generator are proposed (see Figures 1, 2 and 3):

(3) Should diesel generator 2C fail, diesel generator 1B will furnish power to Bus 1J and diesel generator 2B will furnish power to Bus 2J after the sequencers on Buses 1G and 2G have had LOSP loads added. Two river water pumps (Numbers 4 and 5) will start on Bus 1J and two river water pumps (Numbers 1 and 2) will start on Bus 2J.
