Report of Inspection

CO Report No. 289/69-1

Licensee: METROPOLITAN EDISON COMPANY
(Three Mile Island Nuclear
Station No. 1)
Provisional Construction Permit
No. CPPR-40

Date of Inspection: January 7, 1969

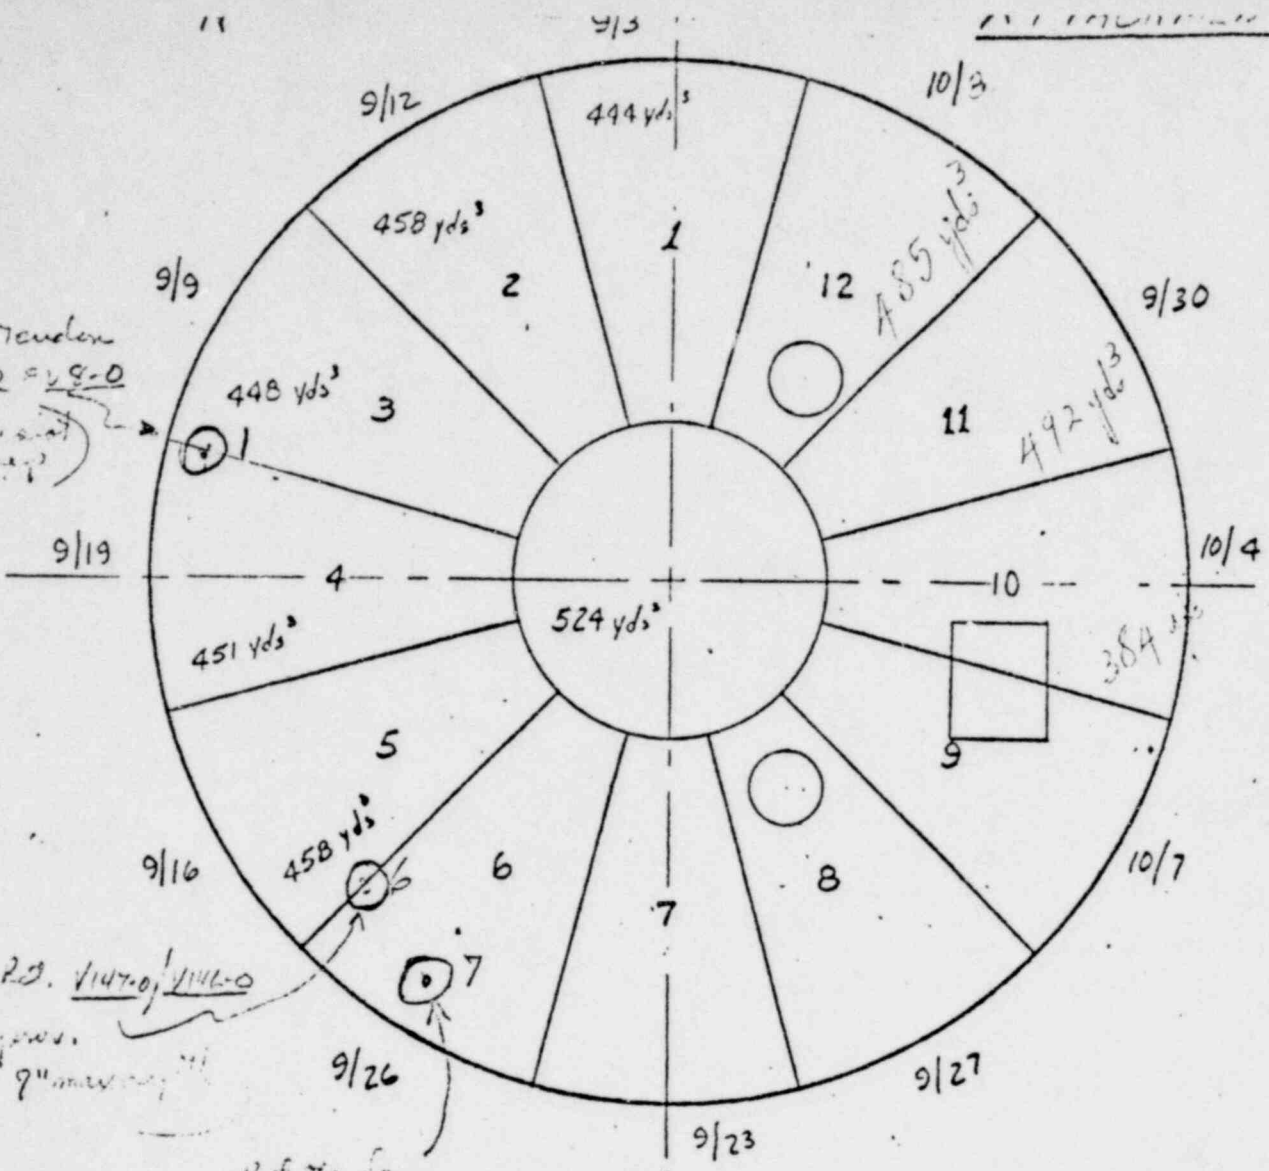
3. The three remaining areas had been created by pieces of wood and penetrated into the concrete for depths of twelve to sixteen inches (12"-16") and would require repairs. All areas affected were between the tendon bearing plates and at only one place was the concrete chipped out from under the bearing plate and this constituted an area of approximately 1" wide by 3" deep and 12" to 15" long. (Location shown in Attachment No. 1, photographs of void areas in Attachment No. 2.)

Ref. Tendons
 V7-0 & V8-0
 (approx. 8\"/>

Ref. Tendons
 V147-0 & V146-0
 (approx. 9\"/>

Ref. Tendons
 V160-0 & V161-0
 (approx. 12\"/>

- 1/ POUR DATE SHOWN OUTSIDE CIRCLE (CENTER WAS POURED FIRST)
- 2/ HEIGHT OF POUR - 8' 6"
- 3/ ⊙ LOCATION OF VOIDS
- 4/ TENDONS INVOLVED:
 V 7-0 & V 8-0
 V 147-0 & V 146-0
 V 160-0 & V 161-0
