Subject: Beaver Valley Power Station - Unit No. 2  
Reactor Containment Liner - Overlay Pod Fillet Weld Crack  
(Your letter of January 19, 1979)

SUBJECT: Beaver Valley Power Station - Unit No. 2  
Reactor Containment Liner - Overlay Pad  
Fillet Weld Crack  
Docket No. 50-412  
Significant Deficiency Report No. 78-03

INTERIM REPORT ON  
REACTOR CONTAINMENT LINER  
OVERLAY PAD FILLET WELD  
AT  
BEAVER VALLEY POWER STATION - UNIT NO. 2

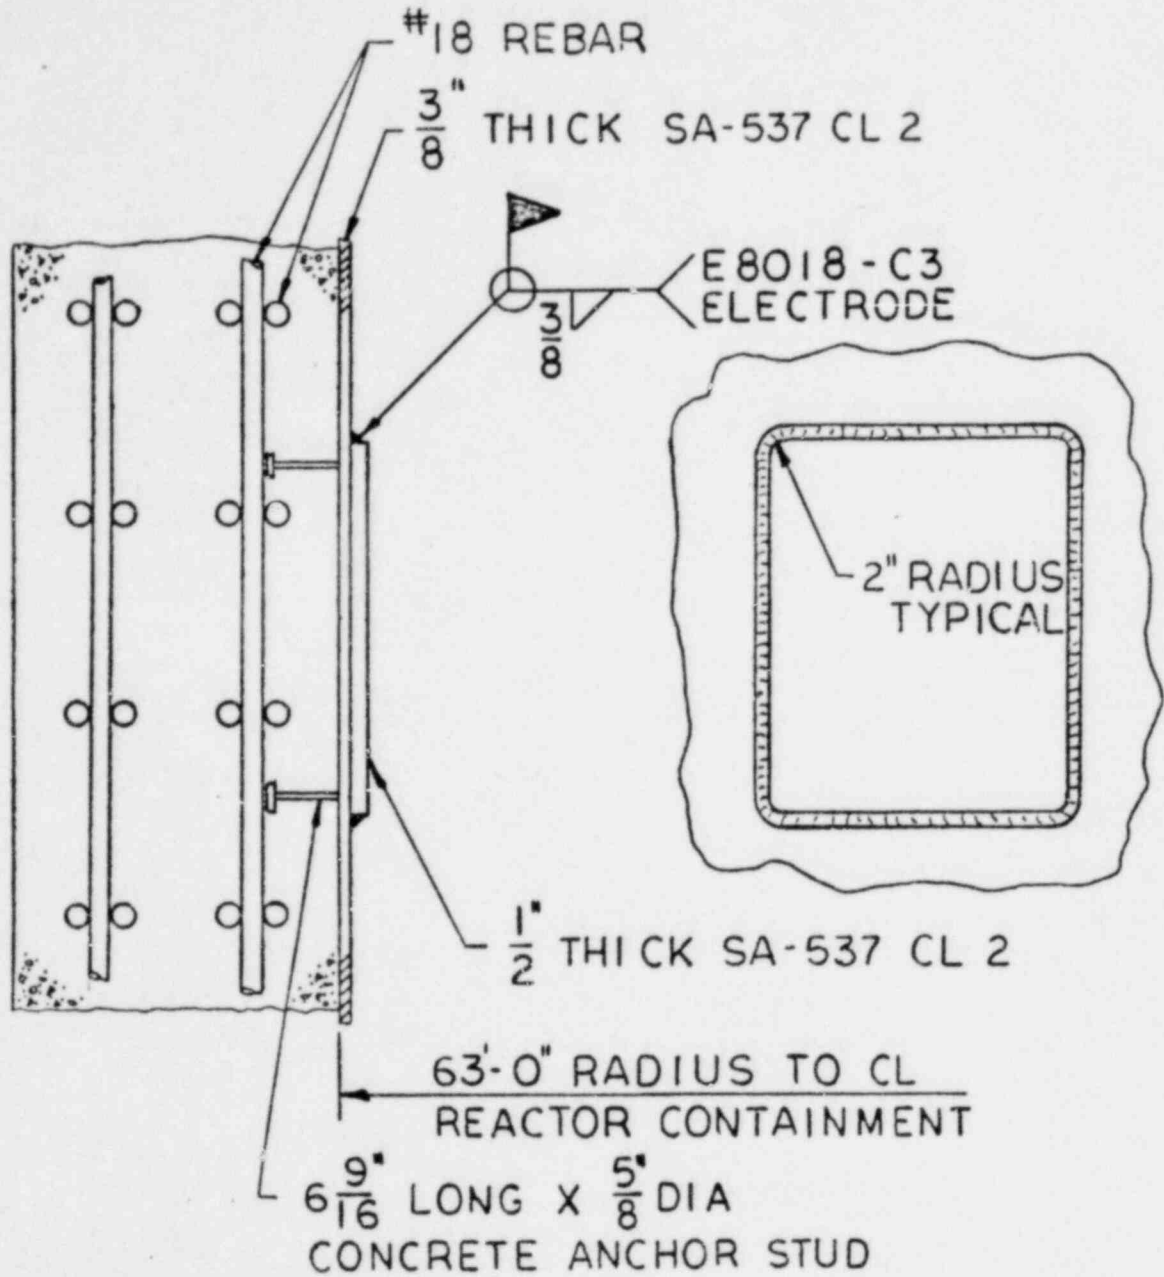
POWER INDUSTRY GROUP		TITLE	SCALE: NONE	
CHECKED	PW/W	TYPICAL OVERLAY PAD	DATE: 1-15-79	
CORRECT	NA		SKETCH NUMBER	
APPROVED	NA		NA	
REVISIONS	②	③	④	⑤

A required visual examination of the reactor containment liner plate and associated equipment, following a sandblast operation required for prime paint substrate, revealed a crack along the toe of a bottom horizontal fillet weld which attaches an overlay pad to the reactor containment liner plate. The overlay pad is located at elevation 719'-4", fourteen feet west of the north containment centerline. See the attached sketch for a typical overlay pad configuration. The crack was approximately 1'-0" in length at the toe of the weld adjacent to the liner plate.

As a result of grinding necessary for repair, the crack depth was found to be greater than half the thickness of the liner material.
