DEFICIENCY REPORT  
TORUS SHELL INDICATIONS

AT THE  
RING BEAM ATTACHMENT WELD ENLARGEMENT

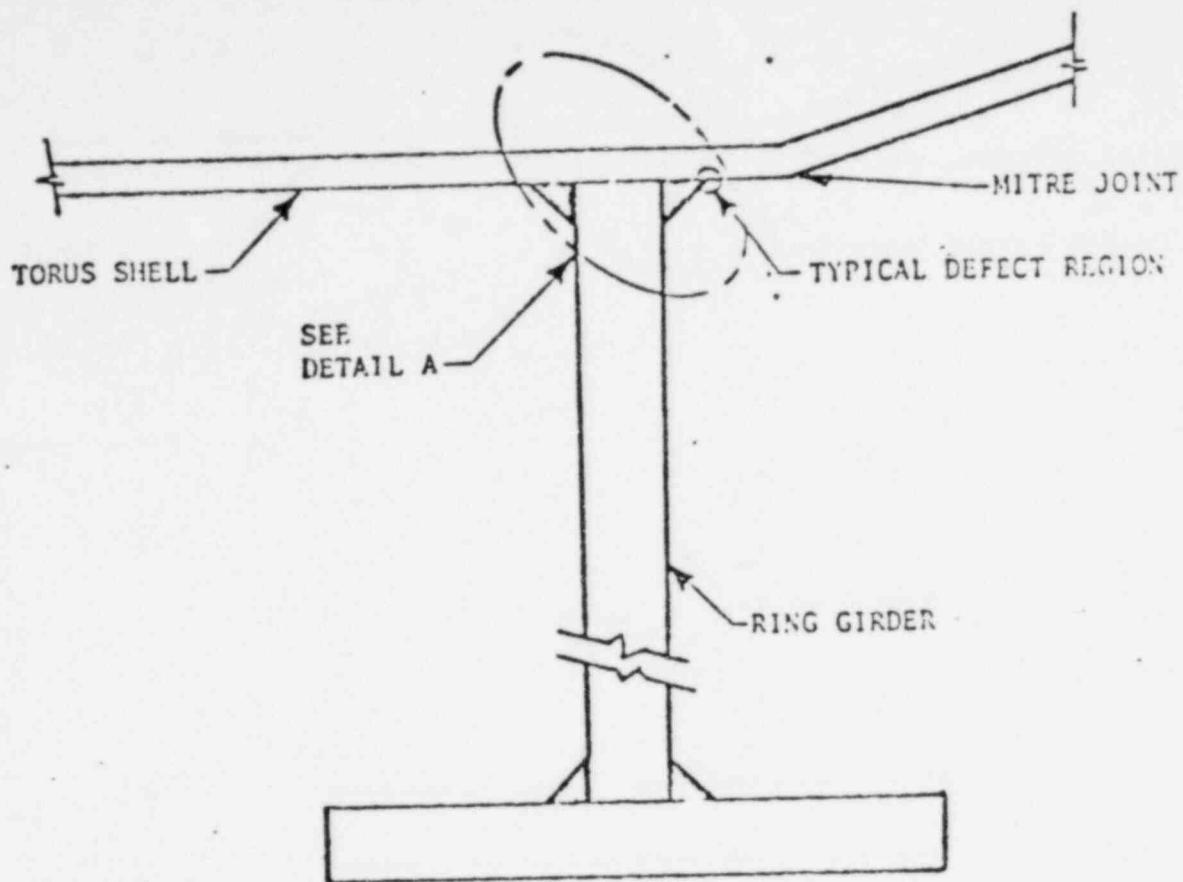
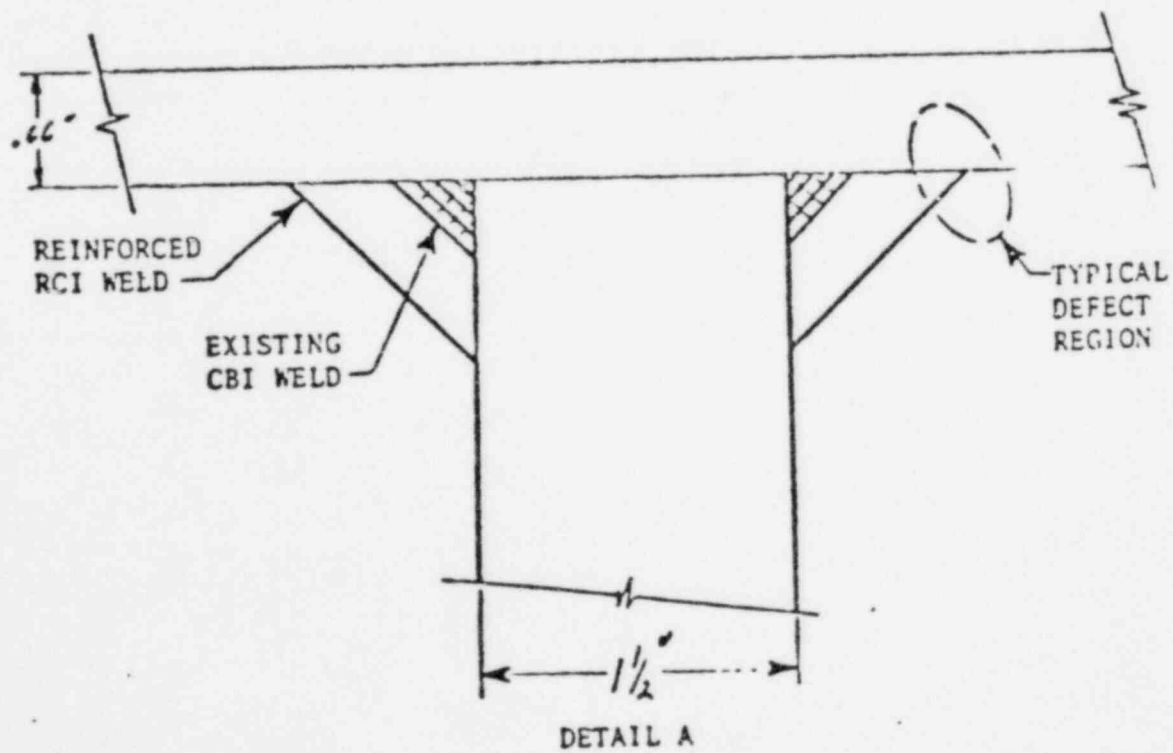
FIGURE 1

The installation of the designed modifications is being performed by Reactor Controls Inc. As part of the modification program, the existing 5/16" fillet weld between the ring girder at each mitered joint and the suppression chamber shell is being increased to 3/4" fillets as shown in Figure 1. In the process of inspecting these welds, defects in the toe of the welds were discovered. The typical locations of these defects are illustrated in Detail A of Figure 1.

The indications were discovered to be relevant defects through magnetic particle examination and liquid penetrant examination. The defects predominantly are oriented parallel to the welds in the area shown in Figure 1. Presently, ultrasonic examination is being conducted to determine the presence of subsurface indications. Documentation providing dimensional description and location of the defects is available at the site.

Ten (10) metal samples were removed from selected locations of the torus ring beam welds to determine the cause of the cracking. Metallurgical and fractographic methods were used to examine these samples. Hardness traverses and chemical analyses were also performed. The surface cracks were found to emanate from the toe of the outermost weld pass of the 3/4" weld. The subsurface cracks observed in the samples emanated from the underbead

welds and were determined to have initiated while applying the 3/4" weld. The cracks then ran through the heat affected zone (HAZ) downward into the shell base material. Once the cracks were in the base material of the shell, they propagated along and across the banded microstructure in a stepwise fashion. The base material chemical analysis and hardness were typical for SA516, Grade 70. Hardness in the HAZ of most of the samples examined exceed 400 Knoop.

The cracks were found to be a result of hydrogen cracking and were characterized by intergranular fracture of coarse grained HAZ. The HAZ of welds which exhibited cracking were excessively hard (Knoop 400). The high hardness HAZ's resulted from rapid cooling and lead to the subsequent formation of martensite, which is susceptible to hydrogen cracking.

After the defects were discovered, a Repair Program Document was written and submitted to the State of Michigan for the repair, as required by the ASME Code. The corrective action consisted of physically removing, by grinding, of all relevant surface and subsurface indications. The base metal and 3/4" fillet welds were restored by utilizing new welding procedures that specified electrode baking (600° to 800°F), preheat (300° to 400°F), specific minimum energy input, and post-weld baking temperature and duration.

The weld repaired area will be magnetic particle examined and ultrasonic tested after a minimum of at least 72 hours after the post bake duration is completed and the weld metal returned to ambient temperature. An integrated leak rate test of the containment vessel in accordance with Appendix J of 10CFR50 will be performed prior to start-up.
