UNITED STATES  
NUCLEAR REGULATORY COMMISSION  
REGION IV  
611 RYAN PLAZA DRIVE, SUITE 1000  
ARLINGTON, TEXAS 76011

IE Information Notice No. 79-04  
Date: February 16, 1979  
Page 1 of 5

DEGRADATION OF ENGINEERED SAFETY FEATURES

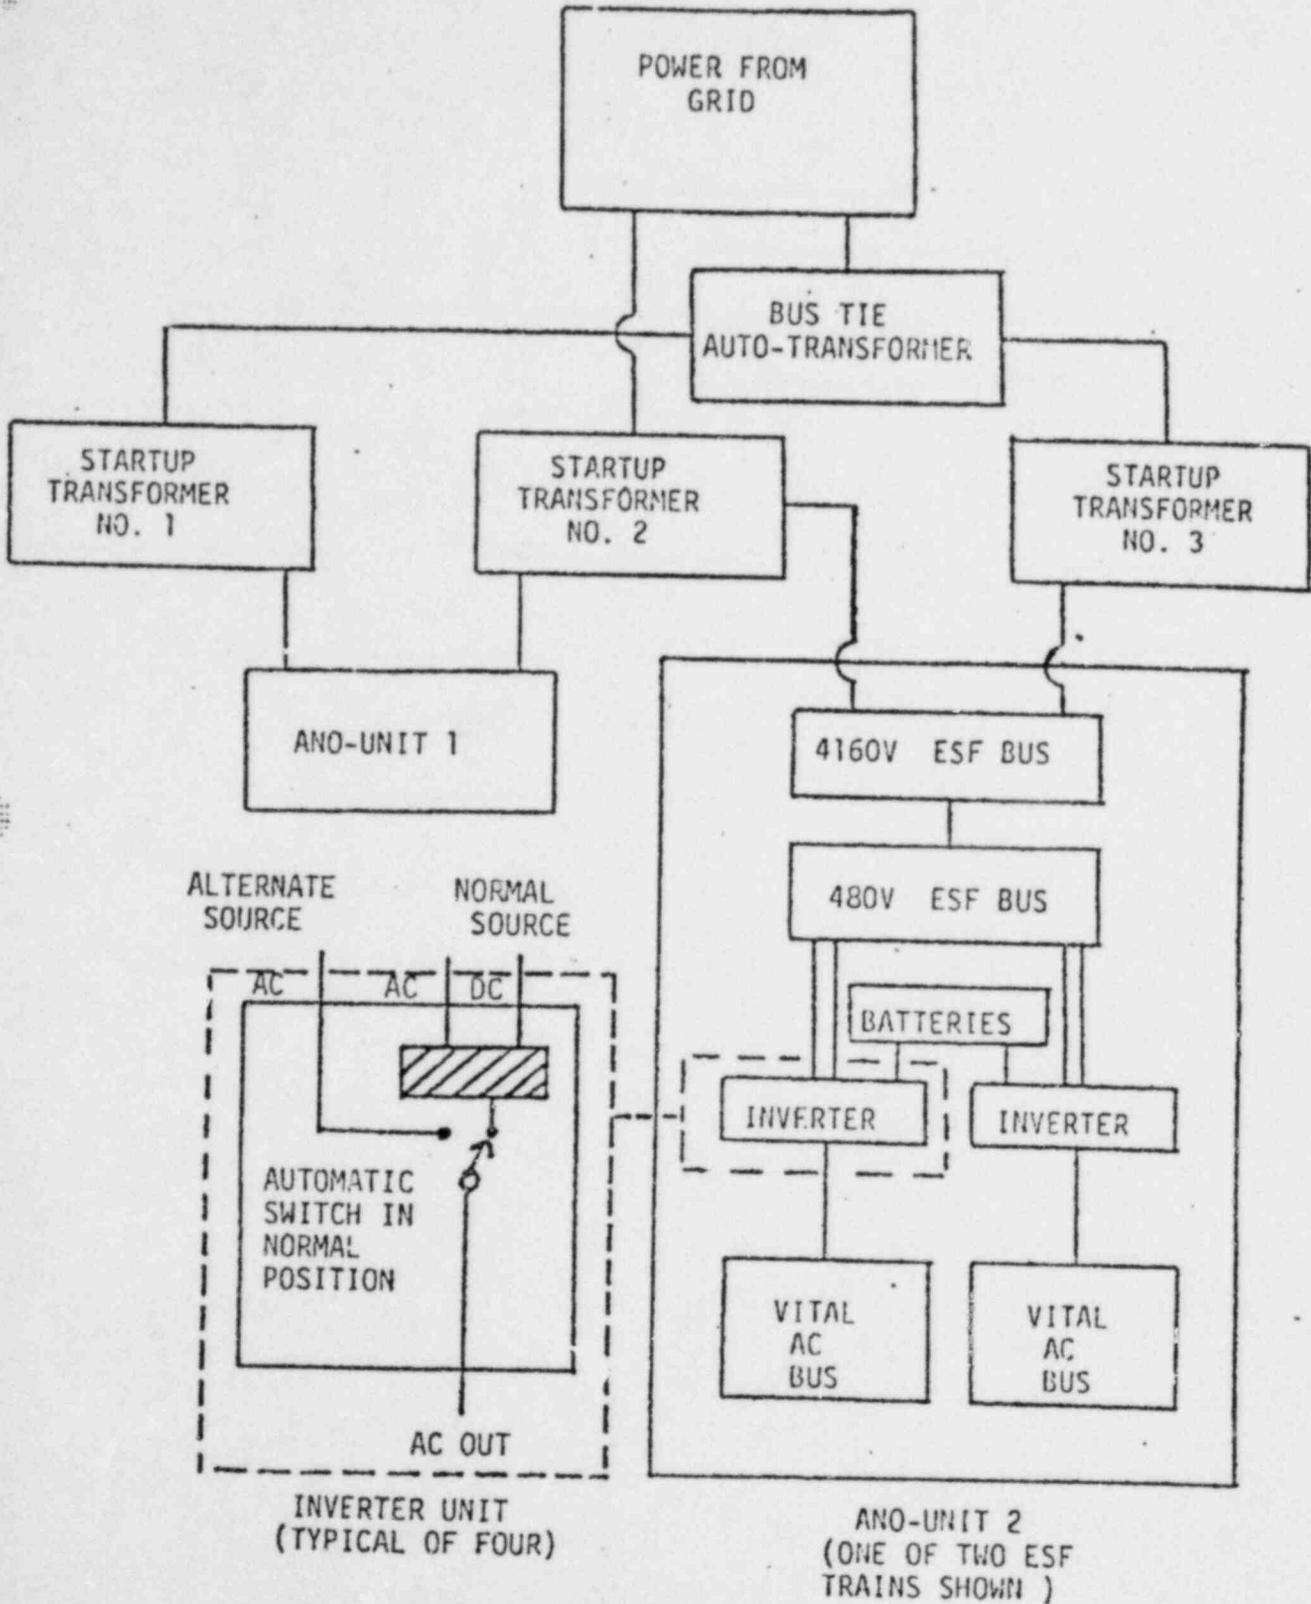
FIGURE 1

The power to Startup Transformer No. 3, which was feeding Unit 2, and to Startup Transformer No. 1, now feeding Unit 1, normally passes through a single piece of equipment, the Bus Tie Auto-Transformer. (Figure 1 shows a simplified block diagram of the principal electrical equipment involved.) The Auto-Transformer has the capacity to provide power for both units, but due to an error, the protective relays were still adjusted for the operation of Unit 1 only. As a result, when both units concurrently drew power from the Auto-Transformer these protection relays tripped and cut off power to Startup Transformer Nos. 1 and 3.

Startup Transformer No. 2, also shown in Figure 1, thus became the only source of offsite power for both Units 1 and 2. The onsite switching equipment automatically transferred the full auxiliary loads for both units to this transformer. However, this transformer is not designed to carry full auxiliary loads for both units. For this reason, Startup Transformer No. 2 became overloaded and the voltage dropped on the station distribution system for offsite power. At this time, and during most of the incident, operating personnel at both units were unaware of the degraded voltage 2/ condition due to the overloaded Startup Transformer No. 2 3/.

The immediate causes of the unusual event at Arkansas Nuclear One were: (1) loss of the Bus Tie Auto-Transformer which resulted in degraded power operation through Startup Transformer No. 2; and (2) multiple Unit 2 inverter failures.

The loss of the Bus Tie Auto-Transformer was caused by inappropriate setpoints for its protective relays. The Bus Tie Auto-Transformer loss had not been adequately reviewed prior to this event in that the overloading of the shared Startup Transformer No. 2 had not been identified during the design and review process.
