Docket No. 50-298

IE Information Notice No. 79-04  
Date: February 16, 1979  
Page 1 of 5

DEGRADATION OF ENGINEERED SAFETY FEATURES

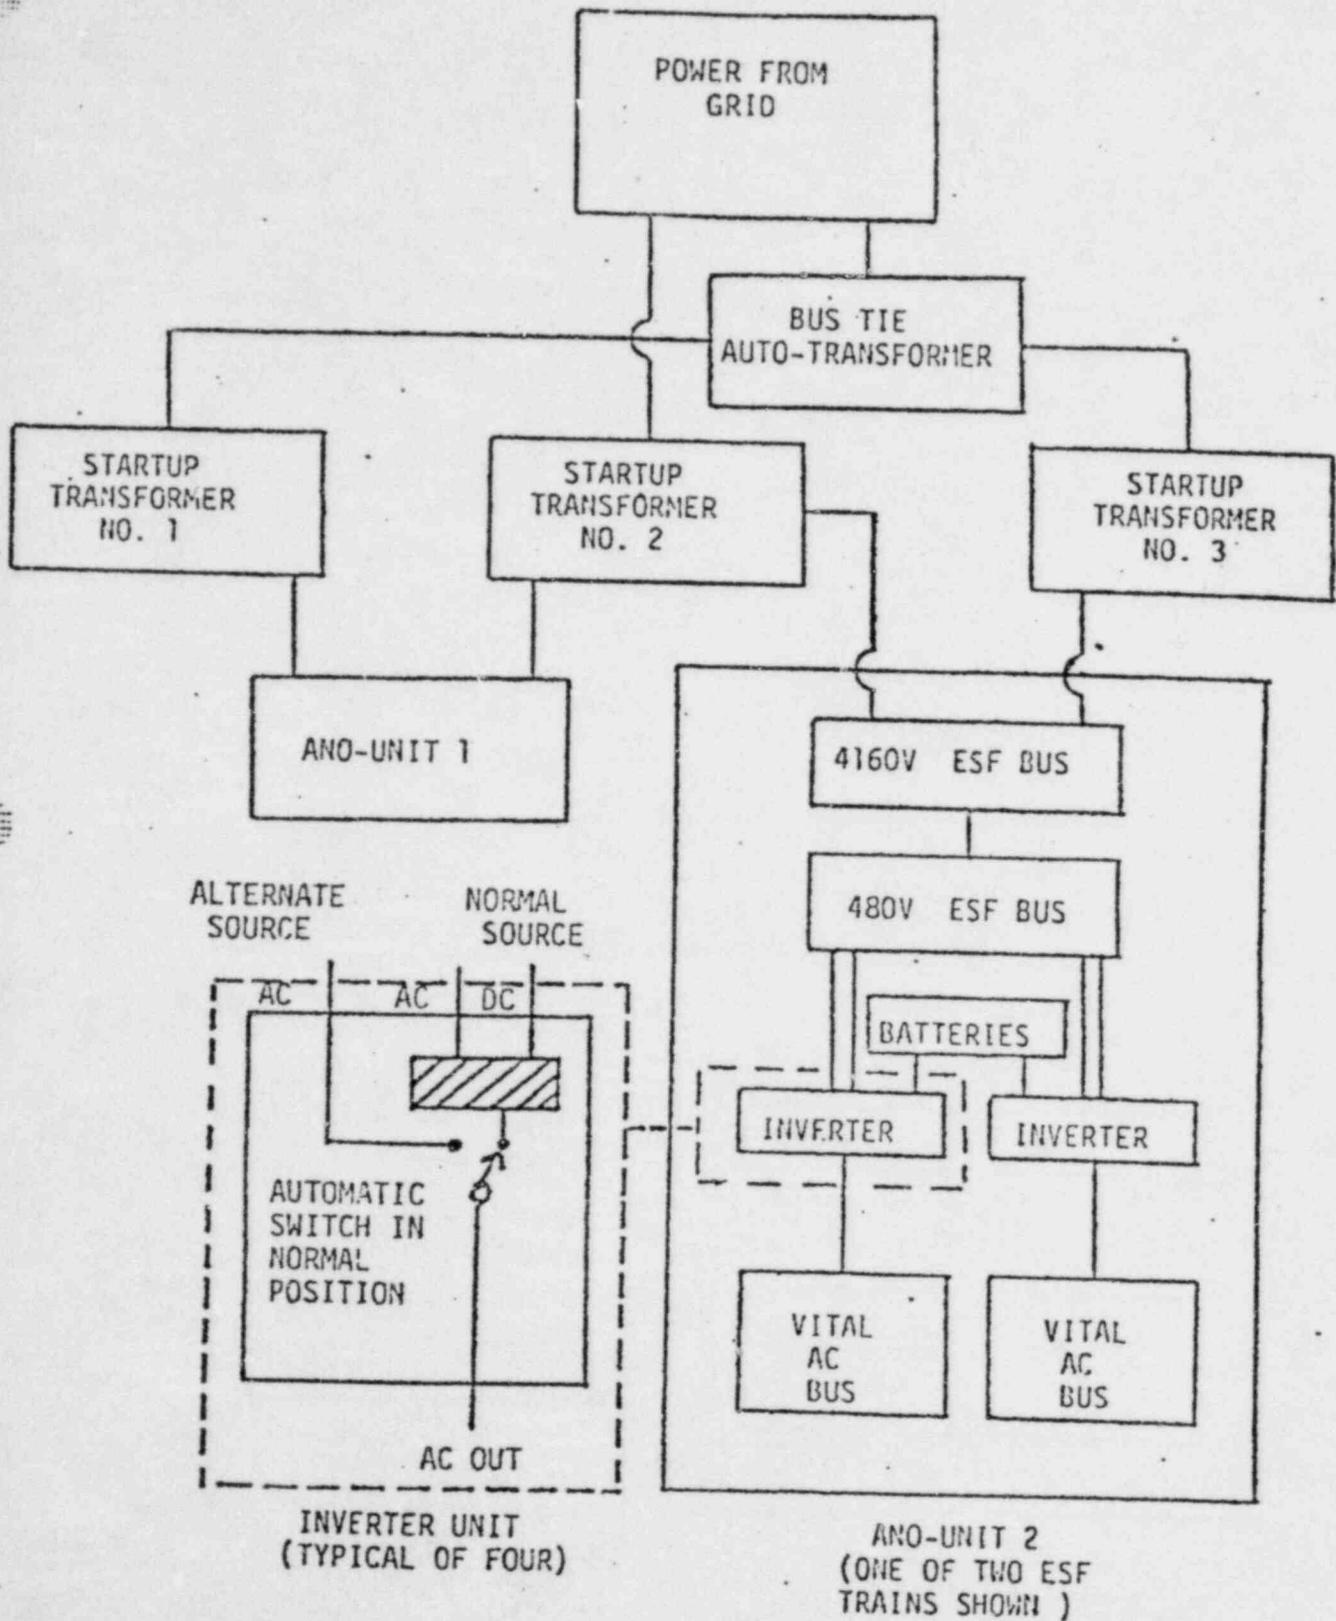
FIGURE 1

The power to Startup Transformer No. 3, which was feeding Unit 2, and to Startup Transformer No. 1, now feeding Unit 1, normally passes through a single piece of equipment, the Bus Tie Auto-Transformer. (Figure 1 shows a simplified block diagram of the principal electrical equipment involved.) The Auto-Transformer has the capacity to provide power for both units, but due to an error, the protective relays were still adjusted for the operation of Unit 1 only. As a result, when both units concurrently drew power from the Auto-Transformer these protection relays tripped and cut off power to Startup Transformer Nos. 1 and 3.

Startup Transformer No. 2, also shown in Figure 1, thus became the only source of offsite power for both Units 1 and 2. The onsite switching equipment automatically transferred the full auxiliary loads for both units to this transformer. However, this transformer is not designed to carry full auxiliary loads for both units. For this reason, Startup Transformer No. 2 became overloaded and the voltage dropped on the station distribution system for offsite power. At this time, and during most of the incident, operating personnel at both units were unaware of the degraded voltage <sup>2/</sup> condition due to the overloaded Startup Transformer No. 2 <sup>3/</sup>.

The immediate causes of the unusual event at Arkansas Nuclear One were: (1) loss of the Bus Tie Auto-Transformer which resulted in degraded power operation through Startup Transformer No. 2; and (2) multiple Unit 2 inverter failures.

The loss of the Bus Tie Auto-Transformer was caused by inappropriate setpoints for its protective relays. The Bus Tie Auto-Transformer loss had not been adequately reviewed prior to this event in that the overloading of the shared Startup Transformer No. 2 had not been identified during the design and review process.
