March 9, 1979
Fort St. Vrain
Unit No. 1
P-79059

REPORTABLE OCCURRENCE 79-05

FORT ST. VRAIN NUCLEAR GENERATING STATION
PUBLIC SERVICE COMPANY OF COLORADO
P. O. BOX 361
PLATTEVILLE, COLORADO 80651

REPORT NO. 50-267/79-05/03-L-0

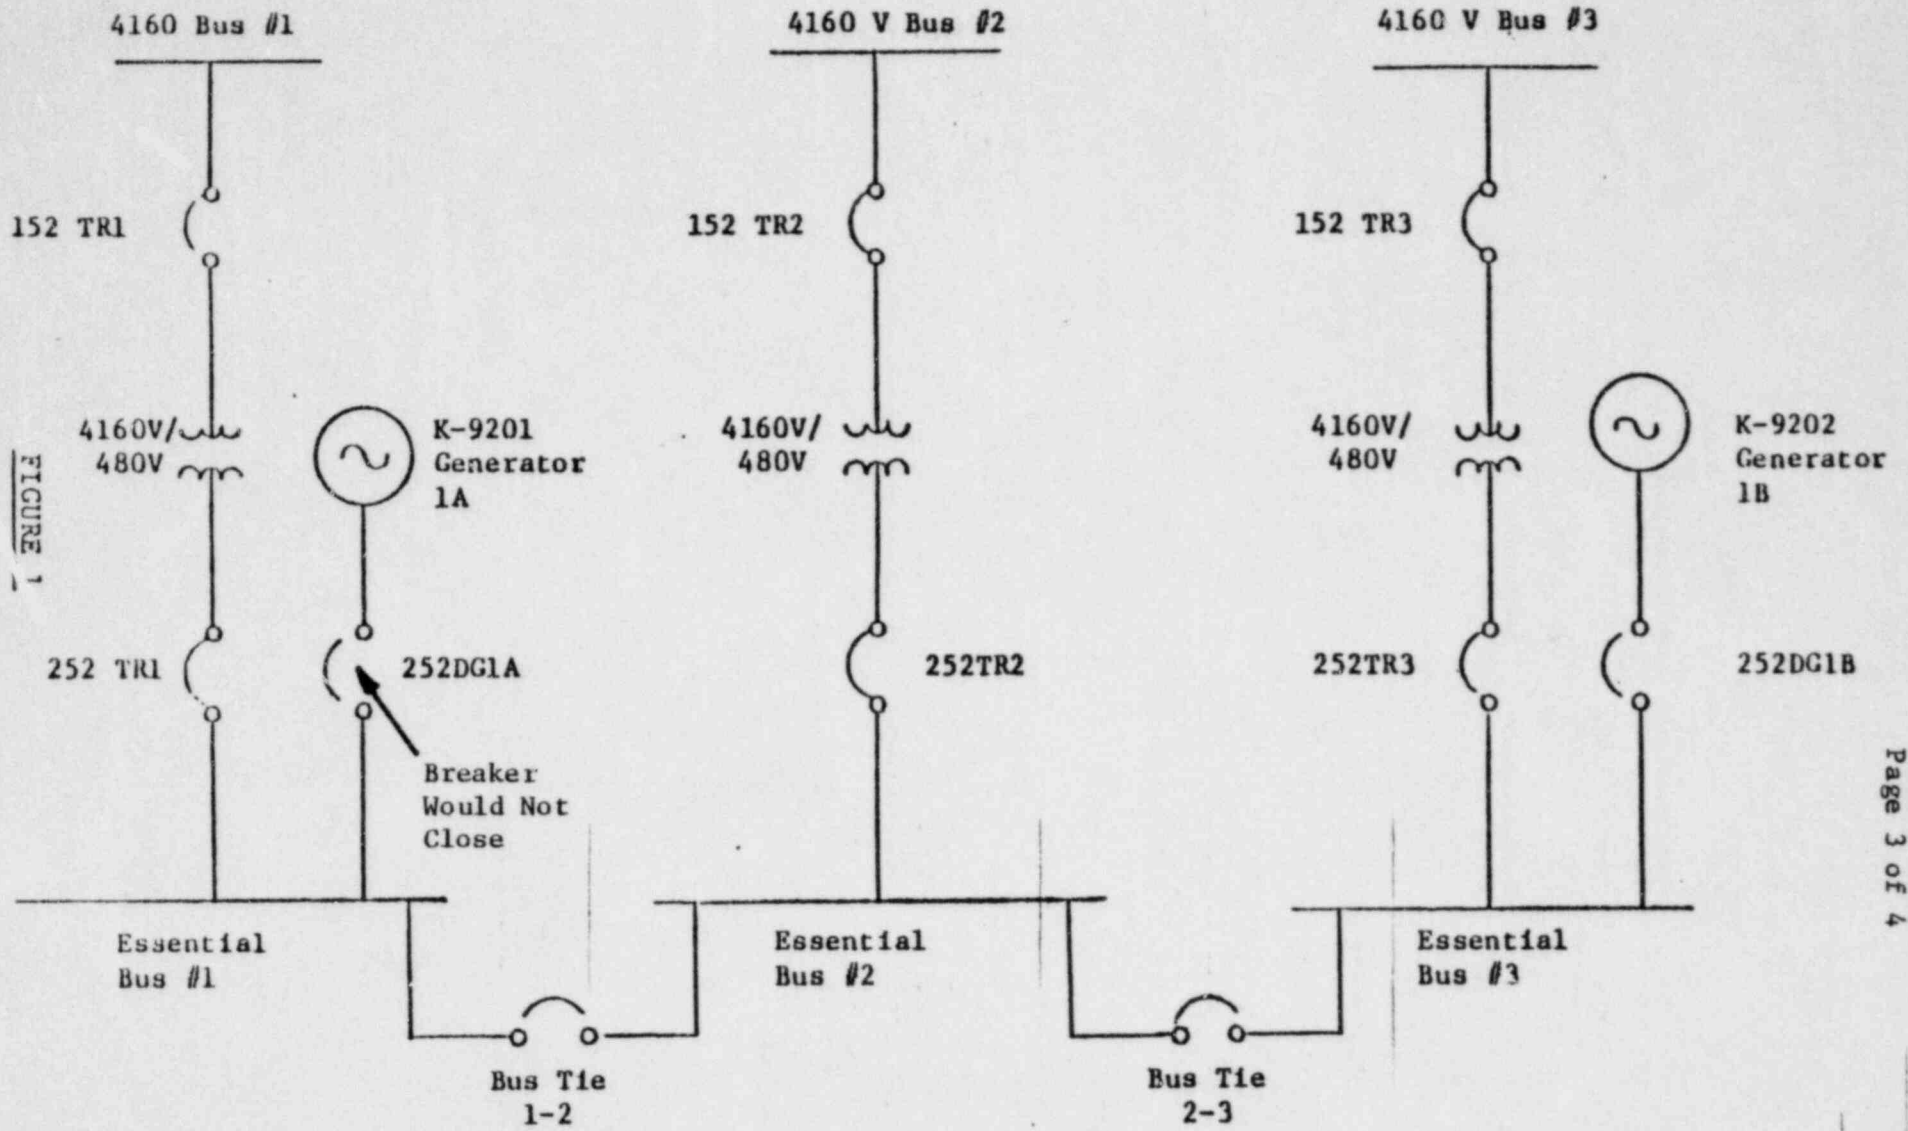
FIGURE 1

On February 9, 1979, while performing the loss of outside electrical power surveillance test, one diesel generator output circuit breaker would not close.

While the plant was shutdown, the surveillance test was being run, which simulates the loss of outside electrical power and main turbine trip. Upon simulation of loss of outside electrical power and turbine trip, both diesel generators started automatically. However, the diesel generator 1A output breaker (252 DGLA) to the essential 480 volt Bus No. 1 did not close (refer to Figure 1). Diesel generator 1B had been interlocked to simulate that it would not be the first generator to reach operating conditions, as called for by the procedure. Therefore diesel generator 1B correctly did not close in on 480 volt Bus No. 3, because diesel generator 1A had not closed in to supply 480 volt Bus No. 1 first.

Undetermined. Bench testing of breaker was successful. No electrical or mechanical malfunction could be ascertained.

The faulty breaker was replaced with a spare and is currently being inspected and tested. The results of the investigation will be reported in a supplement to this report.
