UNITED STATES
NUCLEAR REGULATORY COMMISSION
OFFICE OF INSPECTION AND ENFORCEMENT
WASHINGTON, D.C. 20555

IE Information Notice No. 79-04
Date: February 16, 1979
Page 1 of 5

DEGRADATION OF ENGINEERED SAFETY FEATURES

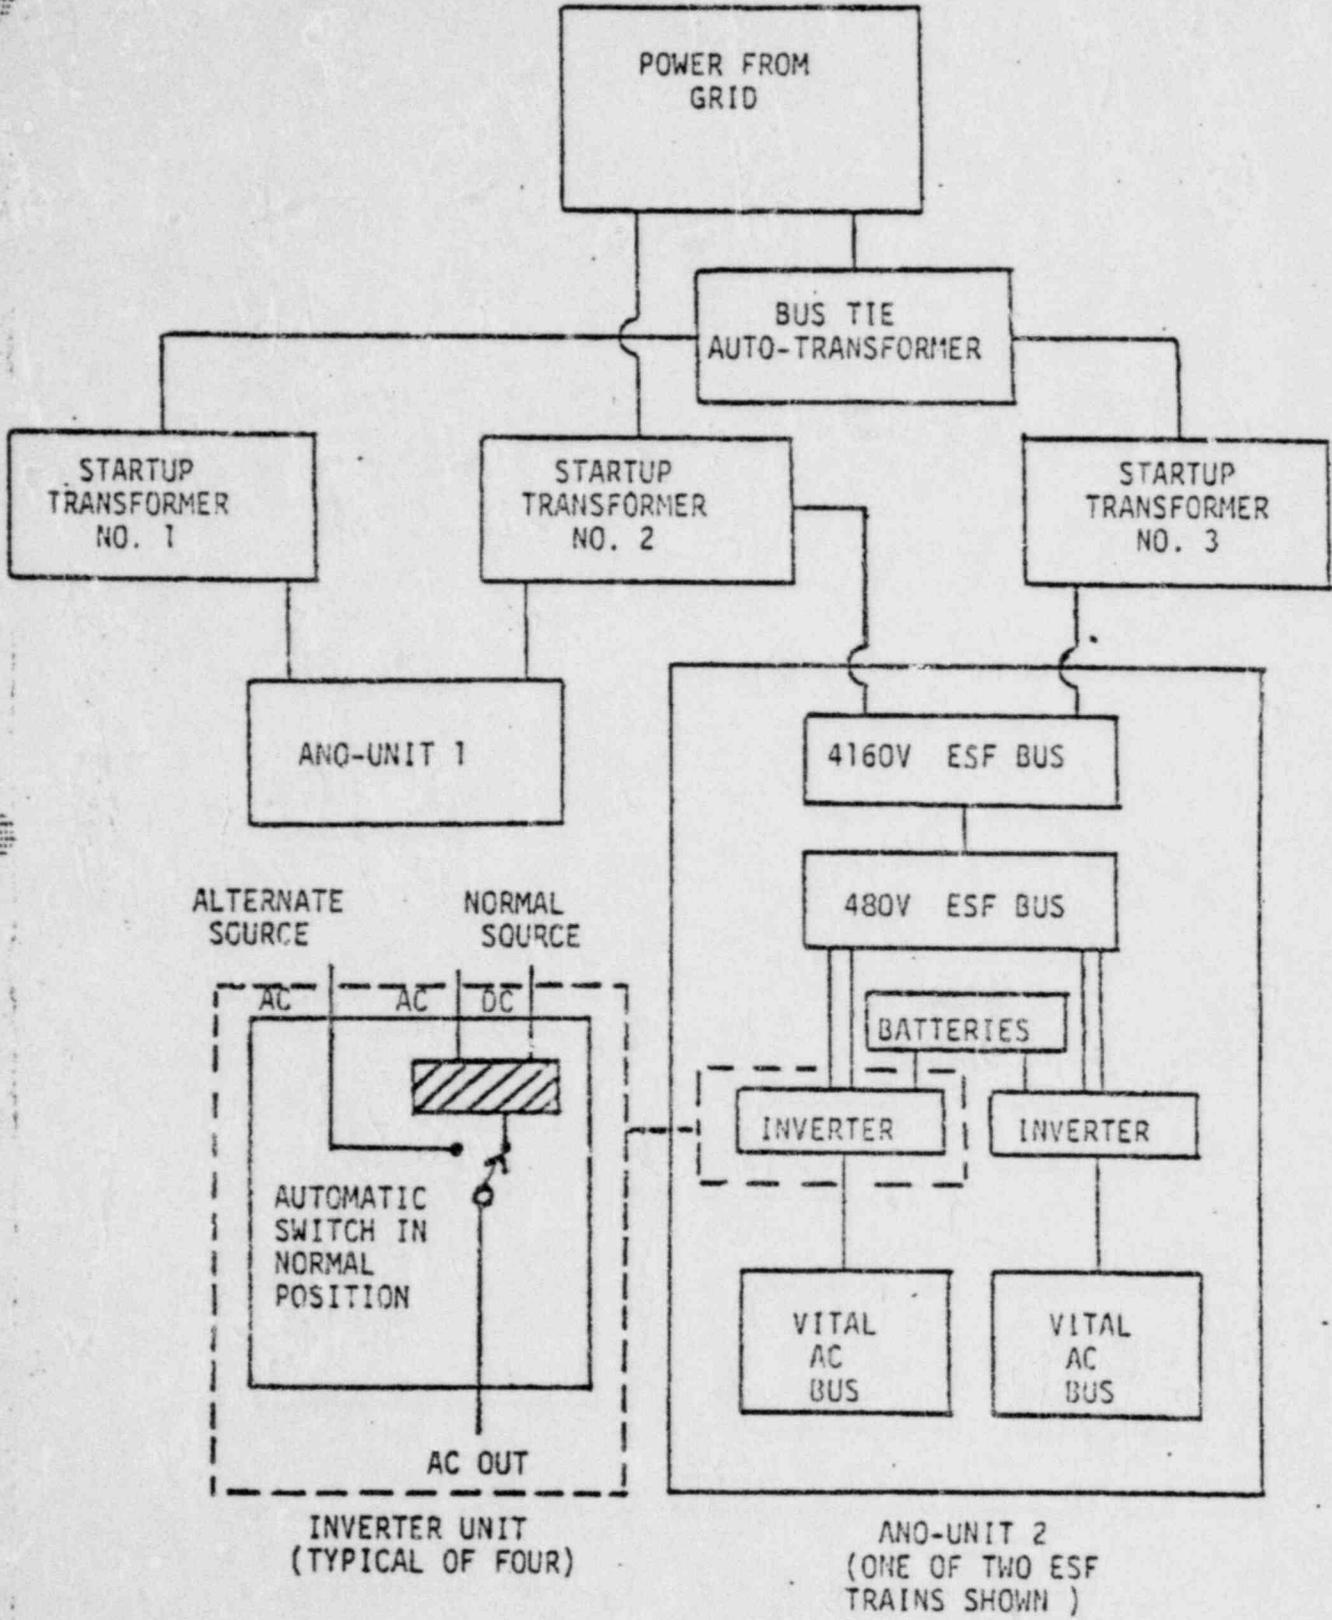
FIGURE 1

The power to Startup Transformer No. 3, which was feeding Unit 2, and to Startup Transformer No. 1, now feeding Unit 1, normally passes through a single piece of equipment, the Bus Tie Auto-Transformer. (Figure 1 shows a simplified block diagram of the principal electrical equipment involved.) The Auto-Transformer has the capacity to provide power for both units, but due to an error, the protective relays were still adjusted for the operation of Unit 1 only. As a result, when both units concurrently drew power from the Auto-Transformer these protection relays tripped and cut off power to Startup Transformer Nos. 1 and 3.

Startup Transformer No. 2, also shown in Figure 1, thus became the only source of offsite power for both Units 1 and 2. The onsite switching equipment automatically transferred the full auxiliary loads for both units to this transformer. However, this transformer is not designed to carry full auxiliary loads for both units. For this reason, Startup Transformer No. 2 became overloaded and the voltage dropped on the station distribution system for offsite power. At this time and during most of the incident, operating personnel at both units were unaware of the degraded voltage² condition due to the overloaded Startup Transformer No. 2.³

Cause or Causes The immediate causes of the unusual event at Arkansas Nuclear One were: (1) loss of the Bus Tie Auto-Transformer which resulted in degraded power operation through Startup Transformer No. 2, and (2) multiple Unit 2 inverter failures.

The loss of the Bus Tie Auto-Transformer was caused by inappropriate setpoints for its protective relays. The Bus Tie Auto-Transformer loss had not been adequately reviewed prior to this event in that the overloading of the shared Startup Transformer No. 2 had not been identified during the design and review process.
