UNITED STATES
NUCLEAR REGULATORY COMMISSION
OFFICE OF INSPECTION AND ENFORCEMENT
WASHINGTON, D.C. 20555

March 7, 1980

IE Information Notice No. 80-08

THE STATES COMPANY SLIDING LINK ELECTRICAL TERMINAL BLOCK

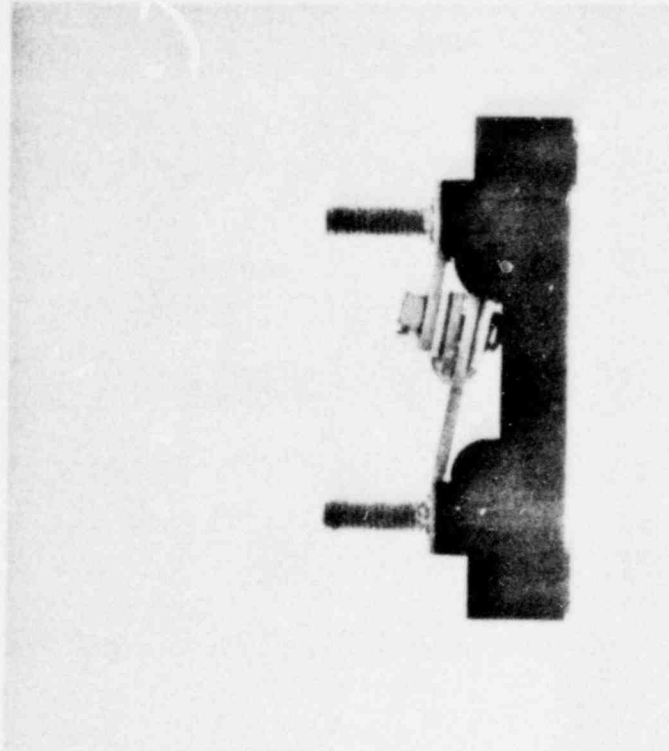
Side View of States Company
Terminal Block in Assembled Position

The connection between the two slotted bars on the terminal block is made by a U-shaped sliding link and spacer located between the two bars. The top of the U-shaped link and the spacer are drilled and the bottom of the link is threaded to accept a 8-32 screw. When the screw is tightened it binds the link, spacer and bar together to make electrical connection. Loosening the screw and sliding the link from between the bars breaks the connection. The purpose of the link is to provide easy insertion of test instruments, etc. into the circuit.

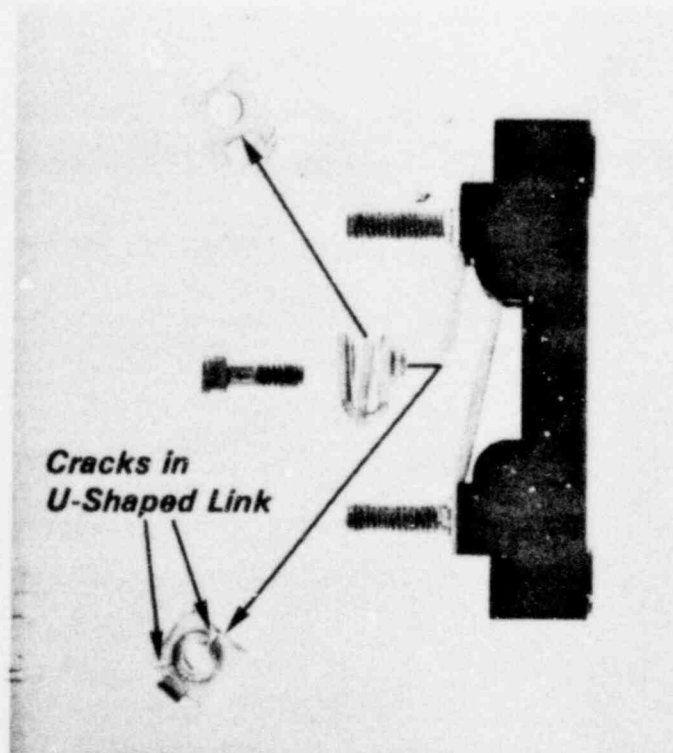
Exploded View of
States Company Terminal Block

The defect, which has been identified in 5% of the terminal blocks checked, occurs in the form of a crack between the threaded screw hole and the side of the U-shaped link. When the screw is tightened the crack widens and a poor or intermittent electrical connection can result. A defective link is impossible to cinch tightly in place and is difficult to detect visually.

Enclosure 1 shows the States Company terminal block. The defect, a crack in the bottom portion of the metal U-shaped link, is displayed in the exploded view of the terminal block assembly. These terminal blocks are widely used in the nuclear industry and may be used as permanent installations in safety related systems. The defective mechanical connection can cause an electrical circuit malfunction.
