SSINS No: 6820
Accession No.:
8006190050
IEB 80-22

September 11, 1980

IE Bulletin No. 80-22: AUTOMATION INDUSTRIES, MODEL 200-520-008 SEALED-SOURCE CONNECTORS

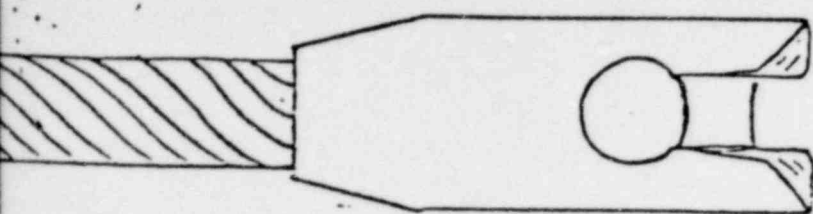
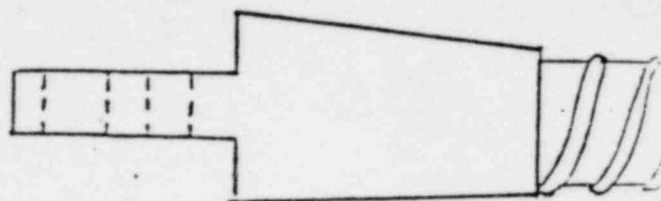
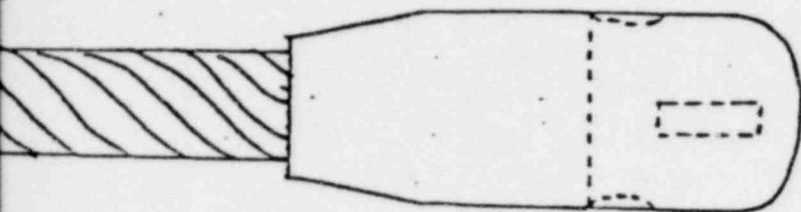
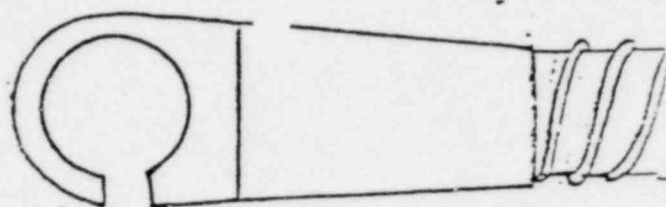
An accident recently occurred in the State of California (an Agreement State) that resulted in several serious overexposures (see enclosed Circular 79-16). The accident involved the use of an Automation Industries (AI) Model 200-520-008 source pigtail to drive cable connection. The connector is identified by the manufacturer as its "quick disconnect" type of connector and is used with several models of cobalt-60 and iridium-192 source assemblies distributed by the manufacturer. The connection is a simple hook and eye connection (see Fig. 1) that will permit separation of the eye from the hook when they are oriented at right angles to each other without any further positive action. As a result of the design, a disconnection may occur any time the source assembly is cranked out of the exposure device without the guide tube being attached. Since the Automation Industries Model 200-520-008 sealed-source assembly is authorized to contain up to 120 curies of iridium-192, a source disconnection creates a potential for a serious exposure.

The removal from service of the "quick disconnect" type of connector will require that those drive cables having the matching open hook connector be modified.

- (1) Determine the number of AI Model 200-520-008 and other assemblies in your inventory that have the "quick disconnect" connector and establish a disposal schedule. Your schedule for iridium-192 sources should be no longer than your usual exchange schedule for diminished activity sources. Your exchange schedule for connector modification for cobalt-60 sources should be accomplished as soon as is conveniently possible. However, you should complete your disposal or modification by September 1, 1981.

- (2) In the interim, a warning mark or tag should be placed on each radiographic device in which AI "quick disconnect" type assemblies are being used.
