UNITED STATES  
NUCLEAR REGULATORY COMMISSION  
REGION III  
799 ROOSEVELT ROAD  
GLEN ELLYN, ILLINOIS 60137

IE Circular No. 79-02

FAILURE OF 120 VOLT VITAL AC POWER SUPPLIES

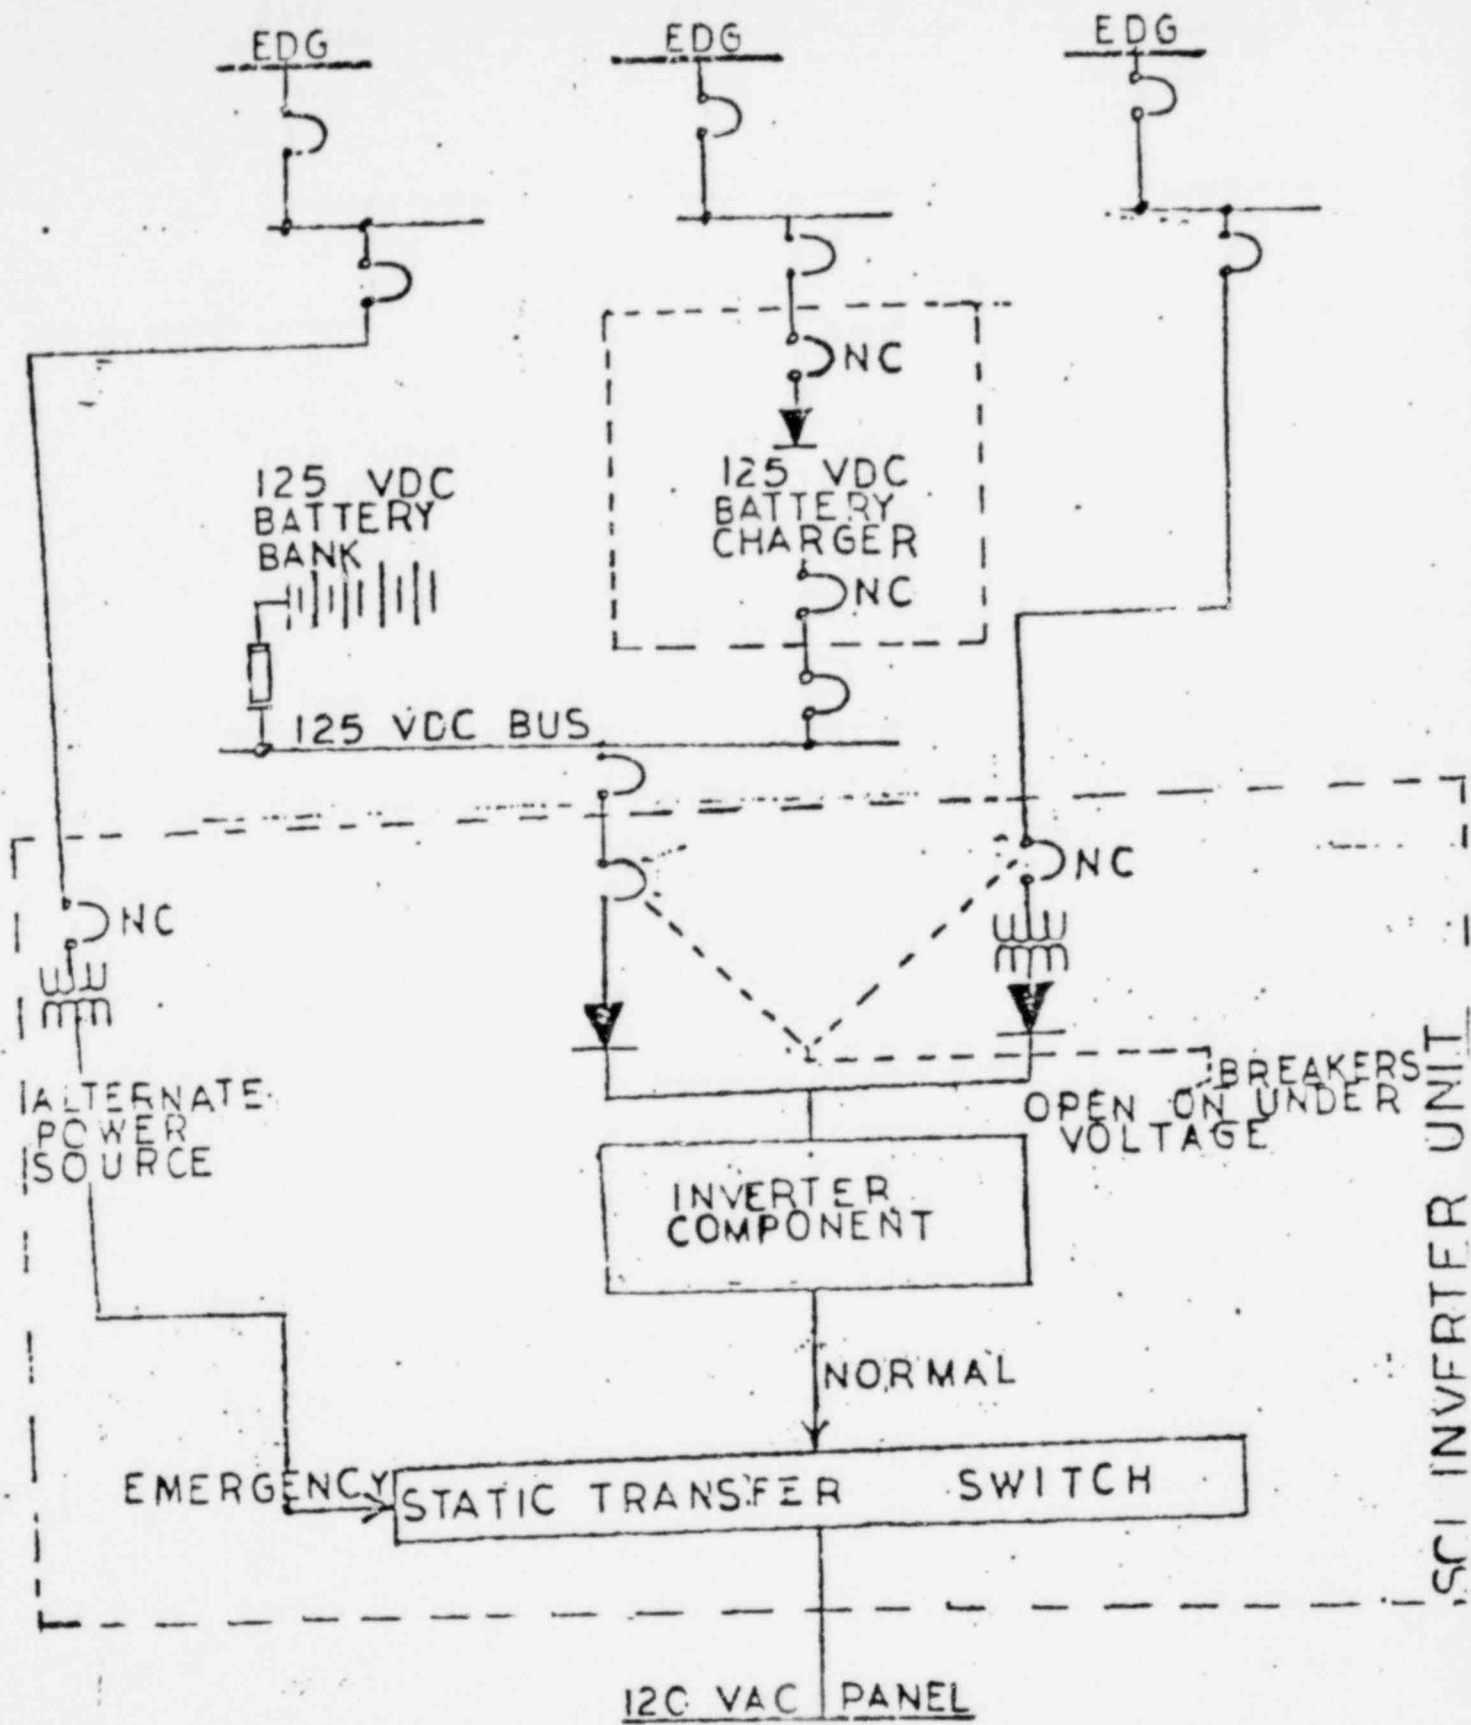
FIGURE 1  
 SINGLE LINE DIAGRAM - 120 VAC

On September 16, 1978, Arkansas Nuclear One - Unit 2 while in hot functional testing preceeding initial criticality, suffered a degradation of both of the independent off-site power sources. This produced an undervoltage condition on the Engineering Safety Features (ESF) Buses and caused an inadvertent ESF actuation. The licensee determined that the ESF actuation occurred on a loss of at least two of the uninterruptable 120 volt vital AC power sources. Immediate investigation revealed that all four of the Solidstate Controls, Inc., (SCI) inverter static switches had automatically transferred to the alternate power supply (the 120 volt AC being supplied by transformers directly off the ESF buses rather than from the inverter output.) Figure 1 (attached) shows the functional interconnection of the 120 volt AC power supply system.

A single conclusive cause of the undesired SCI inverter static switch transfer could not be identified. However, the following problems were discovered during subsequent investigation.

- (a) The SCI inverters have circuitry to monitor the incoming DC voltage level which, on sensing a low voltage (nominally 104 DC volts for these inverters) will trip both input breakers to the inverter component after an adjustable time delay.

- (b) On one SCI inverter, a DC fuse within the inverter component was found blown. The vendor indicated that this fuse will blow due to an excessive DC voltage to the inverter component caused by a transient on the 480 AC input. The licensee has subsequently reset the taps on the 480V to 120V three-phase AC input transformer to limit the DC voltage to the inverter to less than the nameplate maximum rating in the event of a high AC input voltage transient.

- (c) The SCI inverter static switch is designed to transfer to an alternate source on inverter output overcurrent or undervoltage. Initially, these trips were set at 125 percent overcurrent and 80 percent undervoltage. An explanation for the transfer of two of the inverter static switches is that during one of the transfers of site loads, the instantaneous inductive load caused these trip set points to be exceeded. The licensee has subsequently adjusted the transfer sensing circuitry to higher overcurrent and lower undervoltage trip settings to assure that the inverter will maintain load over the widest possible range of voltage and current. (Note that in this case, once the SCI inverter transfers to the alternate source, it will not automatically transfer back to normal source.)

1. Determine whether or not time delay circuitry is used in your inverter units. If so, have they been adjusted to the appropriate set point as required by equipment and the integrated system designs?

2. Determine if the AC input voltage and transformer tap settings are optimized to prevent exceeding the inverter component name-plate maximum rated DC input voltage in the event of a high AC input voltage transient.

3. If an alternate 120 volt source is used in your design, determine if the protection transfer circuitry of the inverter has been optimized within design limits to ensure maximum possible availability of the inverter system during transient loading conditions. An operating history of inexplicable transfers may be indicative of the above.

4. Determine if the administrative controls employed by your facility ensures operability of safety systems after its subcomponents (e.g., time delay relays, switches, etc.) have been subjected to maintenance or testing.
