Docket No. 50-346

IE Circular No. 79-02

FAILURE OF 120 VOLT VITAL AC POWER SUPPLIES

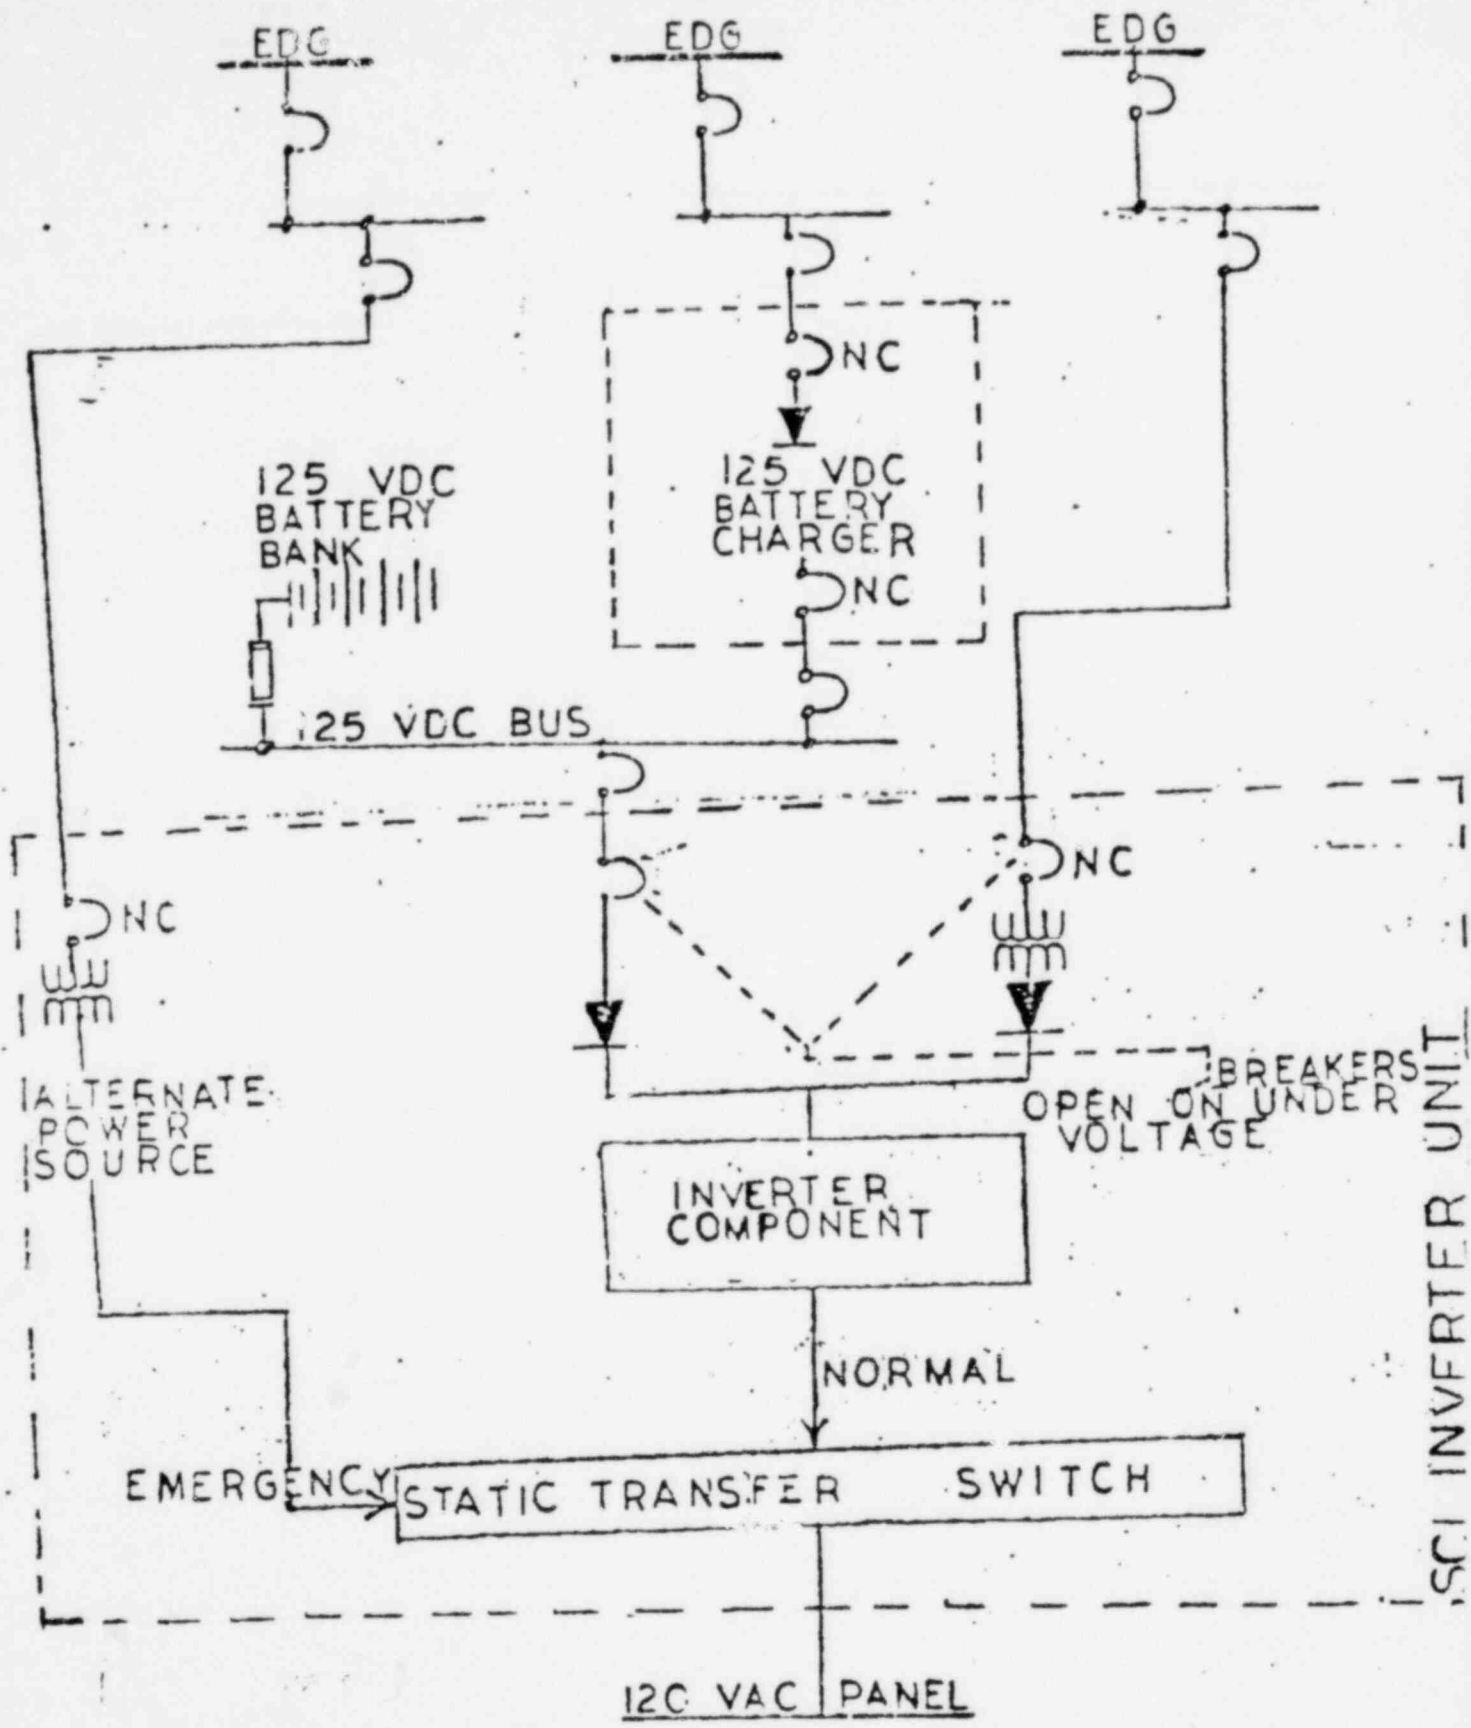
FIGURE 1
 SINGLE LINE DIAGRAM - 120 VAC

On September 16, 1978, Arkansas Nuclear One - Unit 2, while in hot functional testing preceding initial criticality, suffered a degradation of both of the independent off-site power sources. This produced an undervoltage condition on the Engineering Safety Features (ESF) Buses and caused an inadvertent ESF actuation. The licensee determined that the ESF actuation occurred on a loss of at least two of the uninterruptable 120 volt vital AC power sources. Immediate investigation revealed that all four of the Solidstate Controls, Inc., (SCI) inverter static switches had automatically transferred to the alternate power supply (the 120 volt AC being supplied by transformers directly off the ESF buses rather than from the inverter output.) Figure 1 (attached) shows the functional interconnection of the 120 volt AC power supply system.
