FINAL REPORT  
MECHANICAL-ELECTRICAL AUXILIARY BUILDING BASEMAT  
SOUTH TEXAS PROJECT ELECTRIC GENERATING STATION UNIT 2

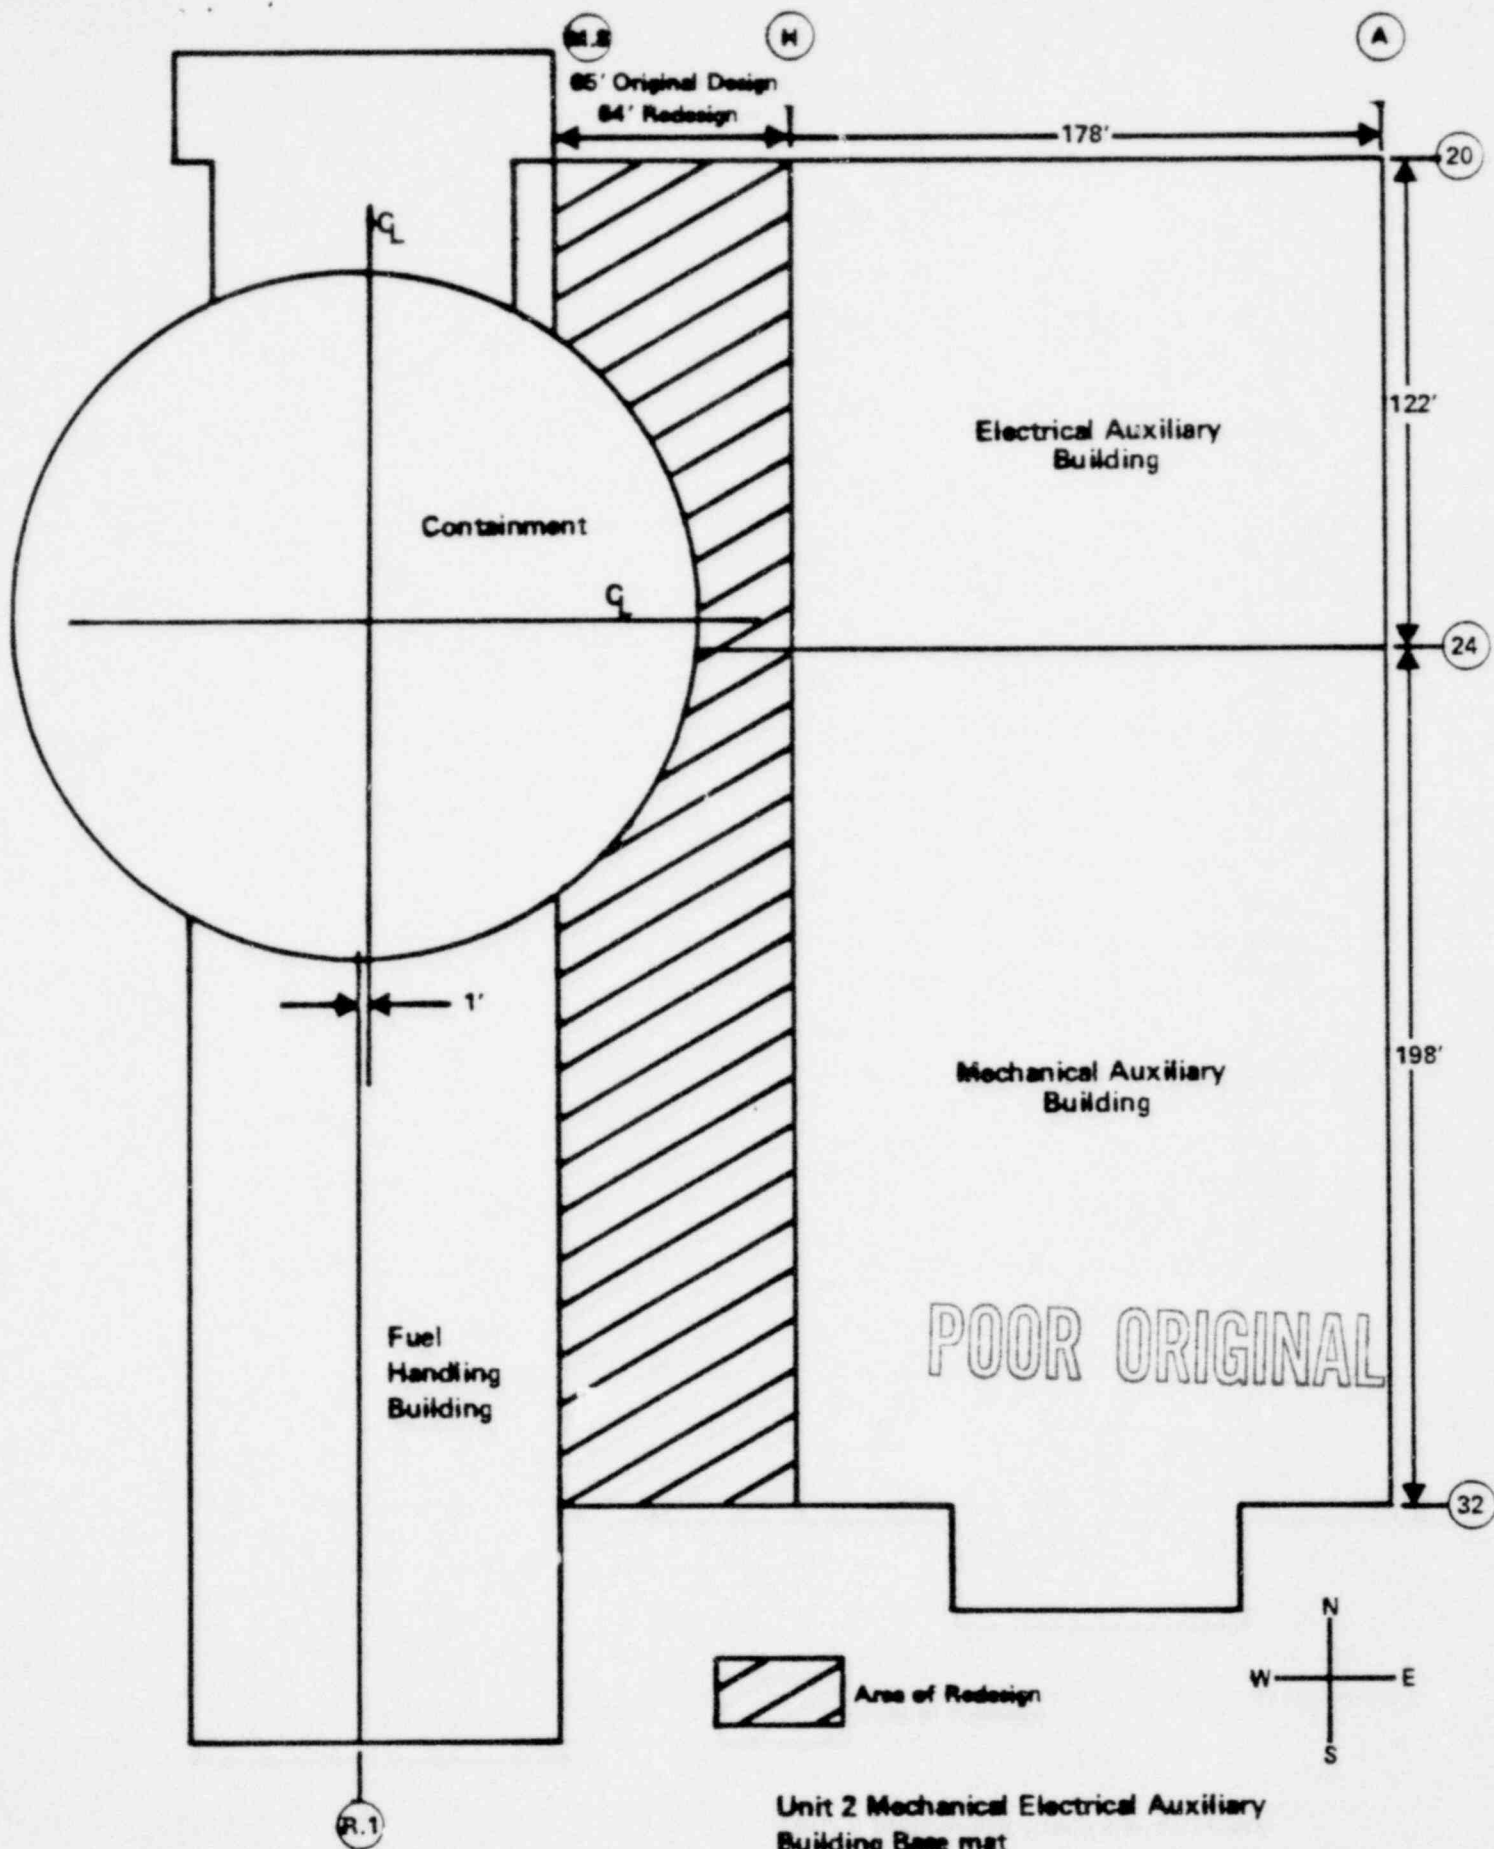
Unit 2 Mechanical Electrical Auxiliary  
Building Base mat  
Figure 1

Due to a survey calculation error, the basemat of the Unit 2 Mechanical-Electrical Auxiliary Building was constructed one foot short on the east side of the building. The error occurred because, instead of using the containment/reactor centerline as the reference as had been intended, the building was laid out in the field using the dimensions relative to column line R.1 in the Fuel Handling Building. Column line R.1 in the Fuel Handling Building is offset one foot to the west of the containment/reactor centerline (see Figure 1) thus resulting in the east edge of the Mechanical-Electrical Auxiliary Building being laid out one foot short of the design. The survey calculations were not properly checked by the Field Engineering Supervision.

Redesign of the Mechanical-Electrical Auxiliary Building to compensate for the one foot dimensional error has resulted in only interior spatial alterations. From column line A to column line H (see Figure 1), the layout within the building is unchanged from the original design. From column line H to column line M.8 the one foot has been compensated by reducing distances between column lines and removing excess floor space around the layout of systems and equipment. The general arrangement of equipment within the redesigned area is unchanged by the one foot dimension. Approximately three-fourths of the building (column A to column line H) is unchanged from the original design and the redesign affected only the west one-fourth of the building.
