FINAL REPORT

INVESTIGATION AND REPAIR OF THE CONCRETE VOIDS IN THE EXTERIOR SHELL WALL OF THE STPEGS REACTOR CONTAINMENT BUILDINGS 1 AND 2

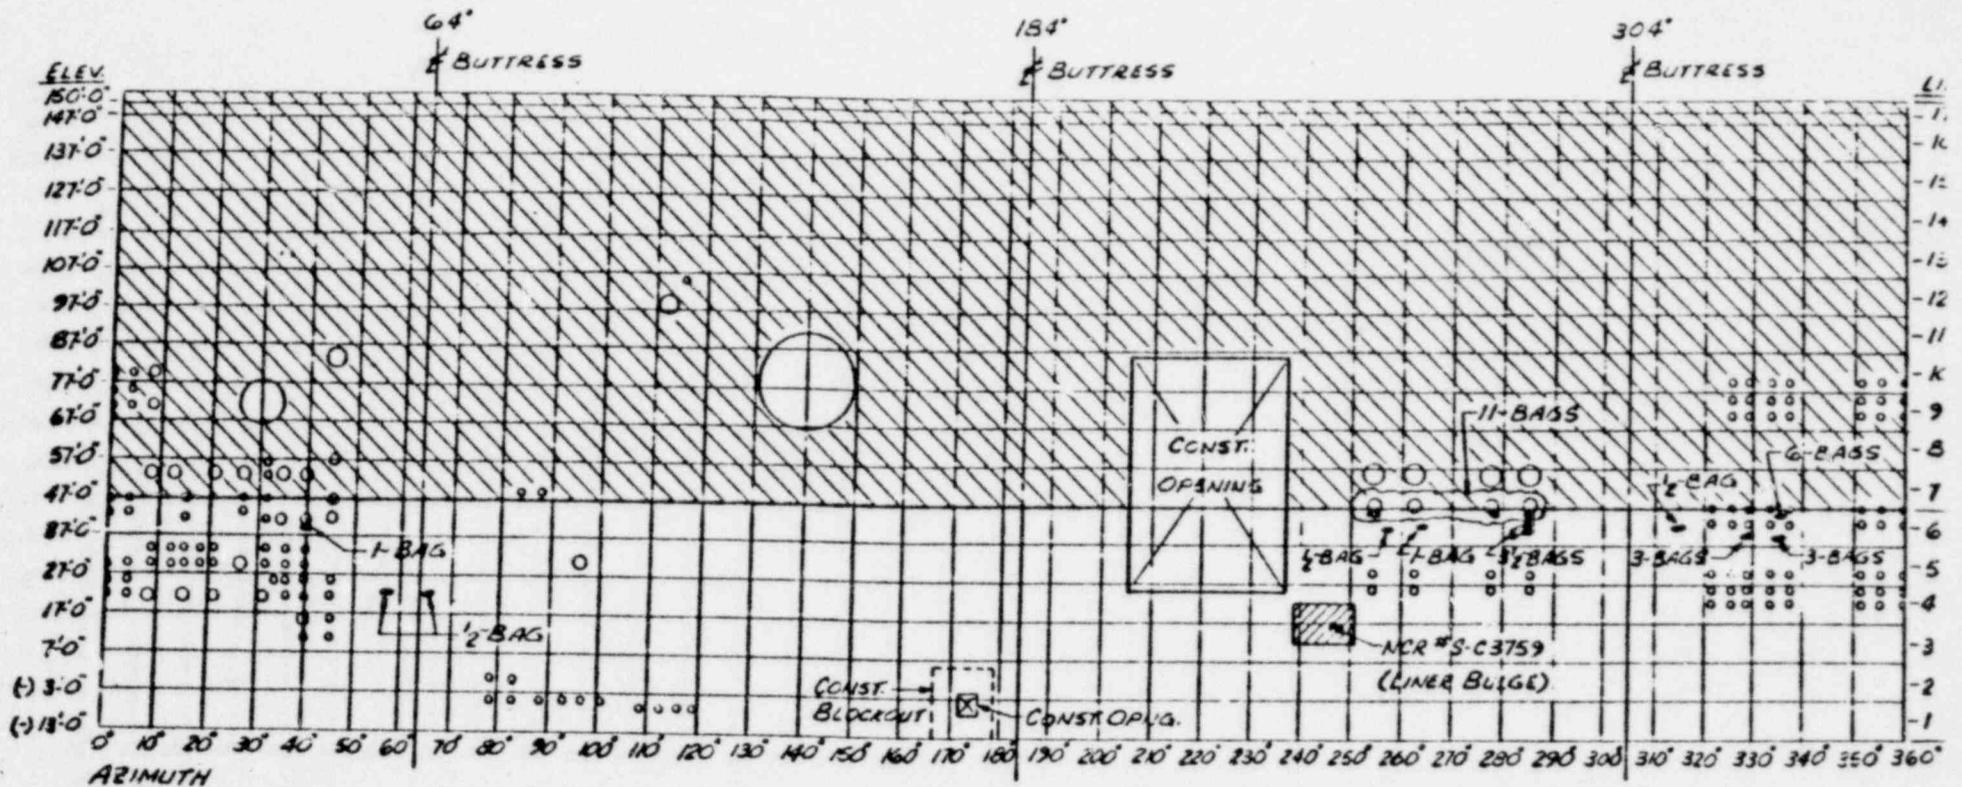
FIGURE - B

Larger voids were found in areas of larger penetrations where concrete placement was more difficult due to the added congestion of reinforcing steel. Figures A and B represent the location and approximate volume of grout pumped into the voids for Units 1 and 2 respectively. Of the total number of holes drilled during this investigation in both Units, including all additional holes added for venting purposes, over 70% indicated that no void existed.

Unit 2: In general, voids determined in Unit 2 were not as large or deep as those found in Unit 1. One isolated area did vent to the outside of the Containment and was located below an electrical penetration near Azimuth 335° and Elev. 45'. All remaining voids were located at random positions beneath other penetrations and/or the 8 inch channel and plate stiffeners.

1. ● DETERMINED VOIDS THAT WERE REPAIRED BY PRESSURE GROUTING.
2. TOTAL NUMBER OF BAGS = 30 = 2 1/2 CU. YDS.
3. TOTAL NUMBER OF HOLES DRILLED INSIDE THROUGH THE LINER PLATE = 96 WHICH INCLUDES APPROX. 30 USED TO LOCATE AND GROUT THE DETERMINED VOIDS. (DOES NOT INCLUDE BULGE AREA.)
4. TOTAL NUMBER OF HOLES DRILLED OUTSIDE TO HELP IDENTIFY AND PERMIT VENTING OF VOIDS LOCATED BENEATH PENETRATIONS = 9.
