AEOD TECHNICAL REVIEW REPORT\*

UNIT: Limerick 1 TR REPORT NO: AEOD/T601  
DOCKET NO: 50-352 DATE: January 27, 1986  
LICENSEE: Philadelphia Electric Company EVALUATOR/CONTACT: T. C. Cintula  
NSSS/AE: General Electric Company/  
Bechtel Corporation

SUBJECT: PRESSURE SENSITIVE TEMPERATURE SWITCH RESULTS IN SPURIOUS  
ACTUATION OF FIRE SUPPRESSION SYSTEM

EVENT DATE: April 10, 1985

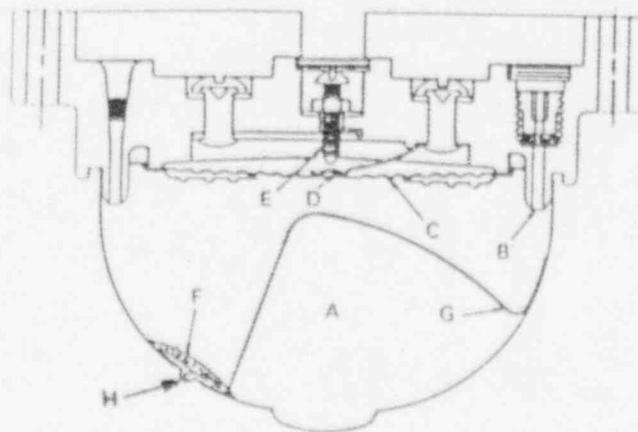
FIGURE 1. CROSS SECTION OF CHEMETRON FIRE SYSTEMS, INC.  
RATE-OF-RISE TEMPERATURE SWITCH

The design and operation of the Chemetron rate-of-temperature-rise switch was investigated by the licensee to determine the cause for the spurious switch actuation when the supply fan tripped. It was found that the switch uses two independent methods for detecting a fire: (1) the rate-of-temperature-rise element; and (2) a fixed temperature element. The rate-of-rise element is an anticipatory feature that detects fires that grow rapidly in intensity by quickly responding to abnormally fast temperature increases. The fixed temperature element detects smoldering fires which grow at a slow rate by actuating at a specific temperature setting. The Chemetron Model EPB 501 dual action thermal fire detector involved in the Limerick event is shown in Figure 1. The rate-of-rise element shown in the figure consists of an air chamber, flexible metal diaphragm and a restricted orifice vent that is accurately calibrated to control the air flow rate in and out of the chamber. The air chamber (A) expands and contracts with ambient room temperature variations. During normal temperature fluctuations, the unit "breathes" through the calibrated vent (B). For rapidly increasing temperature, the air in the chamber expands faster than it can be vented and builds up enough pressure to move the thin metal diaphragm (C) until the flexible silver contact (D) closes an electrical circuit with the stationary contact (E). If the source of heat is subsequently removed, pressure in the chamber is relieved through the vent and the contact resets to the untripped condition. The fixed temperature element is independent of the rate-of-rise heat detection feature. The fixed temperature element has a phosphor-bronze spring (G) that is held under tension by a spot of fusible

alloy (F). When heated to its rated temperature (either 136°F or 190°F), the alloy melts releasing the spring and closing the electrical contacts. If the fixed temperature element operates, the spring is released and opens an easily visible hole (H) on the shell to signal for detector replacement.

The rate-of-temperature-rise function in the thermal fire detector which causes an air chamber to expand and contract with temperature also makes the device sensitive to ambient pressure changes. The sensitivity is controlled by the rate of air flow into and out of the chamber which is controlled by a calibrated vent. Thus, the switch was sufficiently sensitive to ambient pressure increases to cause it to actuate when the standby supply fan was started.

1. Disabling the automatic injection feature of the Halon fire protection system in the auxiliary equipment room. The detectors were rewired to only operate the control room alarms.
2. Replacing the Chemetron fire detector with a Fenwall brand fixed temperature fusible link thermal detector. The Fenwall detector does not have the rate-of-rise anticipatory feature.
3. Restricting the use of portable transmitter/receivers within certain plant areas.
