AEOD TECHNICAL REVIEW REPORT*

UNIT: North Anna Unit 1 TR REPORT NO.: AEOD/T513
DOCKET NO.: 50-338 DATE: November 7, 1985
LICENSEE: Virginia Power EVALUATOR/CONTACT: D. Zukor
NSSS/AE: Westinghouse/Stone & Webster

SUBJECT: FLOODING OF SAFETY-RELATED VALVES IN PITS

EVENT DATE: January 28, 1985

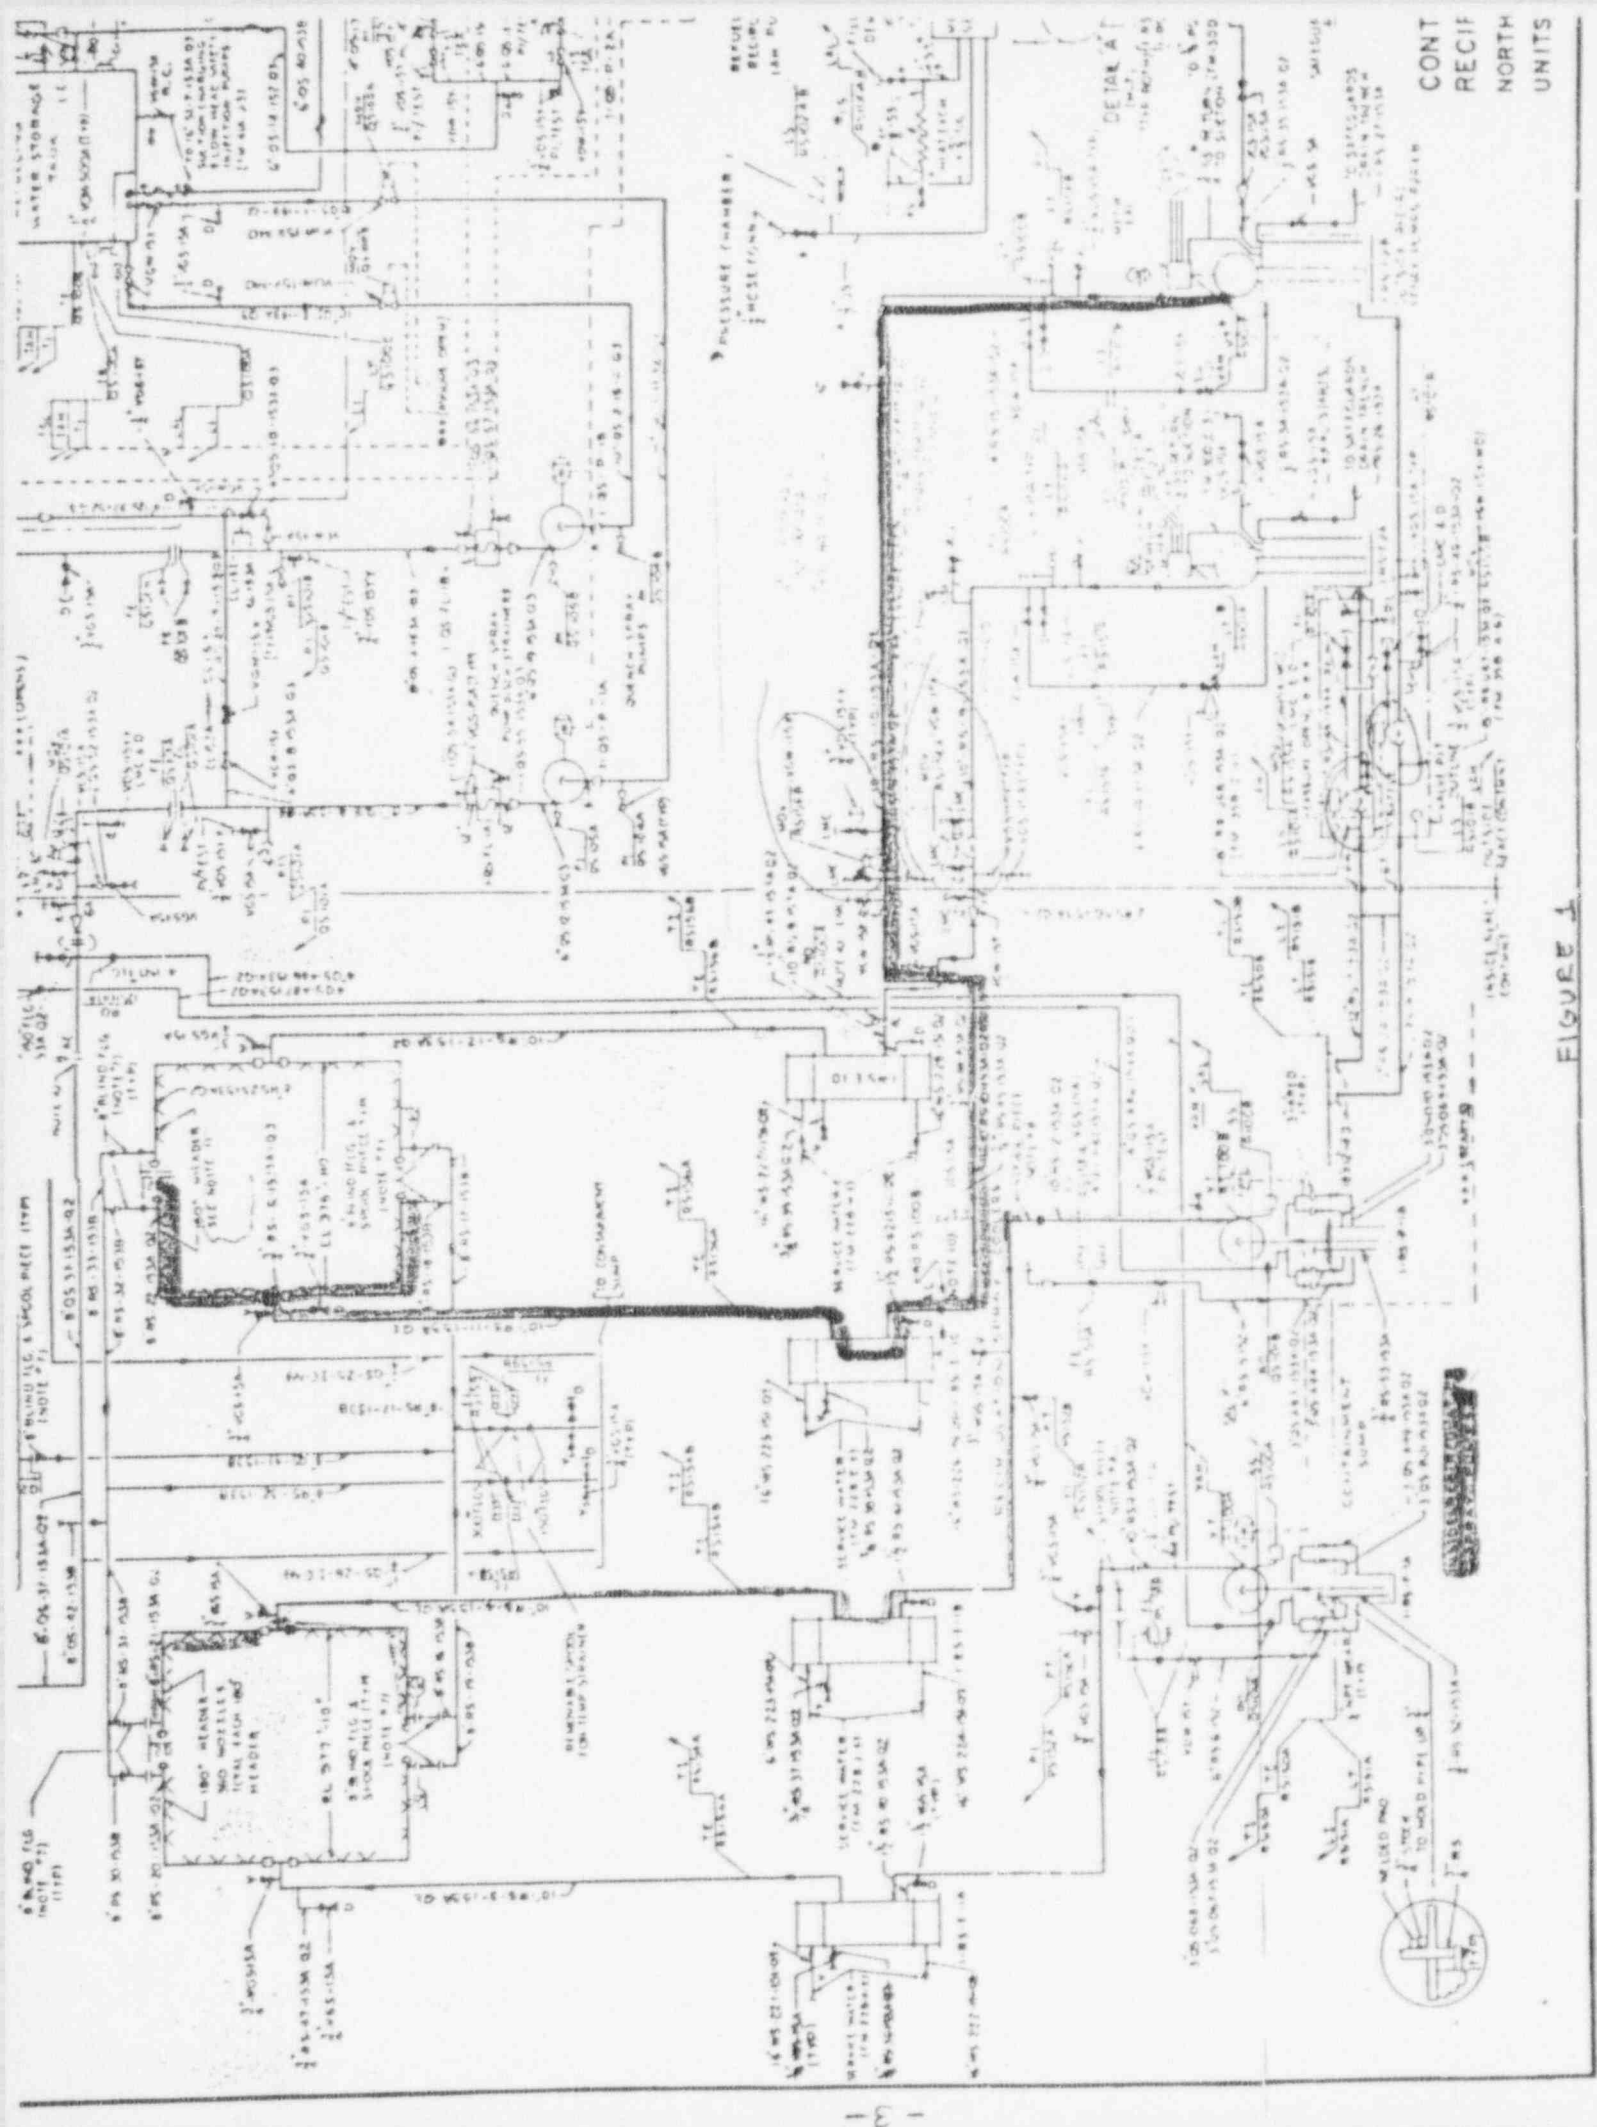
FIGURE 1

containment sump. Once the recirculation mode of safety injection is actuated, the containment sump provides the suction points for the four recirculation spray pumps -- two inside and two outside containment. The heat from the containment sump water is removed by service water when it is pumped through the recirculation spray coolers. A drawing with the indicated flow paths of the RS subsystem may be found in Figure 1. Both suction isolation valves to the two outside recirculation spray pumps are in one valve pit and are separated by a baffle.
