# Technical Bulletin

Subject: <b>Westinghouse NSSS PWR Thermal Shield Degradation</b>	Number: <b>TB-19-5</b>
System(s): <b>Thermal Shield Flexures and Support Block Cap Screws</b>	Date: October 9, 2019
Affects Safety-Related Equipment    Yes <input type="checkbox"/> No <input checked="" type="checkbox"/>	Shop Order: 42

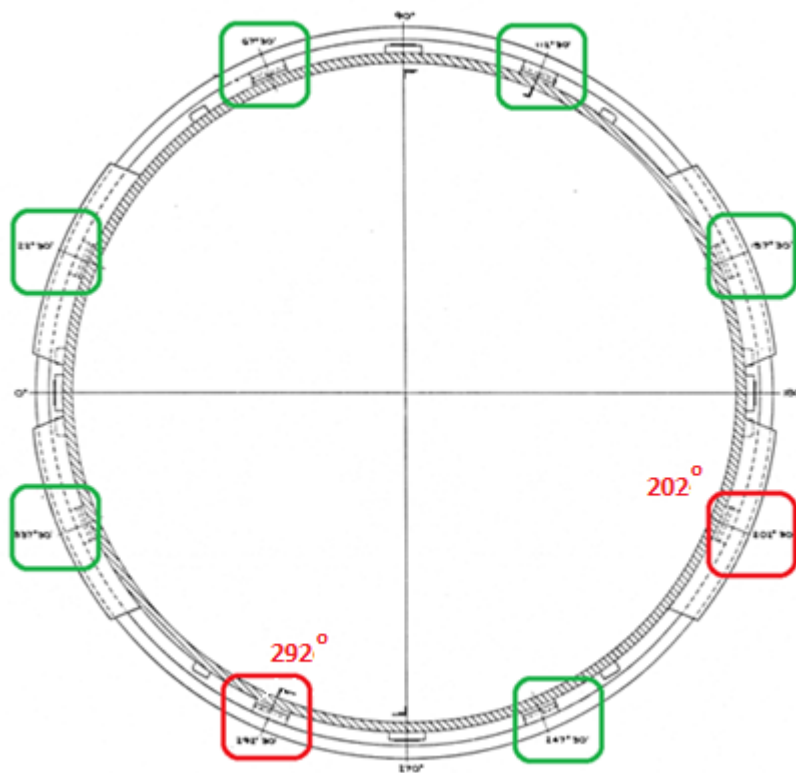
**Figure 4 - Salem Unit 1 Thermal Shield Support Block Layout, Failed Cap Screws in Red (From Top Looking Down)**

In the spring of 2019, Salem Unit 1 discovered four failed TSSB cap screws (severed under the head), two at the 202 degree support location and two at the 292 degree support location (Figure 4). The dowel pin visually appeared intact along with its retention weld at both locations.

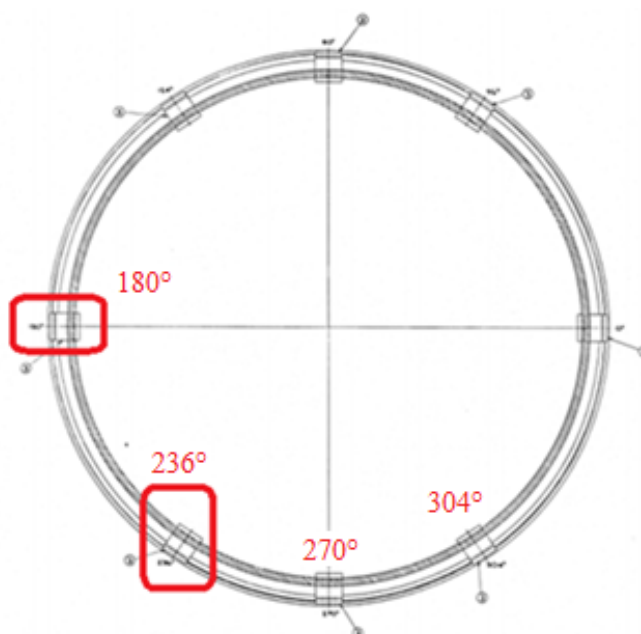
**Figure 5 - Thermal Shield Flexure Layout, Flexures with Confirmed Crack-Like Indications in Red (From Bottom Looking Up)**

In response to the TSSB cap screw failures discovered at Salem Unit 1, external visual inspections of the thermal flexures were recommended and performed to confirm the conditions of the thermal shield supports. Salem Unit 1 identified crack-like indications at the transitions of two flexures, one at 180 degrees and another at 236 degrees (Figure 5 and Figure 6). The extent of the cracking has not been sized, only estimated through non-qualified visual inspection, as of the publication of this TB. Visual indications were also identified but could not be characterized other than as anomalies around the interior flexure welds at the 180, 236, 270, and 304 degree locations.

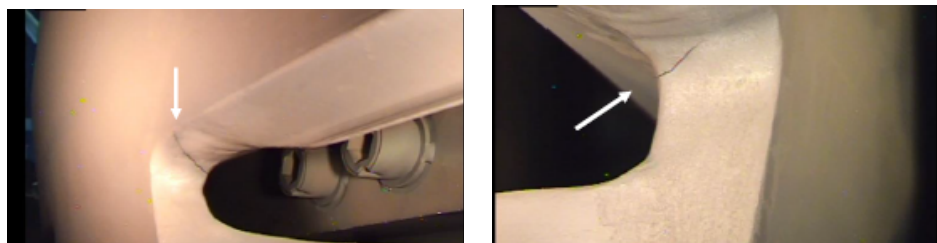
**Figure 6 - Thermal Shield Flexure Crack-Like Indications**

During the spring 2019 outage, Salem Unit 1 identified thermal shield support degradation in the form of failed TSSB cap screws (Figure 7) and crack-like indications in thermal shield flexures (Figure 6). Westinghouse nuclear steam supply system (NSSS) plants that have thermal shields are also potentially affected by this failure mechanism. Operating in this condition can be an asset management concern. To that end, this TB provides details on the TSSB cap screw and flexure issues to provide affected licensees a basis for OE and inspection recommendations. This issue was entered into the Westinghouse corrective action program and was determined not to affect plant safety. Westinghouse determined that there is no impact to operability because the degradation does not affect the core cooling or rod cluster control assembly (RCCA) insertion capability.

- **INSPECTION RECOMMENDATION (ONLY APPLIES IF ONE OR MORE TSSB CAP SCREWS ARE DETERMINED TO BE FAILED).** Perform visual inspections of the thermal shield flexures in accordance with MRP-227 guidance.

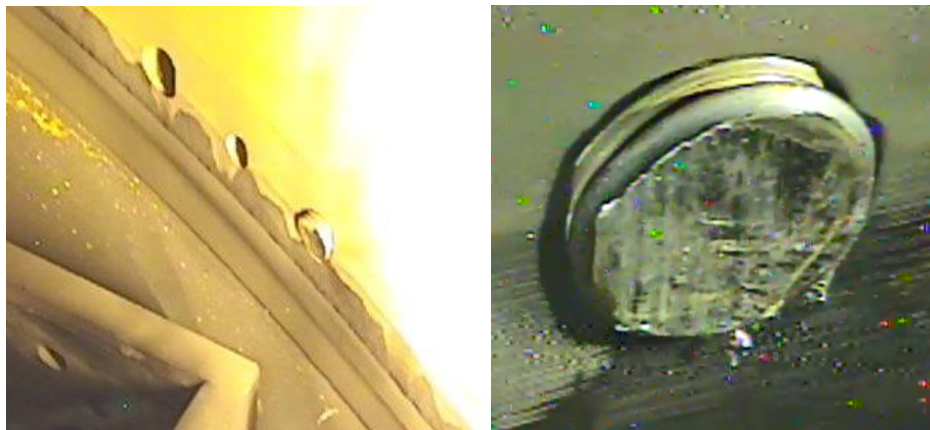
Figure 8 - Core Barrel Inner Diameter Showing Protruding Thermal Shield Support Block Cap Screw

The TSSB cap screw failure was identified due to difficulties removing the upper internals assembly during refueling operations. Once the upper internals were removed, visual examinations of interfacing surfaces revealed a TSSB cap screw shank protruding through the core barrel inner diameter at the elevation of the upper core plate. The holes for the TSSB cap screws at Salem Unit 1, and all other impacted plants identified in Table 1, are threaded the entire way through the core barrel at the elevation of the upper core plate. This configuration could result in the shank portion of the cap screw to potentially unthread toward the interior of the barrel due to normal operating vibrations after separation from the cap screw head. Observations of the visible markings on both the end of the protruding cap screw and the outer surface of the upper core plate (see Figures 8 and 9) were completed. Based on the observations, the investigation concluded that the protruding cap screw interfered with the upper core plate which increased the force required to remove the upper internals assembly. The remaining 15 TSSB cap screws were ultrasonically inspected, resulting in the identification of three more potential failures. Replacement efforts confirmed the three additional TSSB cap screws were also severed under the head. Salem Unit 1 reviewed prior inspection video of this region and identified this condition has existed for a number of previous cycles but did not impede the installation or removal of the upper internals. Prior to the sticking of the upper internals in the spring 2019 outage, there were no alarms recorded on the loose parts monitoring system. The discovery process and ensuing inspections at Salem Unit 1 did not reveal any missing parts that may be loose in the NSSS.

Since the as-built location of the end of the cap screw can vary within the holes due to shimming, any cap screw shank which is wholly contained within the hole cannot be confirmed as failed. Therefore, the acceptance criteria for the visual inspection should be considered as any cap screw shank for which the following observation can be made: the cap screw shank is neither flush with nor protrudes from the core barrel inner diameter (see Figure 8 as an example).

- **MINIMUM INSPECTION RECOMMENDATION.** During the next refueling outage and each subsequent refueling outage, with the upper internals removed, perform a general condition visual inspection of the inside diameter of the core barrel at the elevation of the upper core plate.

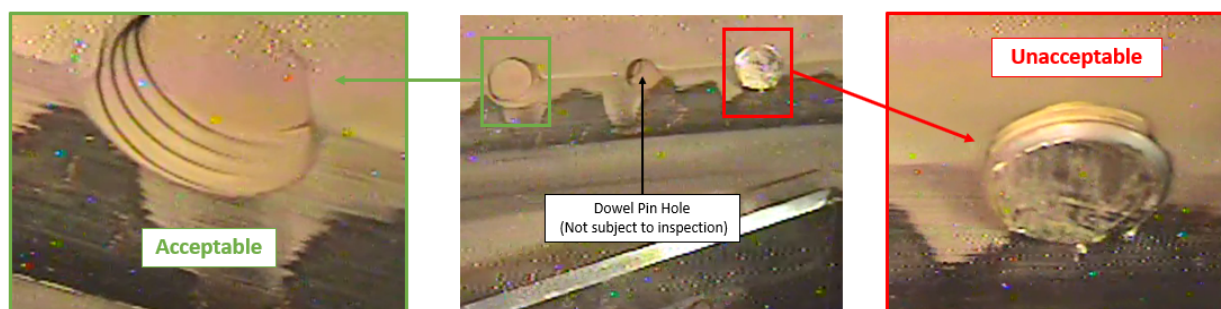
**Figure 11 - Examples of Acceptability of TSSB Cap Screw Condition**

- Any TSSB cap screw shank that is flush with, or protrudes beyond the surface of the core barrel, has separated from the head.
  - Examples of acceptable and unacceptable TSSB cap screw conditions are shown in Figure 11.

- Should visual inspections of the TSSB cap screws reveal degradation, it is recommended that UT be performed, per Supplementary Inspection Recommendation #1, to confirm the condition of the visually degraded bolt, as well as all other support bolts.

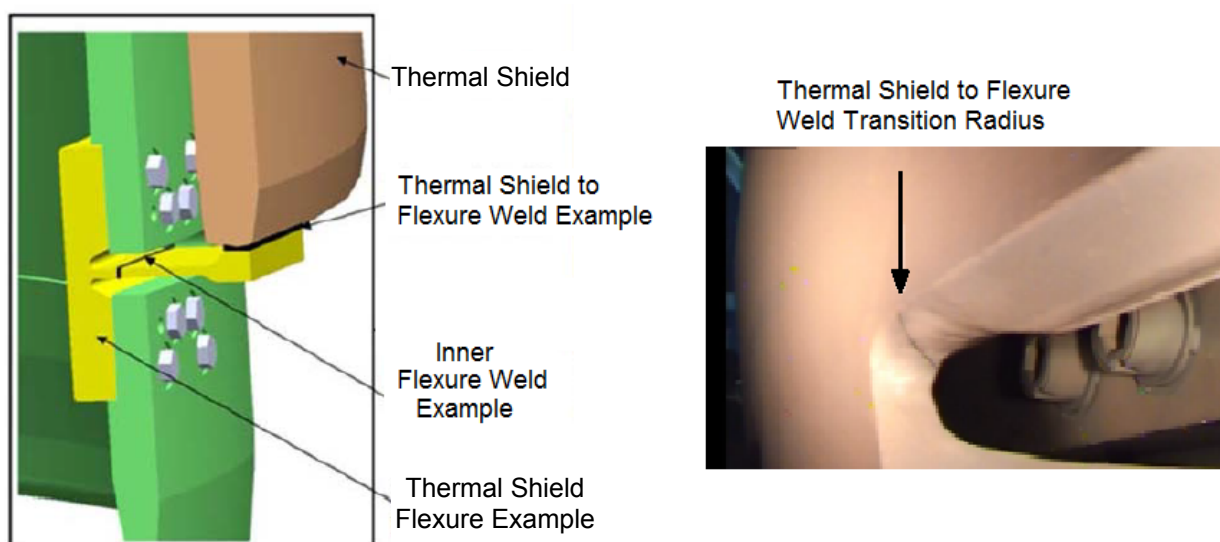
Figure 12 - Thermal Shield Flexure Showing Weld Locations

- **RECOMMENDATION FOR CLARIFIED COVERAGE REQUIREMENT WHEN PERFORMING VISUAL EXAMINATION PER MRP-227-A [2] OR MRP-227, REV. 1 [3].** Examination coverage is 100% of the *accessible surfaces* of 100% of the thermal shield flexures (i.e., all accessible surfaces on each flexure). Minimum coverage shall include the top and bottom accessible surfaces of the inner flexure weld (closest to the attachment to the core barrel) and the outer surface of the thermal shield to flexure weld, including the transition radii of this weld. These weld locations, particularly the inner weld, see the highest levels of fatigue stress and are expected to be the most susceptible to failure. See Figure 12 for an example of these weld locations.
