UNITED STATES
NUCLEAR REGULATORY COMMISSION
REGION II
101 MARIETTA STREET, N.W.
ATLANTA, GEORGIA 30303

IE Circular No. 79-02

FAILURE OF 120 VOLT VITAL AC POWER SUPPLIES

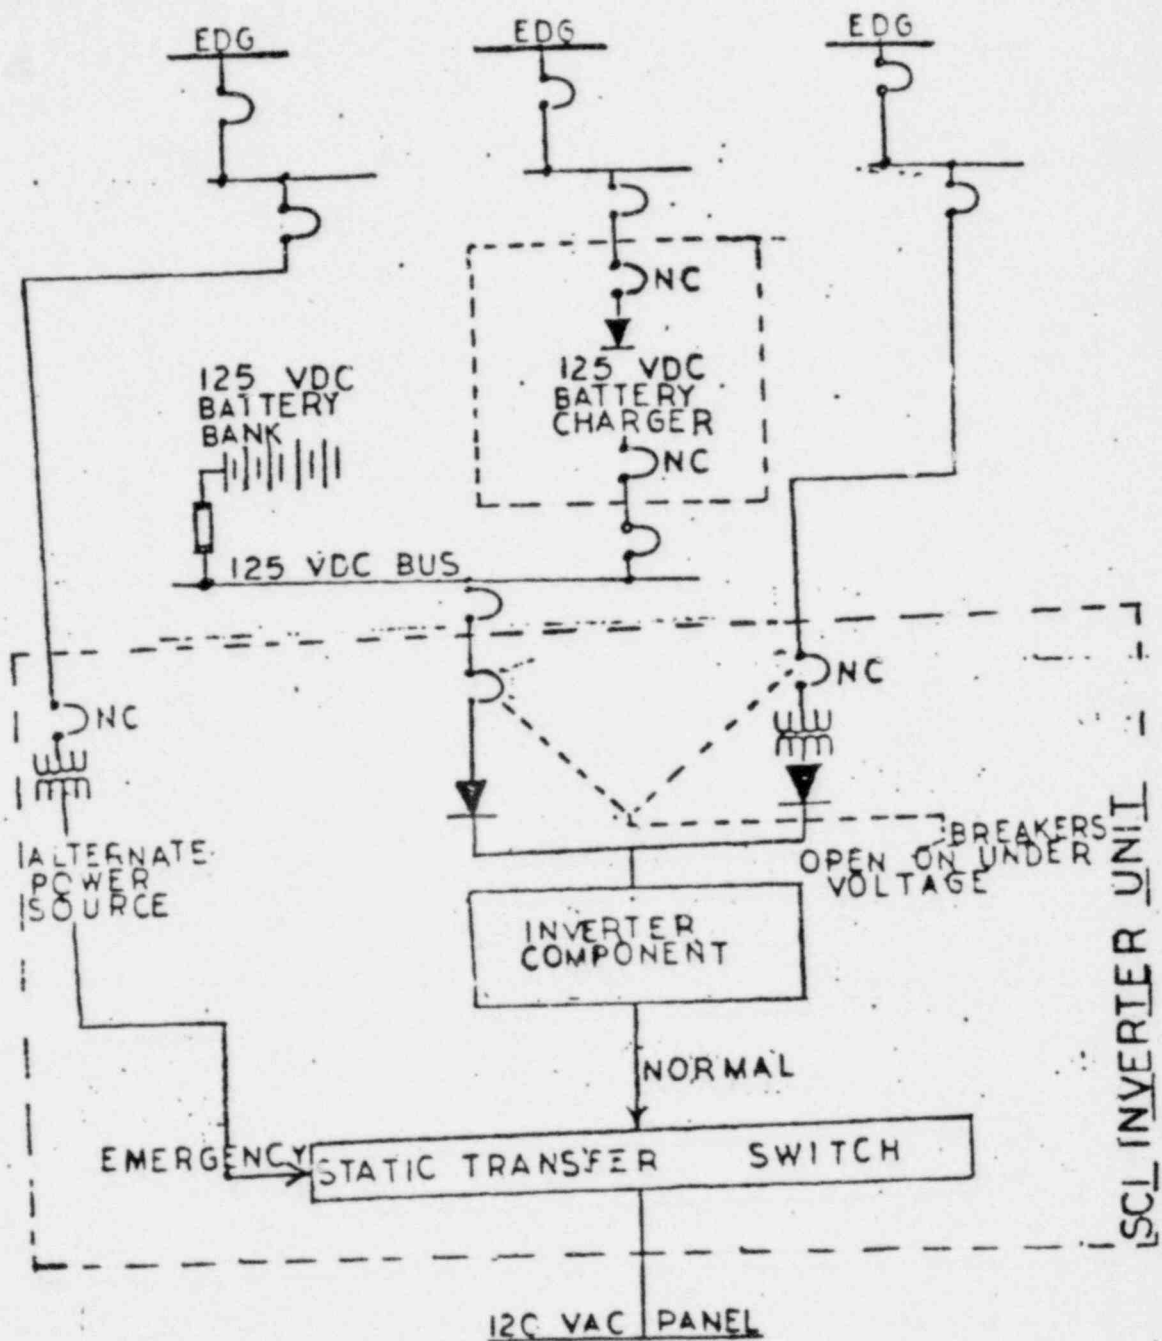
FIGURE 1
SINGLE LINE DIAGRAM-120 VAC

On September 16, 1978, Arkansas Nuclear One - Unit 2, while in hot functional testing preceding initial criticality, suffered a degradation of both of the independent off-site power sources. This produced an undervoltage condition on the Engineering Safety Features (ESF) Buses and caused an inadvertent ESF actuation. The licensee determined that the ESF actuation occurred on a loss of at least two of the uninterruptible 120 volt vital AC power sources. Immediate investigation revealed that all four of the Solidstate Controls, Inc., (SCI) inverter static switches had automatically transferred to the alternate power supply (the 120 volt AC being supplied by transformers directly off the ESF buses rather than from the inverter output.) Figure 1 (attached) shows the functional interconnection of the 120 volt AC power supply system.

A single conclusive cause of the undesired SCI inverter static switch transfer could not be identified. However, the following problems were discovered during subsequent investigation.

- (a) The SCI inverters have circuitry to monitor the incoming DC voltage level which, on sensing a low voltage (nominally 104 DC volts for these inverters) will trip both input breakers to the inverter component after an adjustable time delay.

The setting of these time delay relays were not verified during either preoperational testing or subsequent maintenance. The time delay is necessary in order to accommodate transient loading conditions which may be encountered.

- (b) On one SCI inverter, a DC fuse within the inverter component was found blown. The vendor indicated that this fuse will blow due to an excessive DC voltage to the inverter component caused by a transient on the 480 AC input. The licensee has subsequently reset the taps on the 480V to 120V three-phase AC input transformer to limit the DC voltage to the inverter to less than the nameplate maximum rating in the event of a high AC input voltage transient.

- (c) The SCI inverter static switch is designed to transfer to an alternate source on inverter output overcurrent or undervoltage. Initially, these trips were set at 125 percent overcurrent and 80 percent undervoltage. An explanation for the transfer of two of the inverter static switches is that during one of the transfers of site loads, the instantaneous inductive load caused these trip set points to be exceeded. The licensee has subsequently adjusted the transfer sensing circuitry to higher overcurrent and lower undervoltage trip settings to assure that the inverter will maintain load over the widest possible range of voltage and current. (Note that in this case, once the SCI inverter transfers to the alternate source, it will not automatically transfer back to normal source.)

1. Determine whether or not time delay circuitry is used in your inverter units. If so, have they been adjusted to the appropriate set point as required by equipment and the integrated system designs?

2. Determine if the AC input voltage and transformer tap settings are optimized to prevent exceeding the inverter component name-plate maximum rated DC input voltage in the event of a high AC input voltage transient.

3. If an alternate 120 volt source is used in your design, determine if the protection transfer circuitry of the inverter has been optimized within design limits to ensure maximum possible availability of the inverter system during transient loading conditions. An operating history of inexplicable transfers may be indicative of the above.

4. Determine if the administrative controls employed by your facility ensures operability of safety systems after its subcomponents (e.g., time delay relays, switches, etc.) have been subjected to maintenance or testing.
