Final Report
on
Vertical Fire Dampers
for the
SNLPPS Project

Bechtel Power Corporation
Gaithersburg, Maryland
February 12, 1980

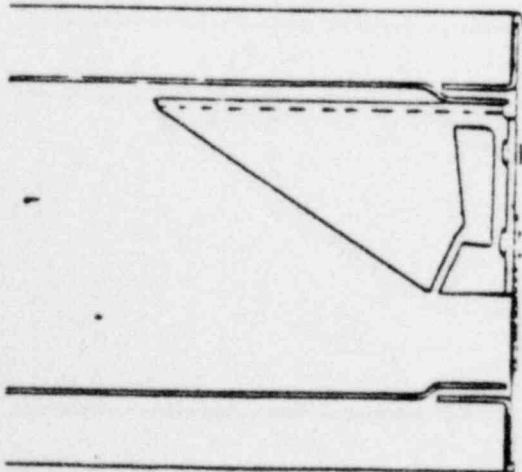
ORIGINAL INSTALLATION
(VERTICAL FIRE DAMPERS
WITH SPRING CLOSURE)

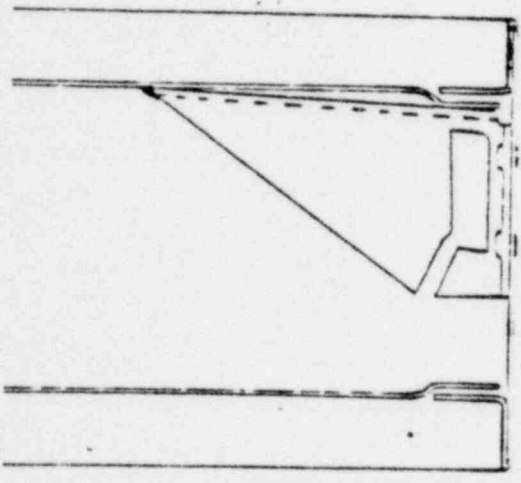
A nonconformance report generated at Callaway Jobsite indicated failure of the lower end of the damper blade closure spring (flat ribbon coil type) to remain in place, resulting in incomplete closure of the vertical dampers. This failure was identified while the dampers were being operationally cycled. One end of spring, on dampers designed for vertical installation, becomes disconnected during cycling. Release of the spring interferes with full closure of the damper.

A bracket at the lower end of the vertical dampers holds the spring which is connected to the damper blade. The brackets were originally designed to be installed as shown in the left hand sketch of Ruskin Manufacturing Company Drawing No. 5398 (copy attached). To provide extra support for the bracket, Ruskin decided to tack weld the top edge of the bracket to the damper blade guide, as shown in the middle sketch on Ruskin Drawing No. 5398. The tack welding resulted in widening of the gap in the brackets and allowing the springs, in some instances, to slip out while they were recoiling during closure of the damper.

TOP EDGE OF BRACKET
TACKWELDED TO PROVIDE
EXTRA SUPPORT FOR
BRACKET & RESULTING
ALTERATION OF SPRING
SLOT
