UNITED STATES  
NUCLEAR REGULATORY COMMISSION  
OFFICE OF INSPECTION AND ENFORCEMENT  
WASHINGTON, D.C. 20555

IE Information Notice No. 80-08  
Date: March 7, 1980  
Page 1 of 1

THE STATES COMPANY SLIDING LINK ELECTRICAL TERMINAL BLOCK

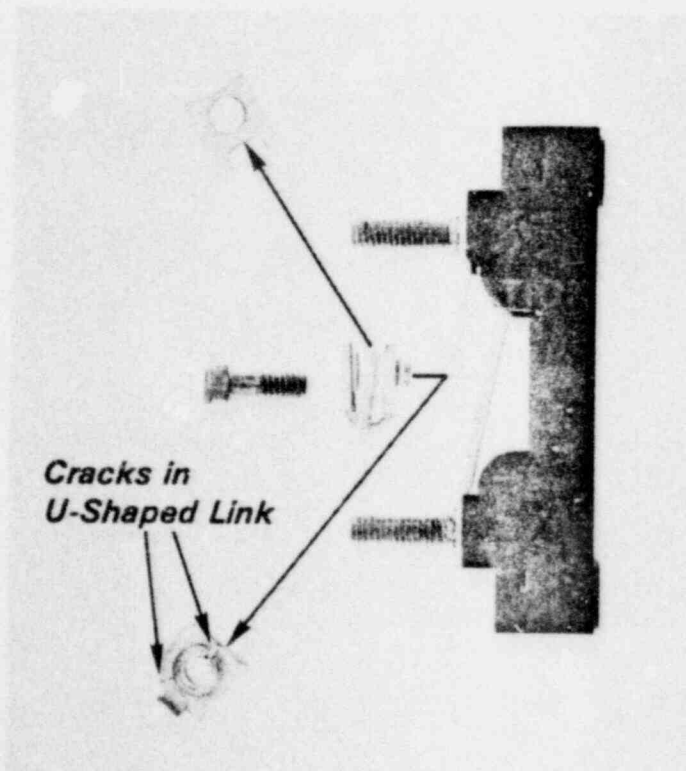
Exploded View of States Company Terminal Block

The defect, which has been identified in 5% of the terminal blocks checked, occurs in the form of a crack between the threaded screw hole and the side of the U-shaped link. When the screw is tightened the crack widens and a poor or intermittent electrical connection can result. A defective link is impossible to cinch tightly in place and is difficult to detect visually.

Enclosure 1 shows the States Company terminal block. The defect, a crack in the bottom portion of the metal U-shaped link, is displayed in the exploded view of the terminal block assembly. These terminal blocks are widely used in the nuclear industry and may be used as permanent installations in safety related systems. The defective mechanical connection can cause an electrical circuit malfunction.
