UNITED STATES
NUCLEAR REGULATORY COMMISSION
REGION I
631 PARK AVENUE
KING OF PRUSSIA, PENNSYLVANIA 19406

IE Information Notice No. 80-08
Date: March 7, 1980
Page 1 of 1

THE STATES COMPANY SLIDING LINK ELECTRICAL TERMINAL BLOCK

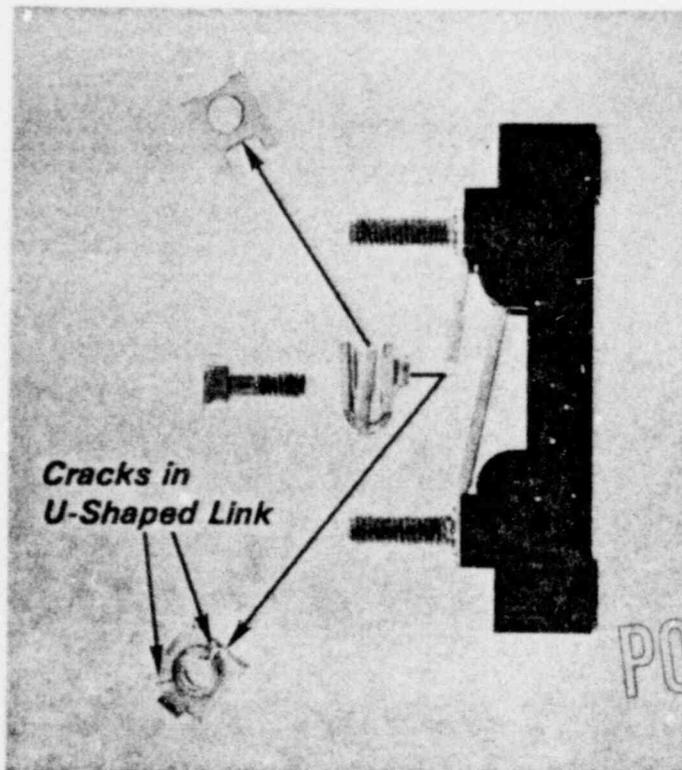
Exploded View of States Company Terminal Block

The defect, which has been identified in 5% of the terminal blocks checked, occurs in the form of a crack between the threaded screw hole and the side of the U-shaped link. When the screw is tightened the crack widens and a poor or intermittent electrical connection can result. A defective link is impossible to cinch tightly in place and is difficult to detect visually.

Attachment 1 shows the States Company terminal block. The defect, a crack in the bottom portion of the metal U-shaped link, is displayed in the exploded view of the terminal block assembly. These terminal blocks are widely used in the nuclear industry and may be used as permanent installations in safety related systems. The defective mechanical connection can cause an electrical circuit malfunction.
