Public Service Company of Colorado

April 9, 1980
Fort St. Vrain
Unit No. 1
P-80075

REPORTABLE OCCURRENCE 80-13

REPORT NO. 50-267/80-13/03-L-0

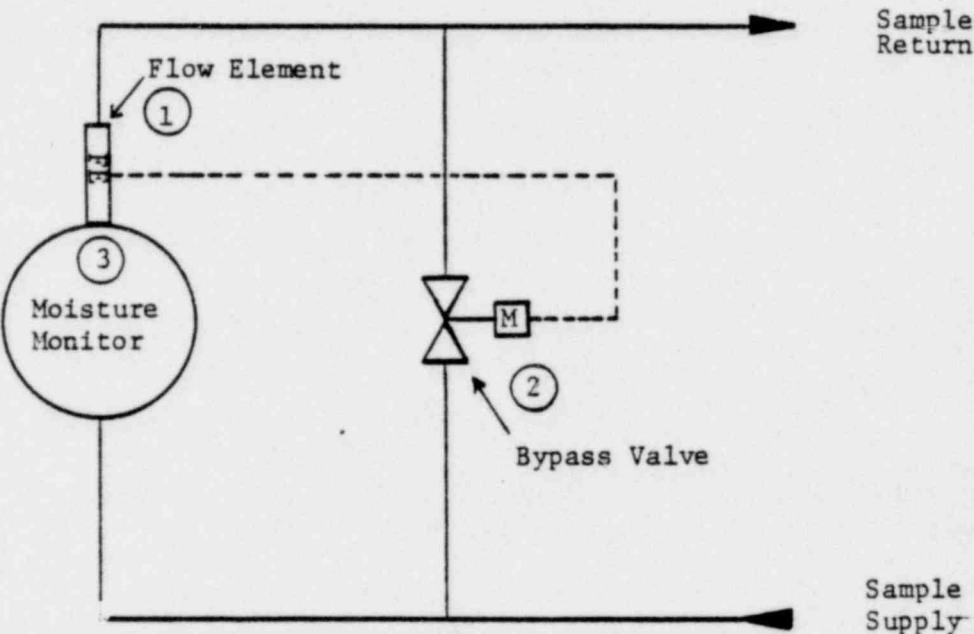
FIGURE 1

Instrument personnel investigated the sample flow problems and found that the flow elements for MM-1117 and MM-1122 were reading incorrectly. See Figure 1. The indicated flow through the flow element ①, was less than required for the moisture monitor to be considered operable. However, considering system conditions and the position of the bypass valve ②, the actual flow should have been greater than the indicated and the required flow. Plant power level was reduced, and as the actual sample flow rate decreased, the sample flow indicated by the flow element ① began to correspond to the expected actual flow rate through the moisture monitor ③.

The Instrument personnel could not determine what caused the erroneous readings in either of the flow elements, and it was decided to replace both of the flow elements.

The insufficient indicated sample flow was the result of incorrect readings from respective moisture monitor flow elements.

The flow element for MM-1122 was replaced and the flow element for MM-1117 will be replaced as plant conditions allow.
