Public Service Company of Colorado

April 9, 1980
Fort St. Vrain
Unit No. 1
P-80072

REPORTABLE OCCURRENCE 80-14
ISSUE 0

REPORT NO. 50-267/80-14/03-L-0

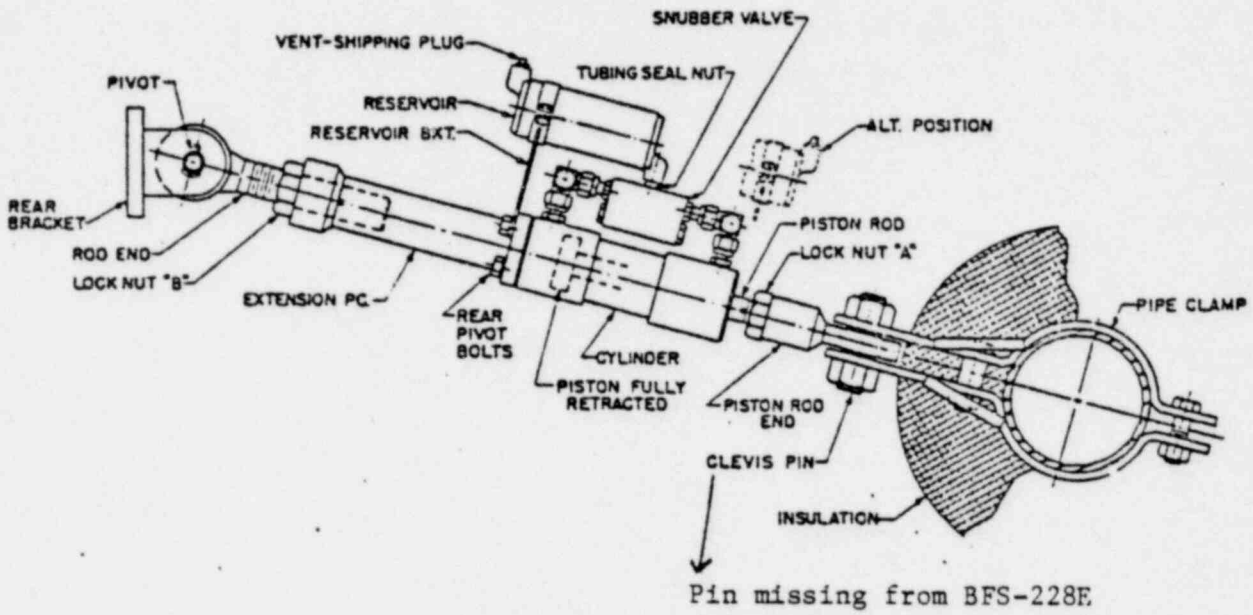
FIGURE 1

On March 11, 1980, with the reactor in a shutdown condition, engineering personnel observed that the pin at the piston rod eye of emergency boiler feedwater snubber BFS-228E was missing. See details of Figure 1.

Because this pin was missing, the snubber was not properly attached to the pipe, and was therefore inoperable. This snubber was verified operable per approved surveillance procedure one week prior to the occurrence.

There appears to be no cause traceable to plant operation which can account for the missing pin.

A new pin was fabricated and installed and the snubber was returned to service. The present surveillance interval is 6 months \pm 25%. No change is required as a result of this occurrence.
