In a November 13, 1978, telephone conversation, Jerry Wills of my staff notified Sydney Miner of your staff that an additional fault had been discovered at the Phipps Bend Nuclear Plant in the unit 2 fuel building area. A conference call was subsequently made to the NRC geologist, Sandy Wastler, on November 14, 1978, to discuss the fault. The enclosure provides a detail description of this feature.

PHIPPS BEND NUCLEAR PLANT  
DOCUMENTATION OF FAULT IN UNIT 2 FUEL BUILDING EXCAVATION

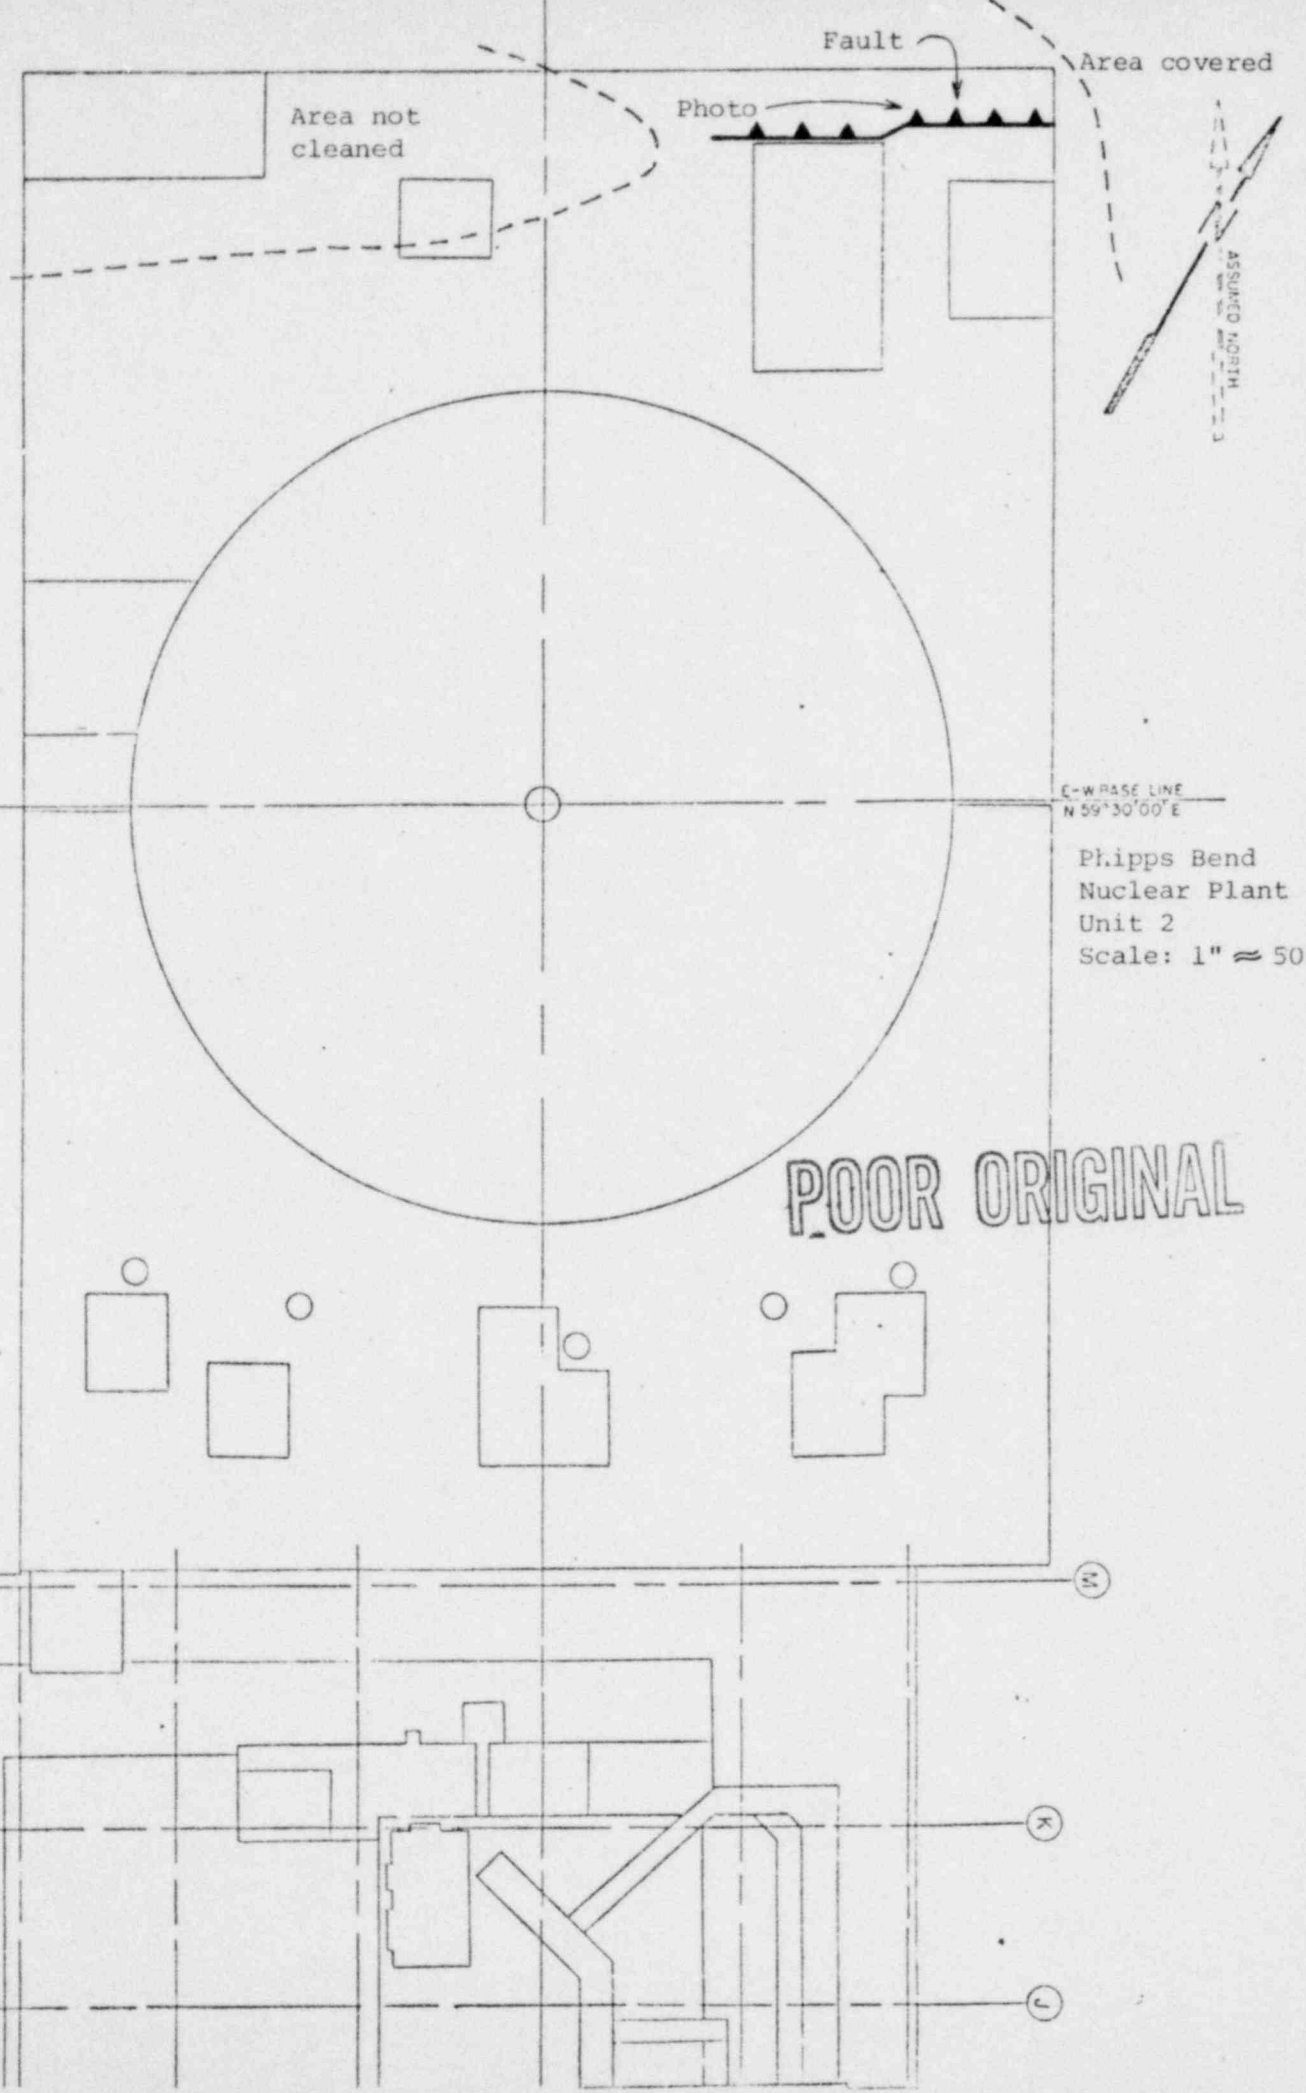
Phipps Bend  
Nuclear Plant  
Unit 2  
Scale: 1" ≈ 50'

The fault is located in the northern half of the unit 2 fuel building area on the east wall of the spent fuel storage pool excavation (see attached sketch).
