DUKE POWER COMPANY  
OCONEE NUCLEAR STATION - UNIT 1  
ABNORMAL OCCURRENCE REPORT  
AO-269/73-4  
REACTOR COOLANT SYSTEM INSTRUMENTATION TUBING LEAK

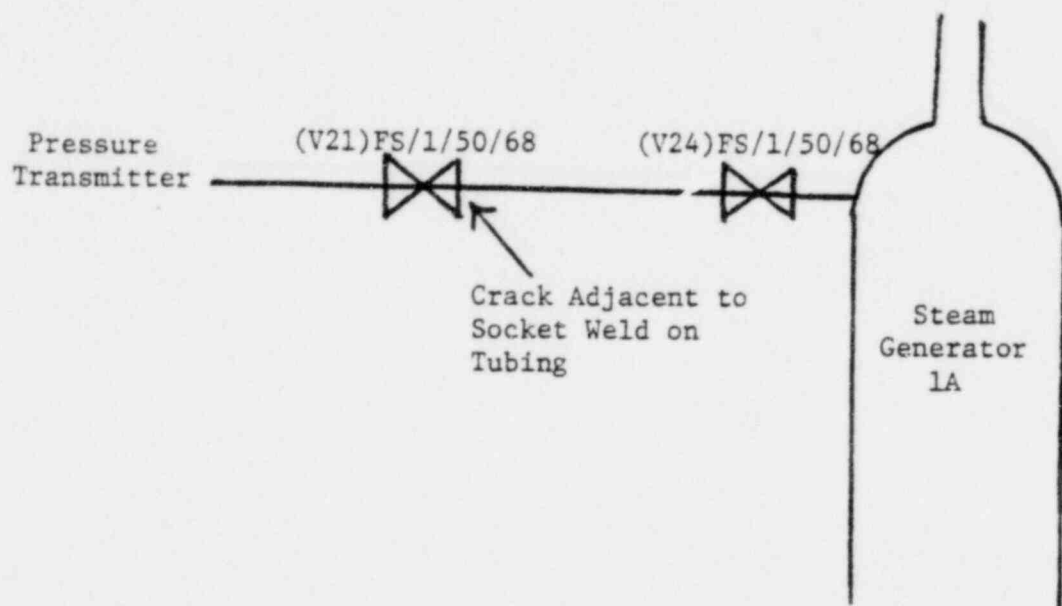
FIGURE 1

On July 5, 1973, a leak was discovered in a weld downstream of instrumentation root valve (V24) FS/1/50/68. This instrument line feeds the wide range pressure signal to Channel B Engineered Safeguards System and the narrow range pressure to Channel B Reactor Protective System. Figure 1 is a sketch showing the location of the leak. This portion of the instrumentation line is inside the biological shield, and during normal operation of the unit, this would be a high radiation area.

The instrumentation line root valve (V24) FS/1/50/68 was closed immediately to isolate the blowing line. The isolation resulted in a trip of analog Channel B of the Engineered Safeguards System placing this system in a one-out-of-two mode. It also tripped Reactor Protective System Channel B low pressure bistable putting the Reactor Protective System in a one-out-of-

On July 6, 1973, the leak was repaired by welding. After the repair was inspected, reactor coolant system pressure was increased to 2285 psig to check the integrity of the weld repair. No leaks were detected. An evaluation of the cause of this tubing failure is now in progress.
