SUBJECT: RESPONSE TO NRC LTR DTD 05/02/78... FORWARDING RESPONSE TO QUESTIONS 1, 2, 3C,  
5, 6, 7, 8, & 10 CONCERNING CONTINUED CYCLE 1 OPERATION WITHOUT BURNABLE  
POISON ROD ASSEMBLIES... NOTARIZED 06/02/78.

PLANT NAME: CRYSTAL RIVER #3

Subject: Crystal River Unit #3  
Docket No. 50-302  
Operating License #DPR-72

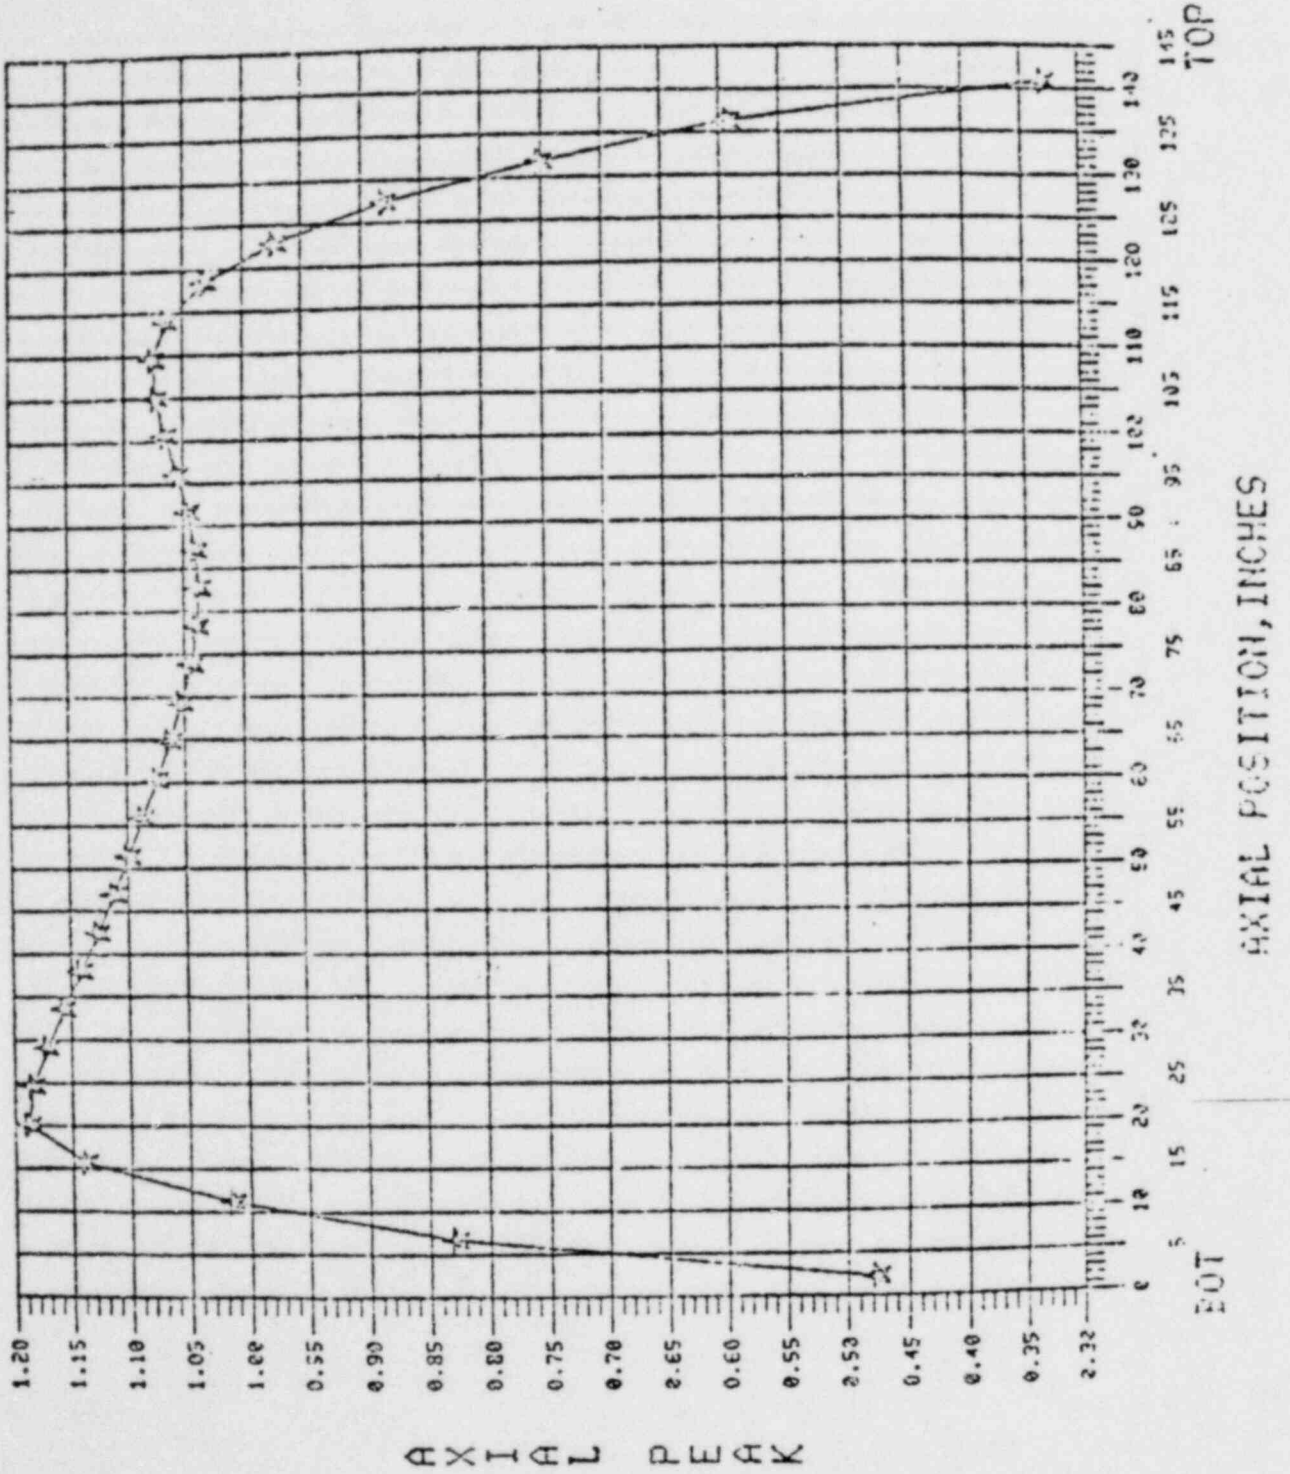
Figure 1  
CRYSTAL RIVER III CYCLE 1  
254 EFPD

The effect of BPRAs removal on the axial power distribution is shown in Figures 1 and 2. The removal of BPRAs causes a shift in the overall distribution, however the magnitude of the axial peak is relatively unchanged. A complete power peaking analysis for the remainder of cycle 1, with BPRAs removed, was performed for C. 3. The study included normal operating conditions, abnormal core conditions including mispositioned control rods and APSRs, and variable xenon conditions. The resultant power peaks were compared to the thermal limits, DNBR and centerline fuel melt, by means of "flyspeck" curves. The original axial imbalance limits for the Reactor Protection System were determined to be conservative for the remainder of cycle 1 with BPRAs removed. The axial imbalance limits for LOCA power peaking have been altered for the remainder of cycle 1 as shown in Reference 3. The LOCA peaking limits are a function of axial position. The removal of BPRAs alters the overall axial distribution such that the peaking behavior at various axial positions is different from the original design.

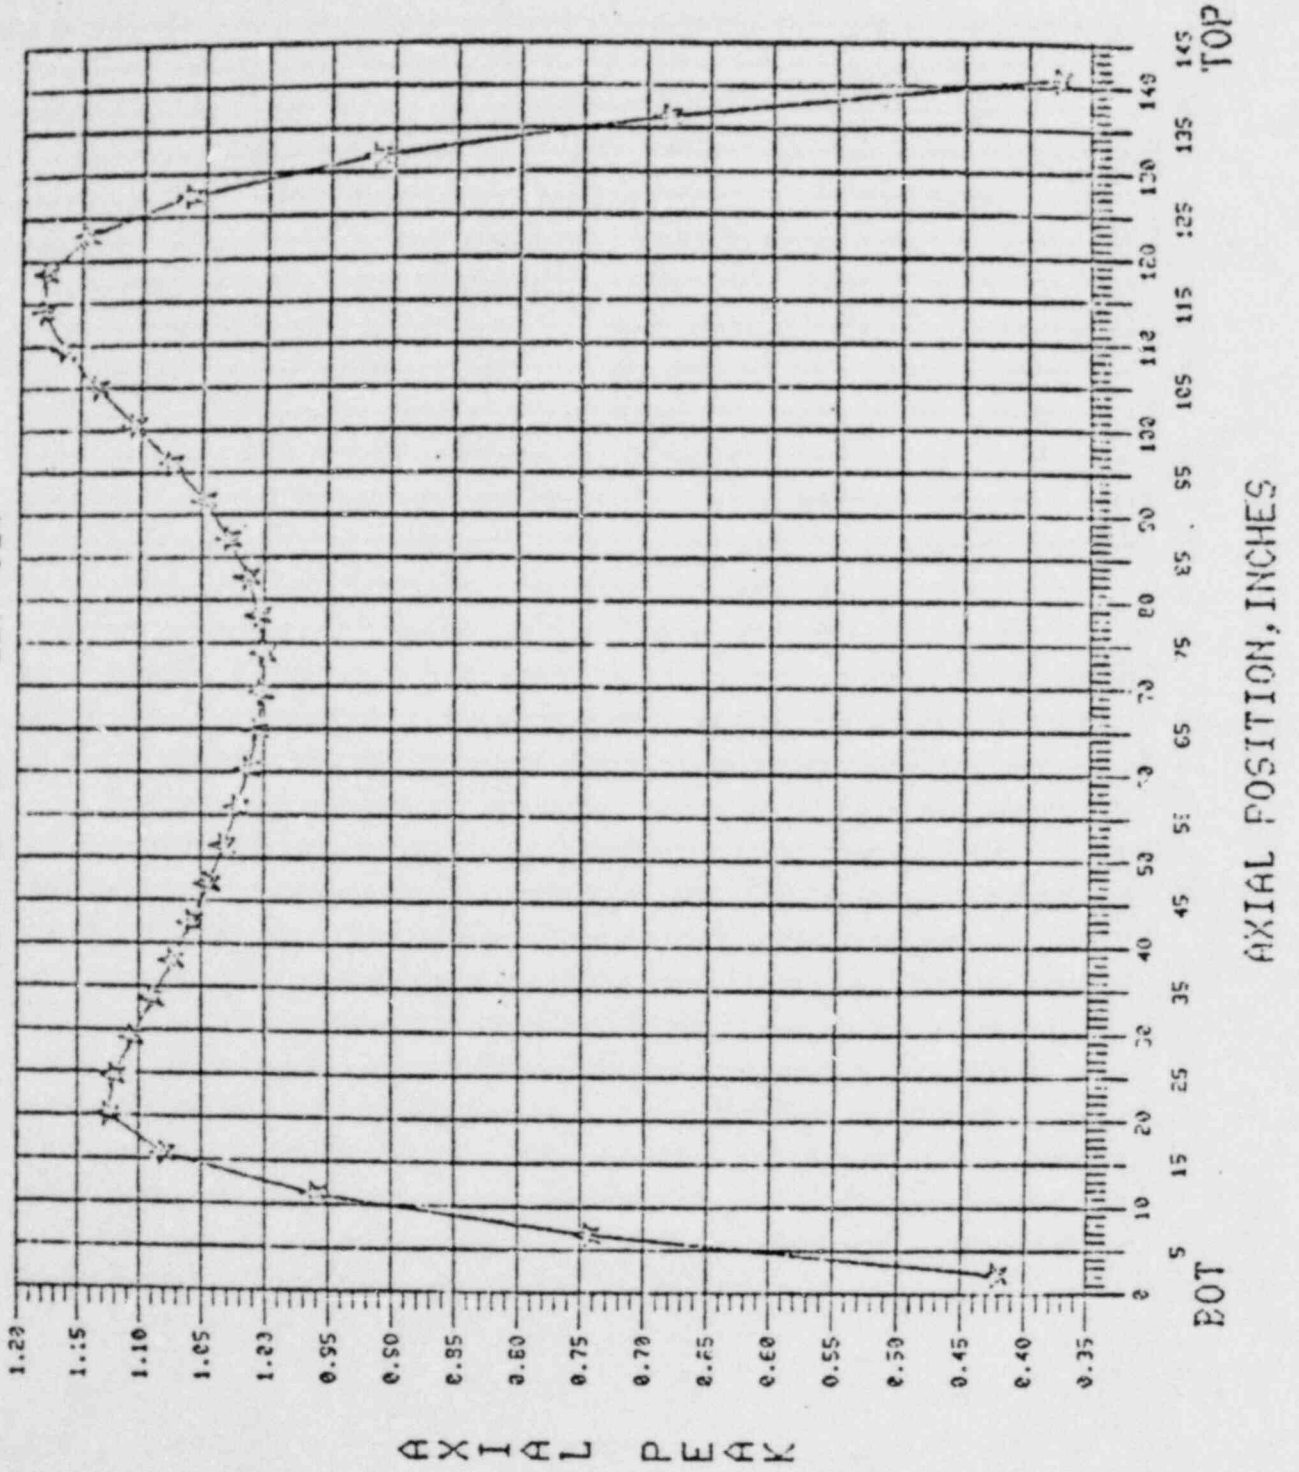
Figure 2

At this time the B-10 is nearly fully depleted. However, the residual B-10 is greater at the extremities and in effect "pushes" power toward the midplane. When the BPRAs are removed the power will shift away from the depleted midplane toward the extremities as indicated in Figure 2.

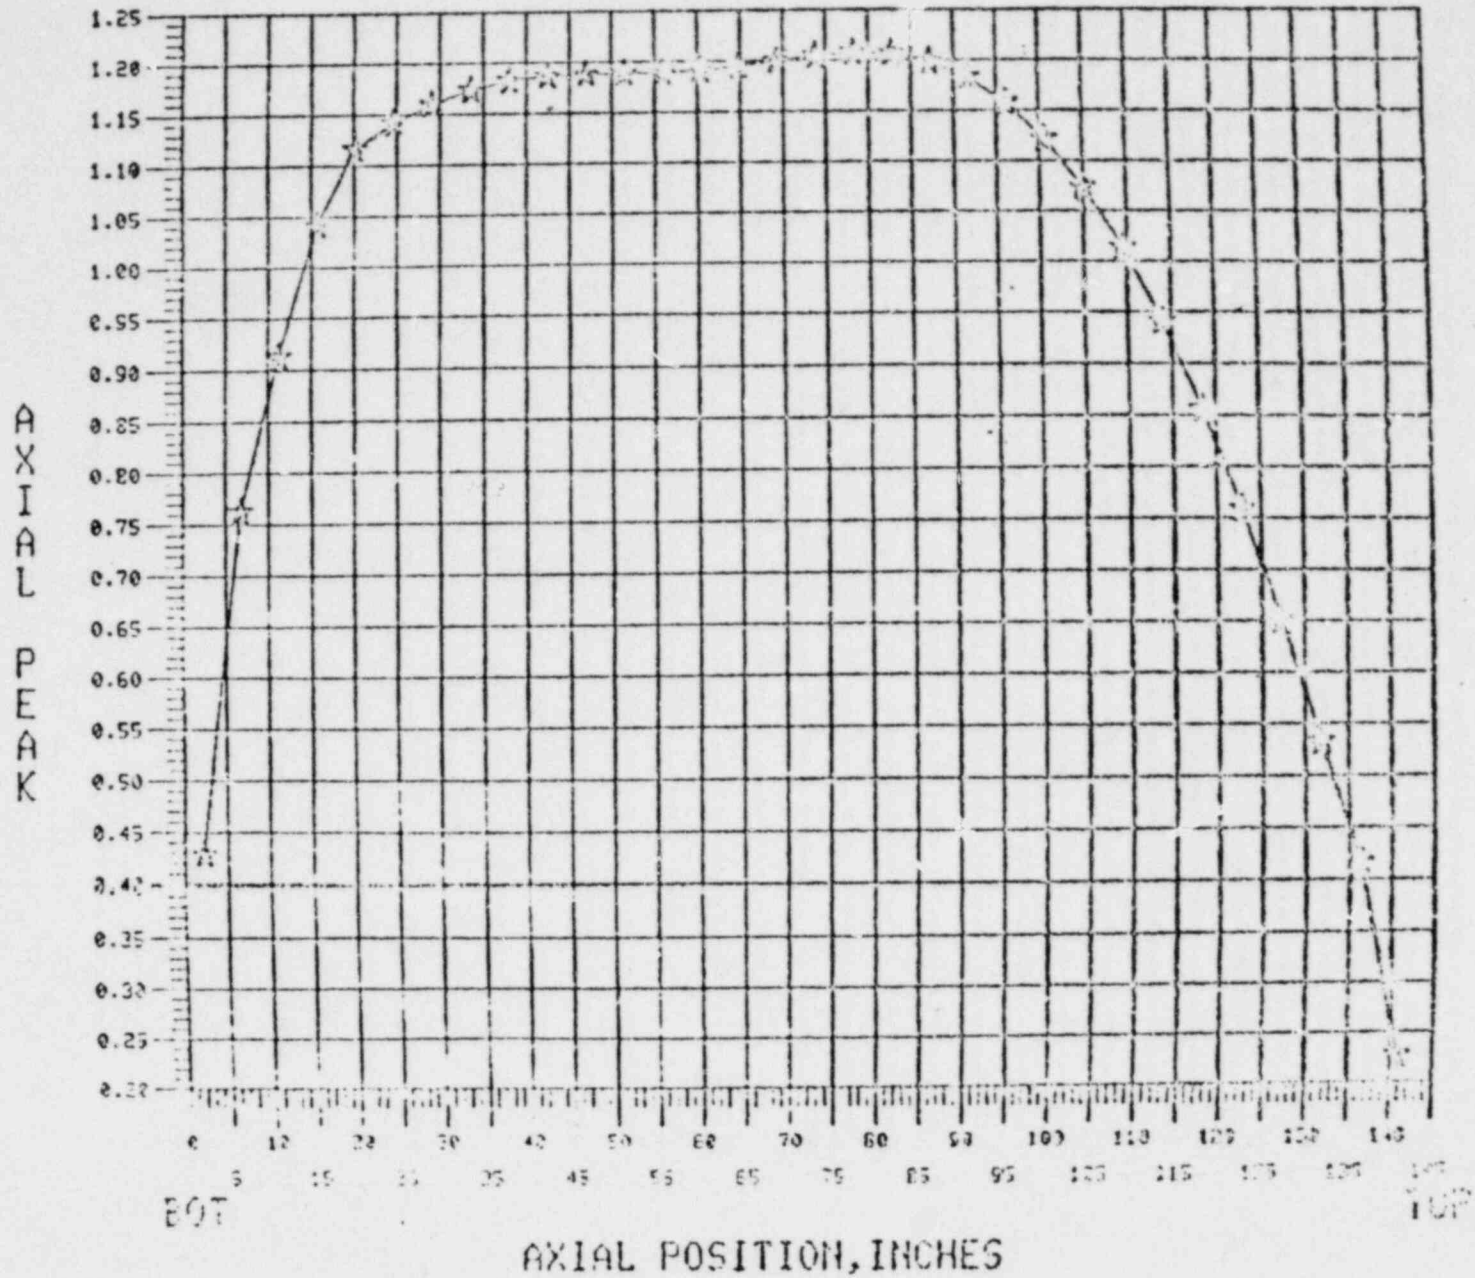
Figure 3

The burnable poison (isotope B-10) depletes non-uniformly in the axial direction. Early in core life (BOC) the axial flux shape approximates a cosine shape, Figure 3. Since the flux is higher at the midplane, the B-10 there depletes faster than at the extremities. This causes an increase in the axial peak at ~50 EFPD as shown in Figure 4. Continued operation of the core leads to a more rapid fuel depletion at the midplane - because of the higher power. The resulting power shape at 254 EFPD, Figure 1, is the relatively flat distribution typical of a depleted core. The axial shapes for the three times in core life are plotted together in Figure 5 which summarizes the combined effects of fuel and poison depletion.
