Public Service Company of Colorado

March 18, 1980
Fort St. Vrain
Unit No. 1
P-80055

REPORT NO. 50-267/78-05/03-X-3

FINAL SUPPLEMENT

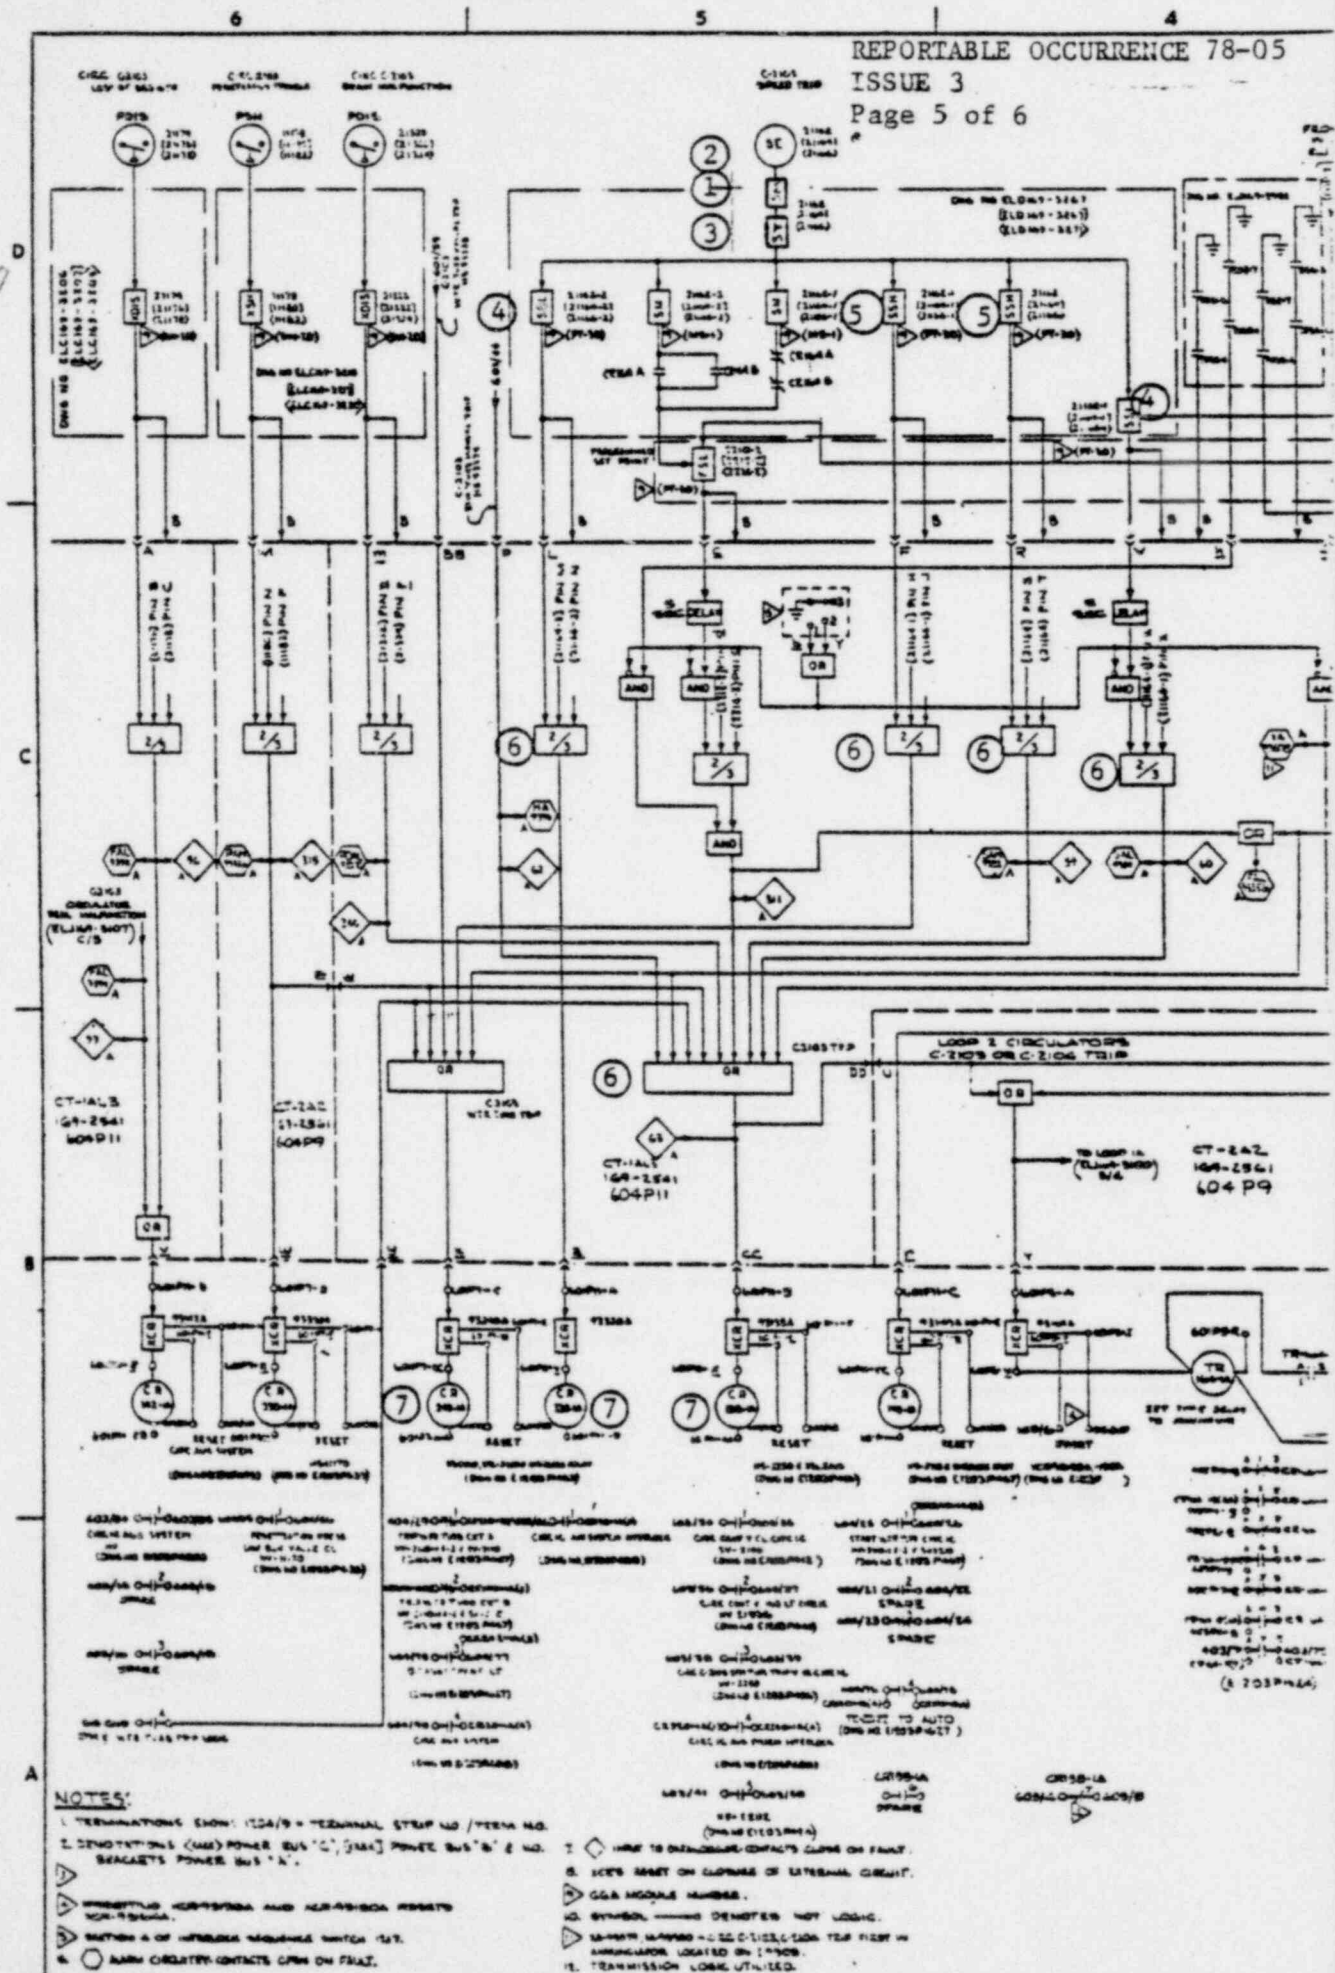
See Figure 1. The speed measuring system (SM), ①, is designed to measure the rotational speed and alignment wobble of the helium circulator shaft. This is accomplished by the use of a reluctance type detector probe (SE), ②, connected to a phase sensitive carrier type electronics system.

Three separate channels monitor the speed of each helium circulator. The pulse signals are transmitted by the SM's, ①, to the speed transmitter (ST's), ③, which produces a 0 to 10 volt output signal proportional to shaft RPM for use in the summer modifiers and process trip modules. The process trip modules are the speed switches low (SSL), ④, and speed switches high (SSH), ⑤. If the circulator speed reaches either the high or low trip setting, the SSL's or SSH's initiate trip signals to the two of three solid state logic, ⑥, which produces a circulator shutdown via the special control relays (XCR's), ⑦.

Instrument calibration drift due to bridge unbalance.

The balancing problem was caused by a change in resistance between the two leads of the speed element and ground at the circulator connection end. The difference in resistance occurs over a period of time in the cable connectors as a result of the temperature and humidity of the ambient air.

New cable connectors were certified to conform with the requirements and specifications of the purchase order.

The new cable connectors have been installed and tested.
