UNITED STATES
NUCLEAR REGULATORY COMMISSION
REGION III
799 ROOSEVELT ROAD
GLEN ELLYN, ILLINOIS 60137

IE Information Notice No. 80-08

THE STATES COMPANY SLIDING LINK ELECTRICAL TERMINAL BLOCK

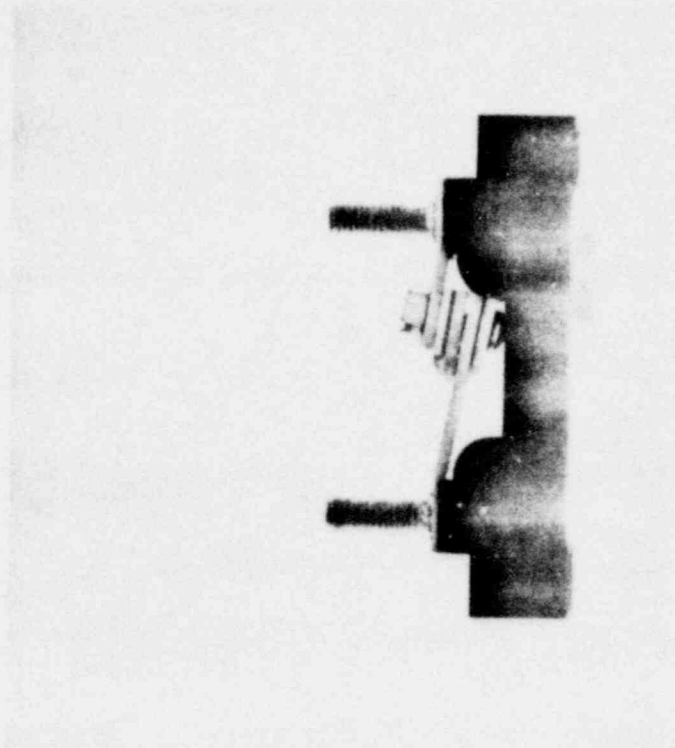
Side View of States Company
Terminal Block in Assembled Position

The connection between the two slotted bars on the terminal block is made by a U-shaped sliding link and spacer located between the two bars. The top of the U-shaped link and the spacer are drilled and the bottom of the link is threaded to accept a 8-32 screw. When the screw is tightened it binds the link, spacer and bar together to make electrical connection. Loosening the screw and sliding the link from between the bars breaks the connection. The purpose of the link is to provide easy insertion of test instruments, etc. into the circuit.

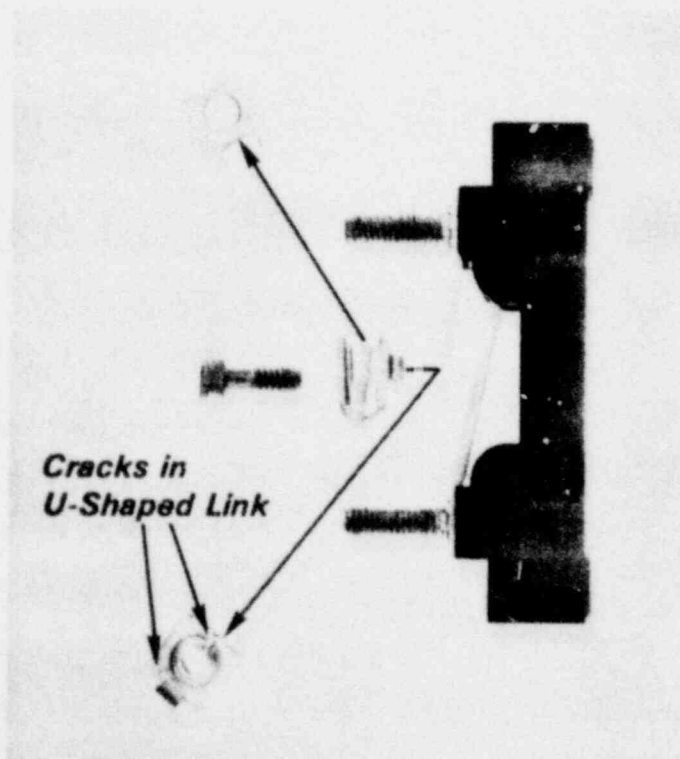
Exploded View of
States Company Terminal Block

The defect, which has been identified in 5% of the terminal blocks checked, occurs in the form of a crack between the threaded screw hole and the side of the U-shaped link. When the screw is tightened the crack widens and a poor or intermittent electrical connection can result. A defective link is impossible to cinch tightly in place and is difficult to detect visually.

Enclosure 1 shows the States Company terminal block. The defect, a crack in the bottom portion of the metal U-shaped link, is displayed in the exploded view of the terminal block assembly. These terminal blocks are widely used in the nuclear industry and may be used as permanent installations in safety related systems. The defective mechanical connection can cause an electrical circuit malfunction.
