IE Information Notice No. 80-08

THE STATES COMPANY SLIDING LINK ELECTRICAL TERMINAL BLOCK

ENCLOSURE 1 TO IE INFORMATION NOTICE 80-08

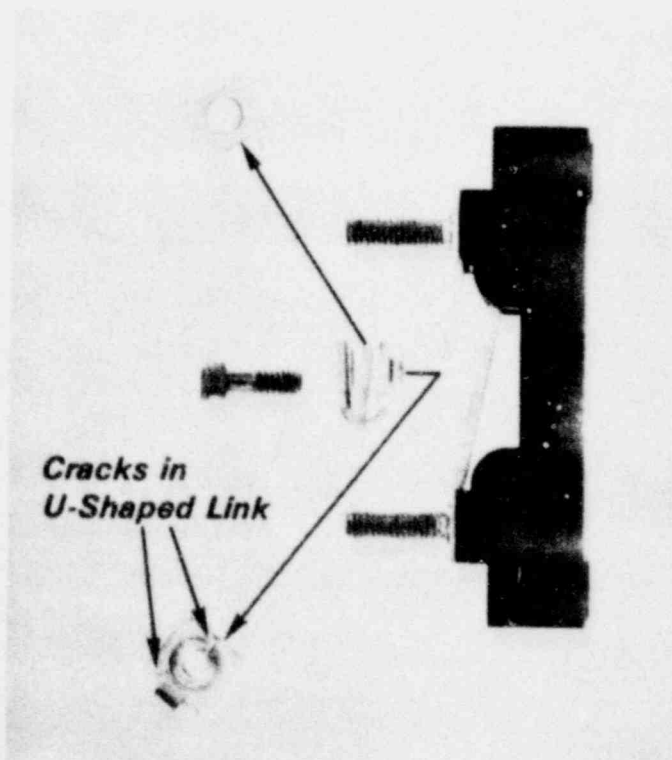
Exploded View of
States Company Terminal Block

The defect, which has been identified in 5% of the terminal blocks checked, occurs in the form of a crack between the threaded screw hole and the side of the U-shaped link. When the screw is tightened the crack widens and a poor or intermittent electrical connection can result. A defective link is impossible to cinch tightly in place and is difficult to detect visually.

Enclosure 1 shows the States Company terminal block. The defect, a crack in the bottom portion of the metal U-shaped link, is displayed in the exploded view of the terminal block assembly. These terminal blocks are widely used in the nuclear industry and may be used as permanent installations in safety related systems. The defective mechanical connection can cause an electrical circuit malfunction.
