SUBJECT: FAULTING IN UNIT 1 ESW PUMPING STATION AND  
UNIT 2 TURBINE BUILDING AREA

## PHIPPS BEND NUCLEAR PLANT

### Fault Zone In The Rock Foundation For The Unit 2 Turbine Building

PHIPPS BEND NUCLEAR PLANT  
REVERSE AND TRANSVERSE FAULTS  
IN THE UNIT 1 ESW PUMPING STATION

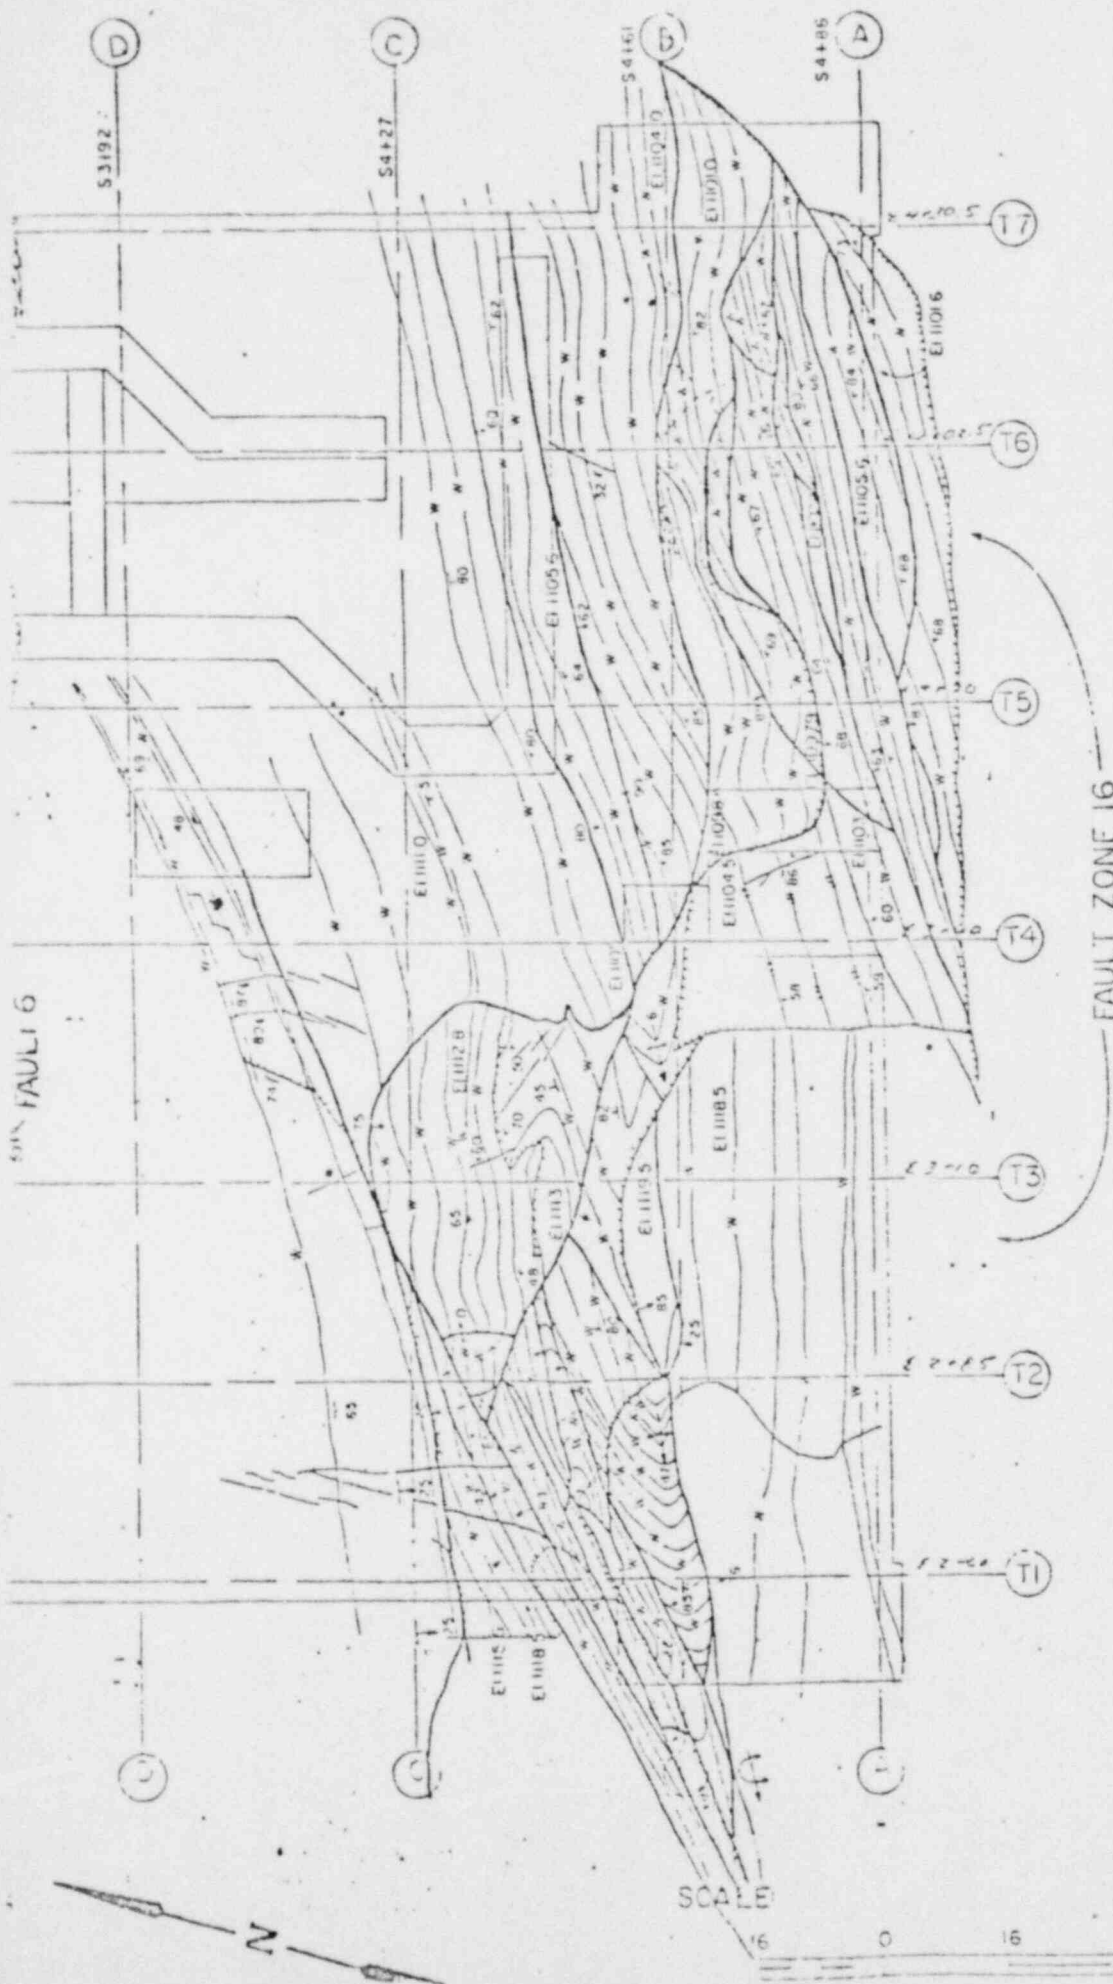
MAP A

Continued excavation of the weathered rock in the south end of the Unit 2 turbine building has exposed complex folding and faulting (see attached map A).

This area is defined by a weathered, faulted, contorted rock zone striking approximately N 50° E and dipping from horizontal to vertical, but generally parallel to the regional dip. On the east perimeter of the turbine building excavation, the faults extend under the overburden. They are exposed again by excavation 300 feet to the east in the CCW trench, from which they can be traced along the excavated rock surface to the CCW pumping station (see attached map B).

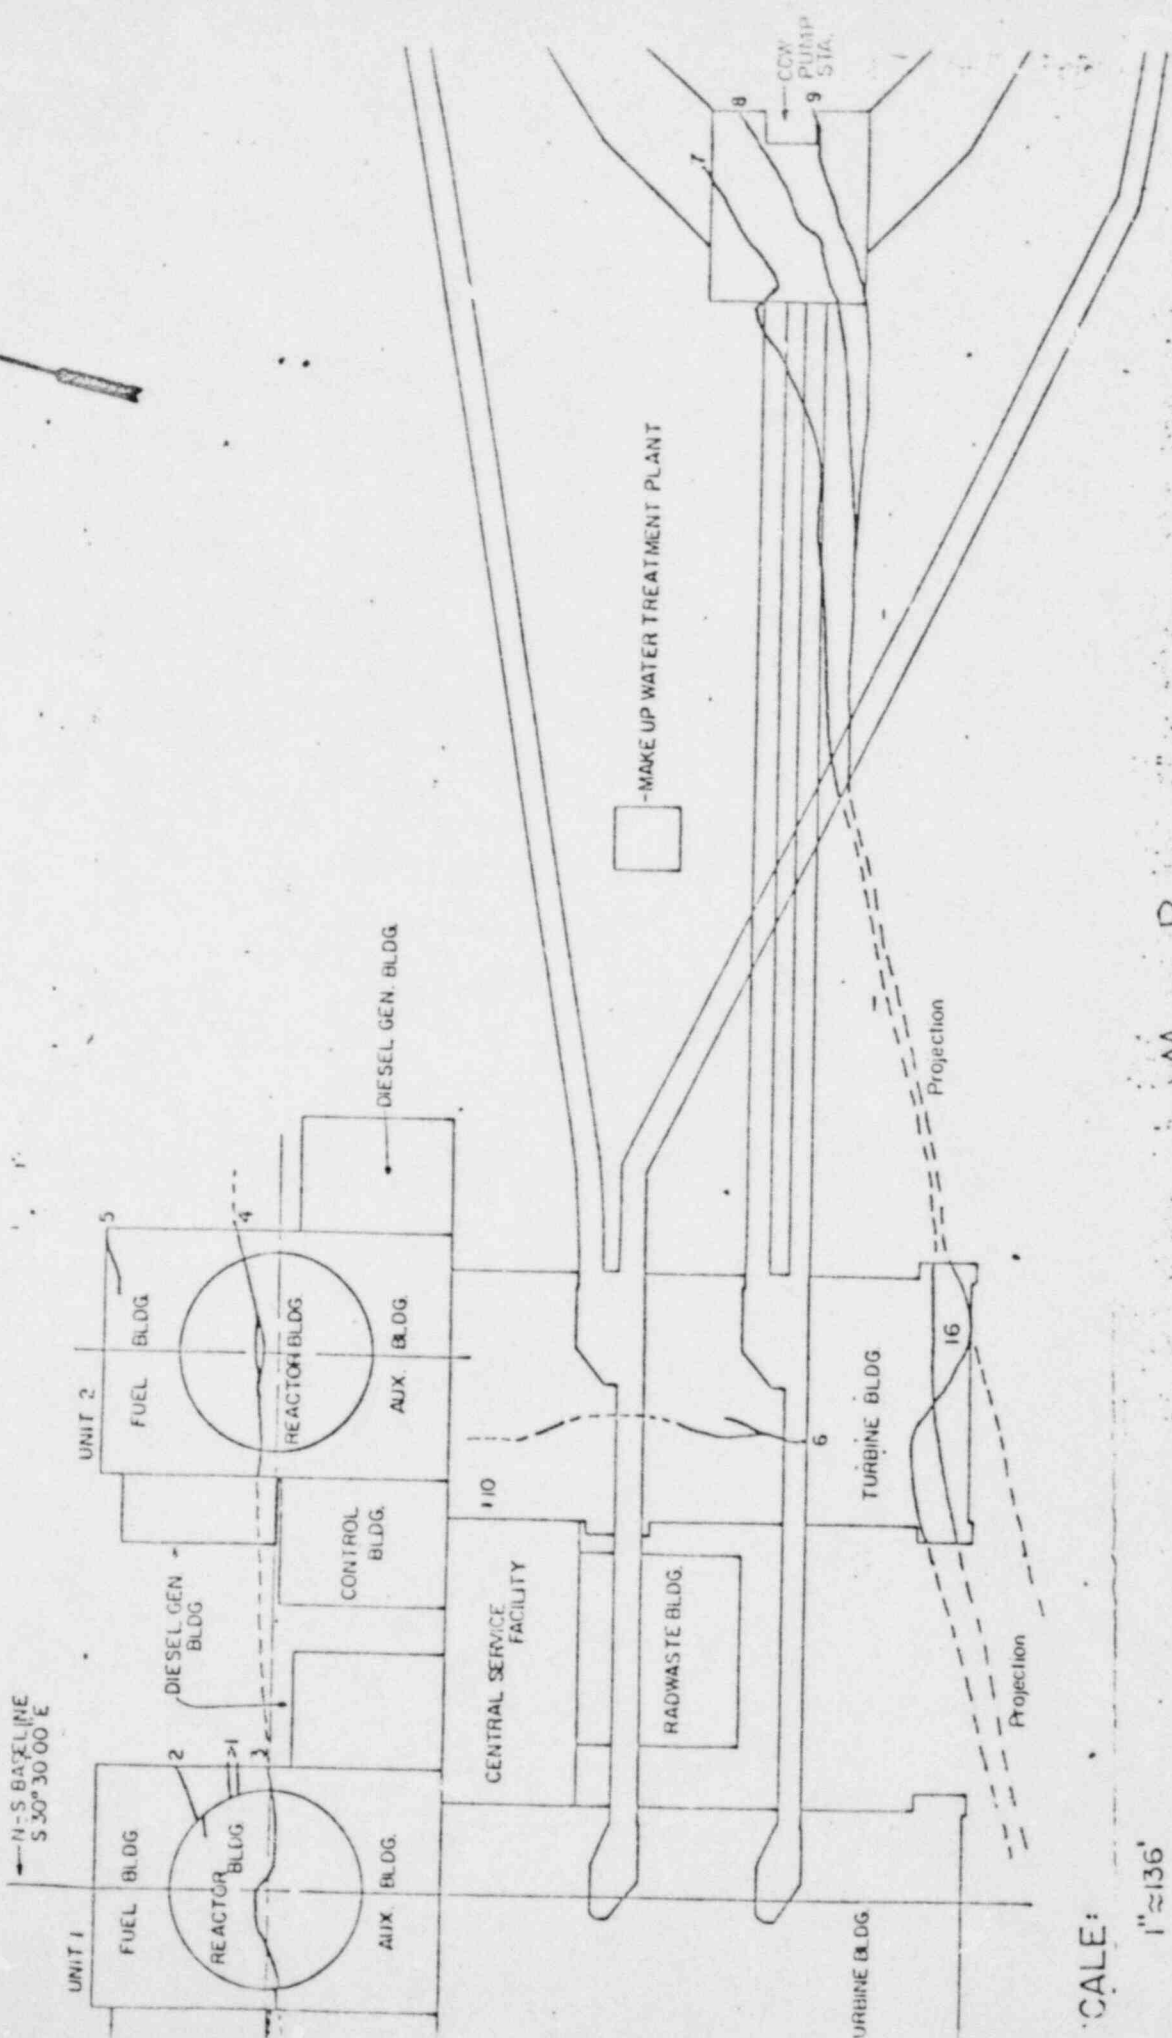
MAP B

This fault zone (designated number 16) is an extension of faults 7, 8 and 9, located in the CCW pumping station foundation. This was reported to NRC in a memorandum from J. E. Gilliland to H. W. Denton, dated April 30, 1979 (MEB 790502 521).

Examination of the overburden-rock contact around the perimeter of the excavation has revealed no offsetting of Quaternary terrace deposits. The folds and faults in the Unit 2 turbine building excavation show no evidence which would indicate that they did not occur in the early tectonic development of the Paleozoic (250+ million years) folding and faulting in this area. These faults, having been stable for 250 million years are not considered to be capable of producing ground offsets or generating earthquakes. Therefore, we do not classify them as capable faults, within the meaning of Appendix A to 10CFR part 100.

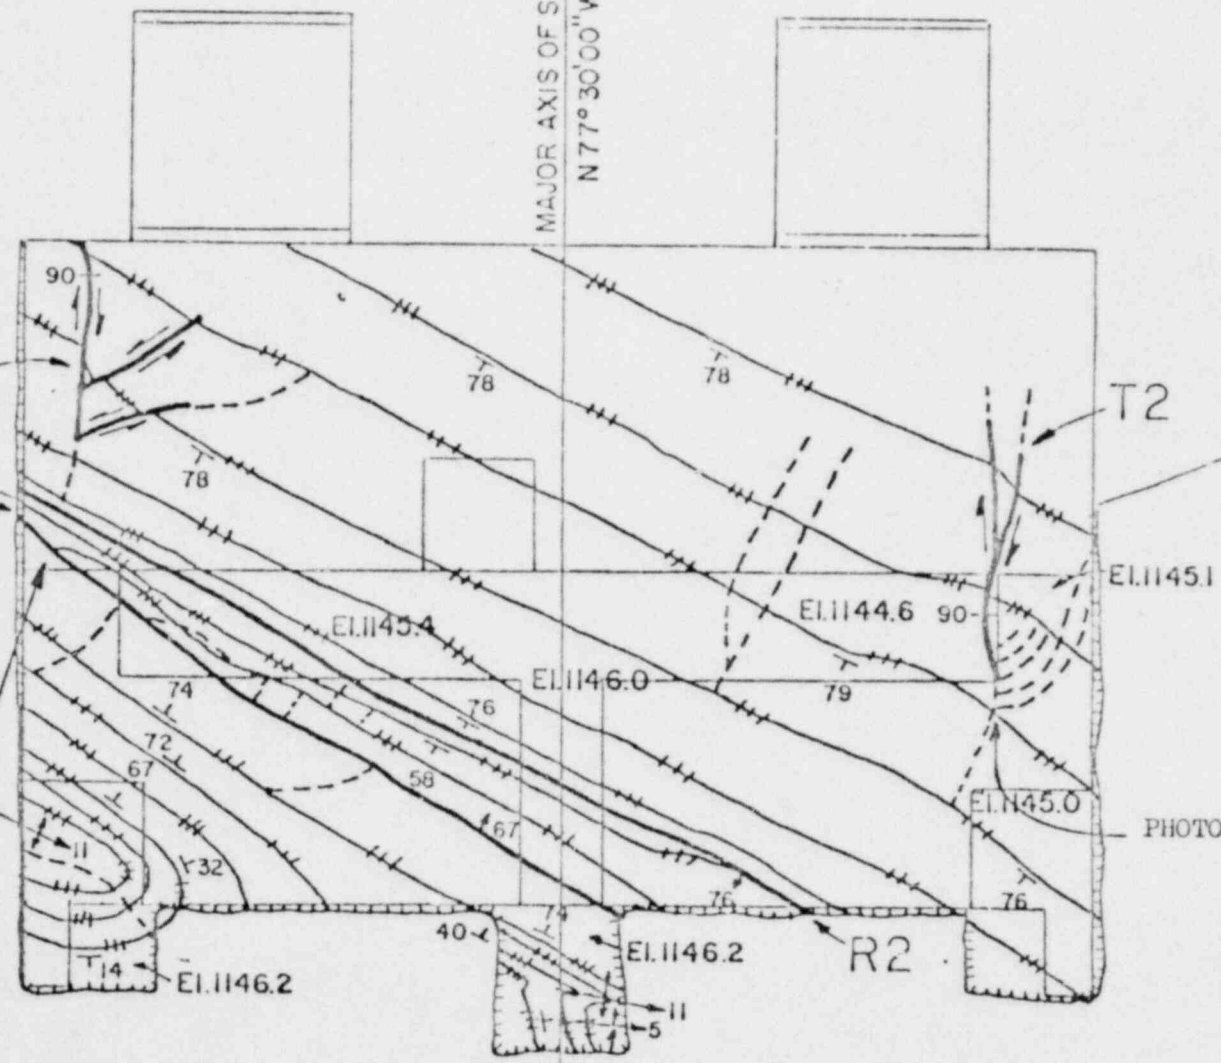
FAULT ZONE 15

Geologic mapping of foundation bedrock in the Unit 1 ESW pumping station has revealed two reverse faults in the southeast quadrant of the building, and two transverse faults located west of the reverse faults. They are grouped as fault zone 15 and designated R1, R2, T1, and T2 (see attached photos and drawing for locations).

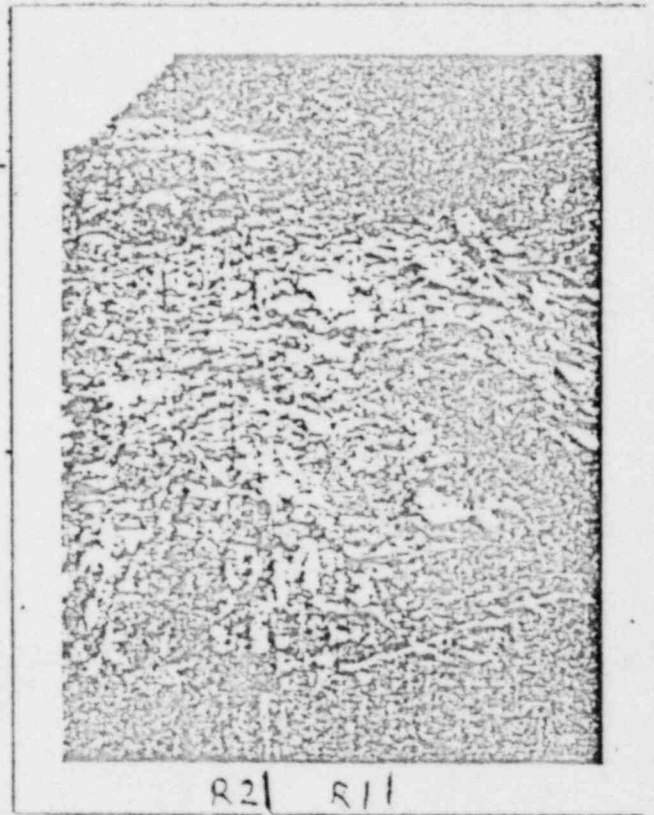
Faults R1 and R2 are reverse faults parallel to the axis of an anticline to the southeast. R1 dips  $67^{\circ}$  NW. and strikes N.  $50^{\circ}$  E. R2 dips  $76^{\circ}$  SE. and strikes N.  $50^{\circ}$  E. Both fault traces are defined by calcite-healed fractures that extend across the floor of the excavation from the south wall to the east wall of the building.

PHOTO 15 - Fault zone, 15 - R2, R11  
View North
