U.S. NUCLEAR REGULATORY COMMISSION
OFFICE OF INSPECTION AND ENFORCEMENT

Report No. 79-07

Facility Name: Oyster Creek Nuclear Power Station

Inspection on April 18-20, 1979 and July 19-20, 1979 (Report No. 50-219/79-07)

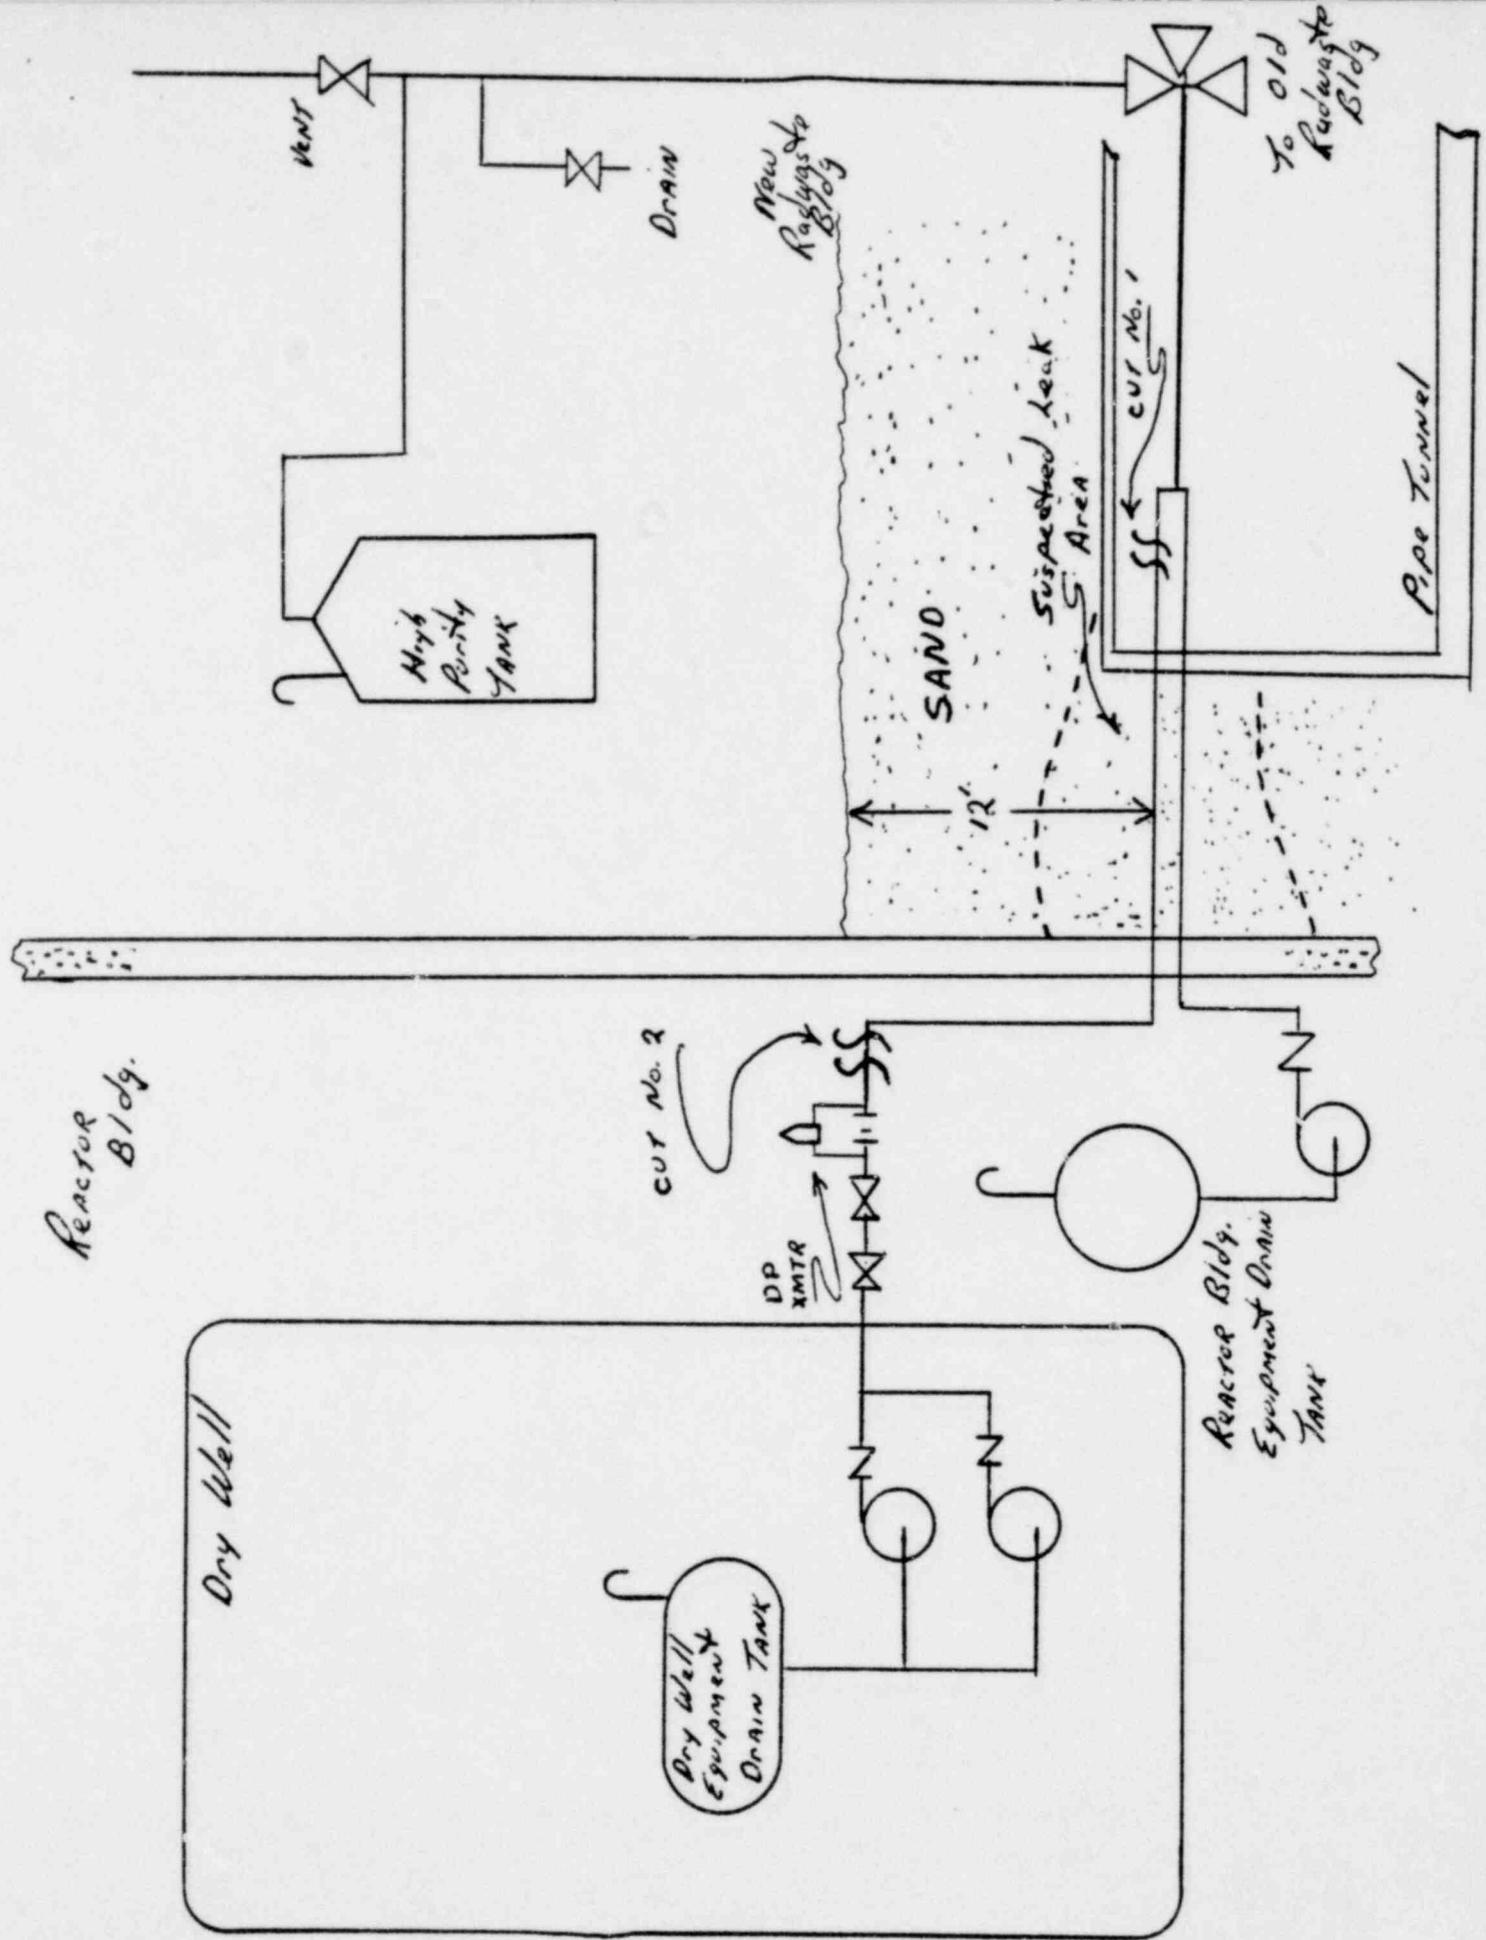
Figure A

On March 15, 1979, in-leakage was observed in the radwaste pipe tunnel at the rate of 2-4 gpm. Upon investigation by the licensee, it was concluded that a portion of the buried line between Drywell Equipment Drain Tank (DWEDT) in the reactor building and the radwaste tunnel was the source of the leakage. (See Figure 1)

Plans were developed to immediately repair the leak but no action was taken until March 16, 1979 at which time it was decided to reroute the DWEDT line to the Reactor Building Equipment Drain Tank (RBEDT) to isolate the presumed leaking section of pipe. (See Figure A, attached)

Two pipe cuts were necessary to isolate the suspected section of line. The first cut in the radwaste pipe tunnel was to be made for the purpose of draining the line, a fact that was not comprehended by the representatives of the Radiation Protection Department throughout the job planning. The second cut was to be made on the 23 foot elevation of the Reactor Building, for the purpose of providing a tie-in for the temporary line to be routed to the RBEDT.

From interviews with the two mechanics who were directed to perform the pipe cut (See Figure A. Cut No. 1), the inspector learned that the individuals were told only to perform the cut by their management. Information pertaining to the radiological hazards involved in the operation (i.e., the pipe they were to cut was full of radioactive water under pressure and the radiological status of the work site) was not conveyed to them. For example, the latest survey data utilized for RWP 062279 was fifteen days old and did not represent the actual radiation and contamination levels in the area. The RWP indicated a radiation level of 1.0 mrem/hr while actual radiation levels were as high as 200 mrem/hr in the work area. (See Detail 6)
