LICENSEE EVENT REPORT

Attachment To LER 80-25/01T
Beaver Valley Power Station
Duquesne Light Company
Docket No. 50-334

Event Description And Probable Consequences (continued)

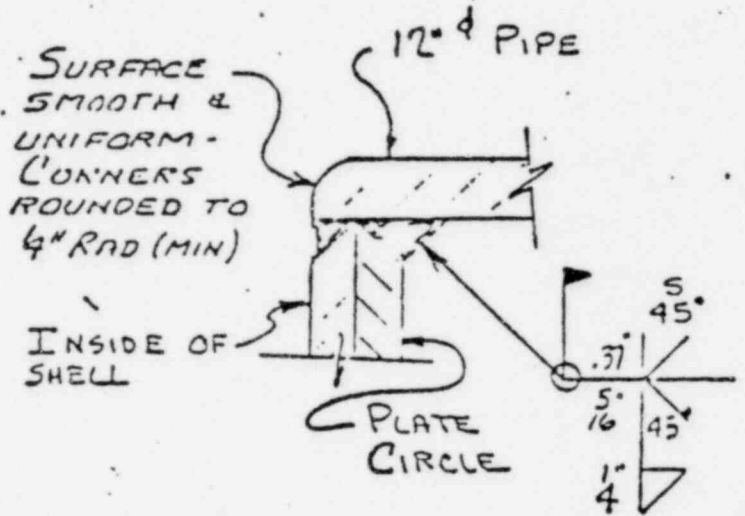
DETAIL "A"

AS PER GRAYER TANK DWG. B-314710

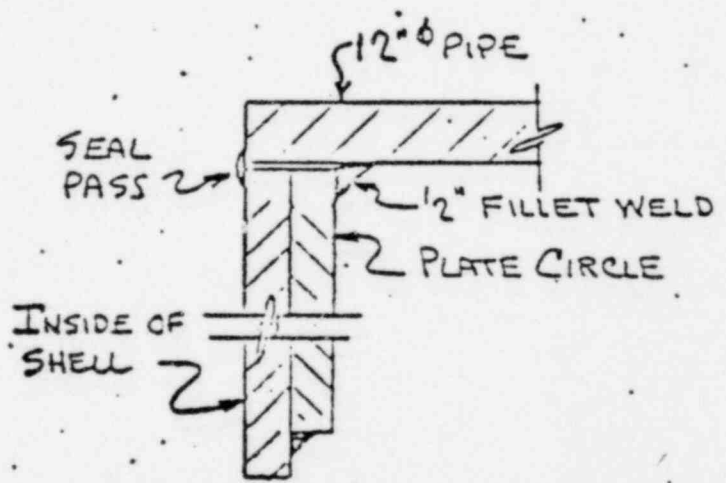
DETAIL - AS FOUND CONDITION IN QS-TK-1

02 | During a tank modification project, Beaver Valley field engineers reported on
03 | 4/15/80 that a weld on one of the 12" nozzle penetrations to the Refueling Water
04 | Storage Tank [OS-TK-1] does not conform with the manufacturer's design. This tank
05 | [OS-TK-1] was manufactured by Graver Tank and Mfg. Co. This condition was
06 | discovered during the process of adding an internal elbow to the tank. The design
07 | specification called for all tank penetrations to be full penetration welds. As
08 | found, the piping penetrations are seal welded on the inside (continued on attached)

of the tank and a reinforcing pad external to the tank is fillet welded. (See attached drawing of one 12" penetration). The stress analysis for the "as found" weld has not yet been completed so no probable consequences can be advanced. The results of this analysis will be identified in a followup report.

Demineralized Water Storage Tank [WT-TK-10], Boron Recovery Test Tanks [BR-TK-2A] and [BR-TK-2B], Coolant Recovery Tanks [BR-TK-4A] and [BR-TK-4B] and Primary Water Storage Tanks [BR-TK-6A] and [BR-TK-6B]. At the present time, Demineralized Water Storage Tank [WT-TK-10] will be inspected and repaired, if found to need it. There is no program at the present time to test any of the non-safety related tanks. Beaver Valley Onsite Engineering Group and a construction service crew will make all necessary repairs. No time frame for completion of the inspections has been set as of this date.
