OCONEE NUCLEAR STATION
STEAM GENERATOR TUBE LEAK
STATUS REPORT

September 24, 1977

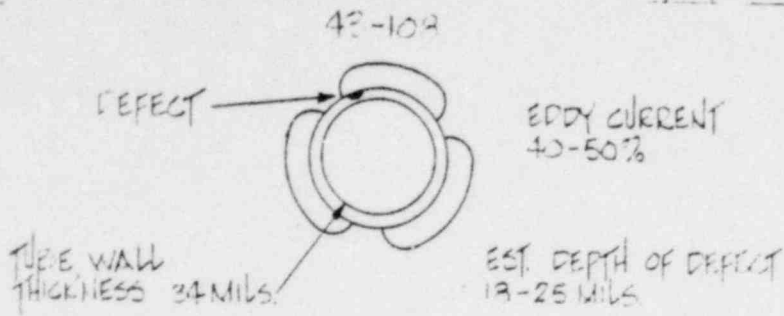
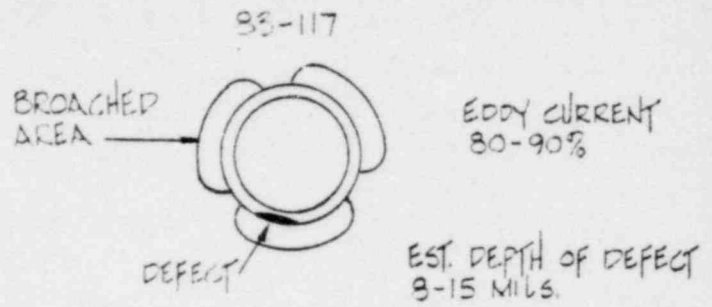
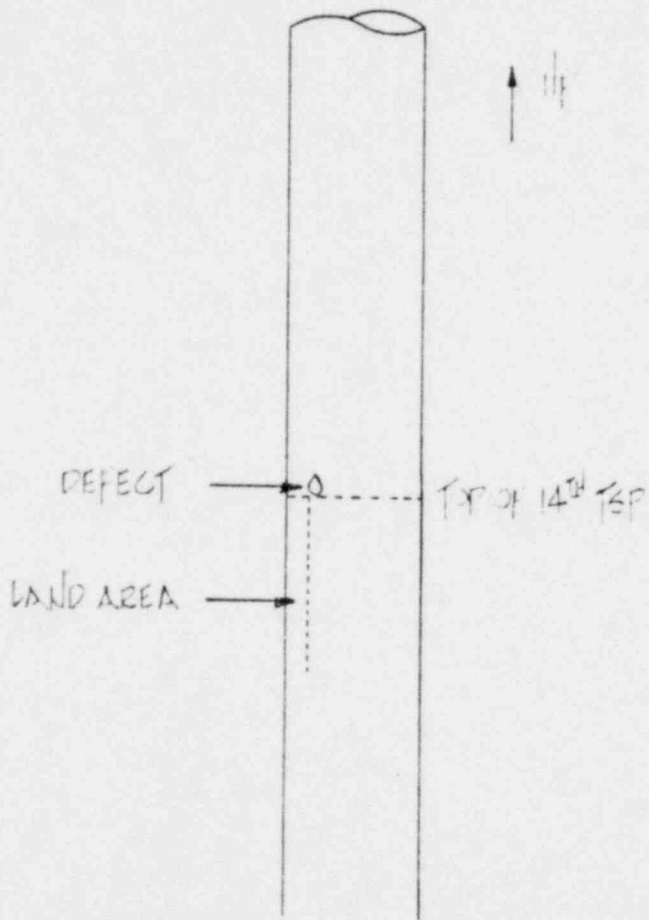
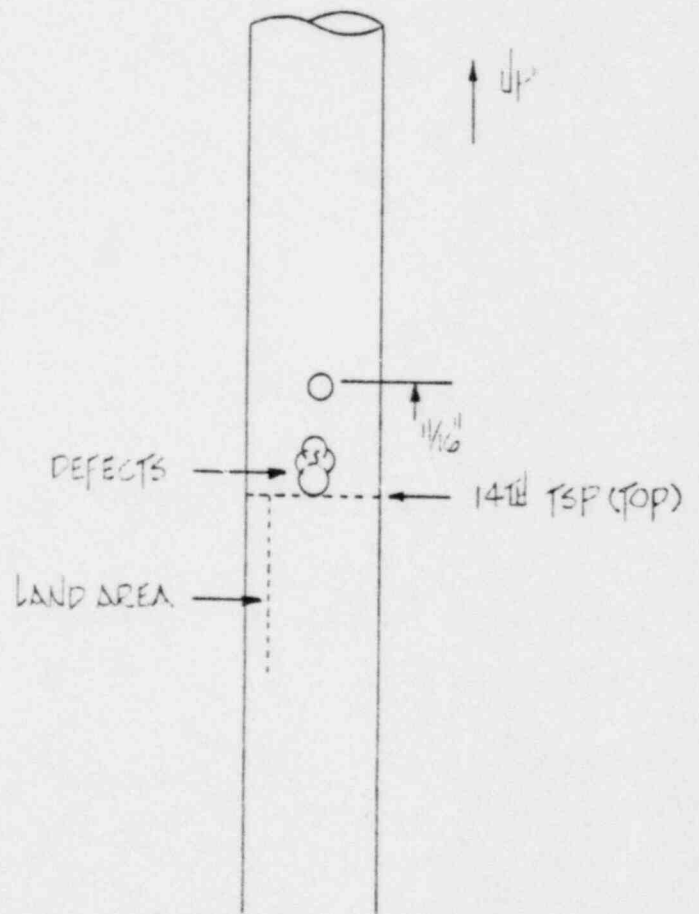
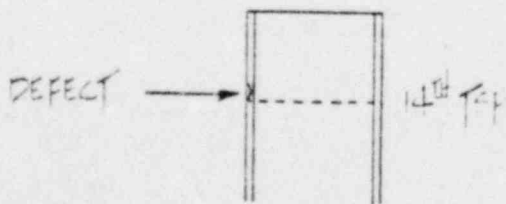
FIGURE 2

Due to the large number of defective eddy current indications, some of which indicated 90%-100% through wall, it was considered essential to obtain tube samples from the periphery for examination. A technique was developed and two tubes were removed and visually inspected on site, with detailed metalurgical analyses to be performed at a later date. The first tube removed was 43/108 which had an eddy current indication of 45-50% through wall at just above the 14th support plate. A visual inspection revealed an eroded area 1/8 inch long and 1/16 inch wide approximately .020 inches deep.

The second tube removed was 83/117 which had an eddy current indication of 80-90% through wall. This tube had erosion wear along a greater area approximately 1 inch long but appeared only to be about 0.010 inches deep. It appeared that the relatively large area of these defects caused the eddy current interpretation to be significantly overestimated. A diagram of these two defects is provided in Figure 2.

1. Information will be provided in a subsequent status report on the metallurgical examination conducted on removed tubes 43/108 and 83/117. This information is expected to be available by December 15, 1977.
